### **Puyallup River Basin Flood Risk Reduction Feasibility Study**

# Appendix F-1

## Geotechnical: Levee Characterization

**Puyallup River Basin  
Flood Risk Reduction Feasibility Study**

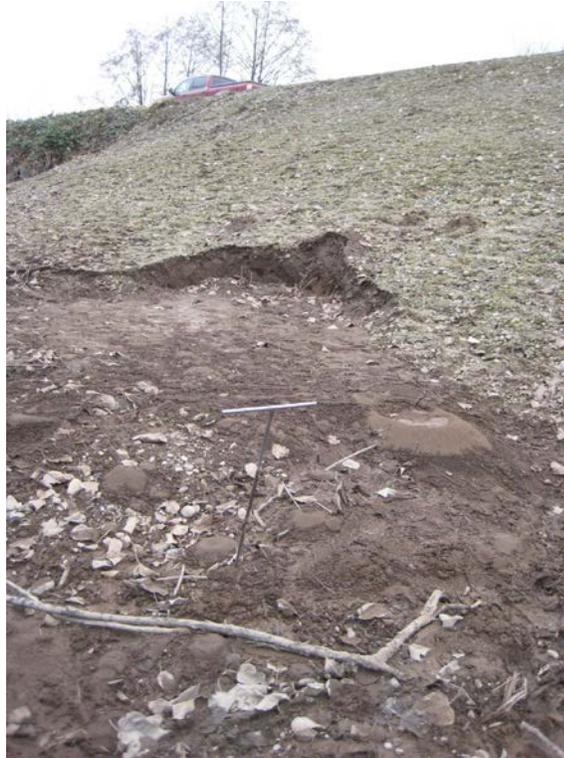
Seepage boils with significant sand cones and landward slope stability sloughing were noted on the North Levee Road levee near the Sha Dux site in the January 2009 event, which loaded the levee to approximately 90% of its full height. This location has been repaired by the County with a seepage berm and toe drain in Fall of 2012.

Figure #: Seepage boils and landward toe sloughing during January 2009 high water.

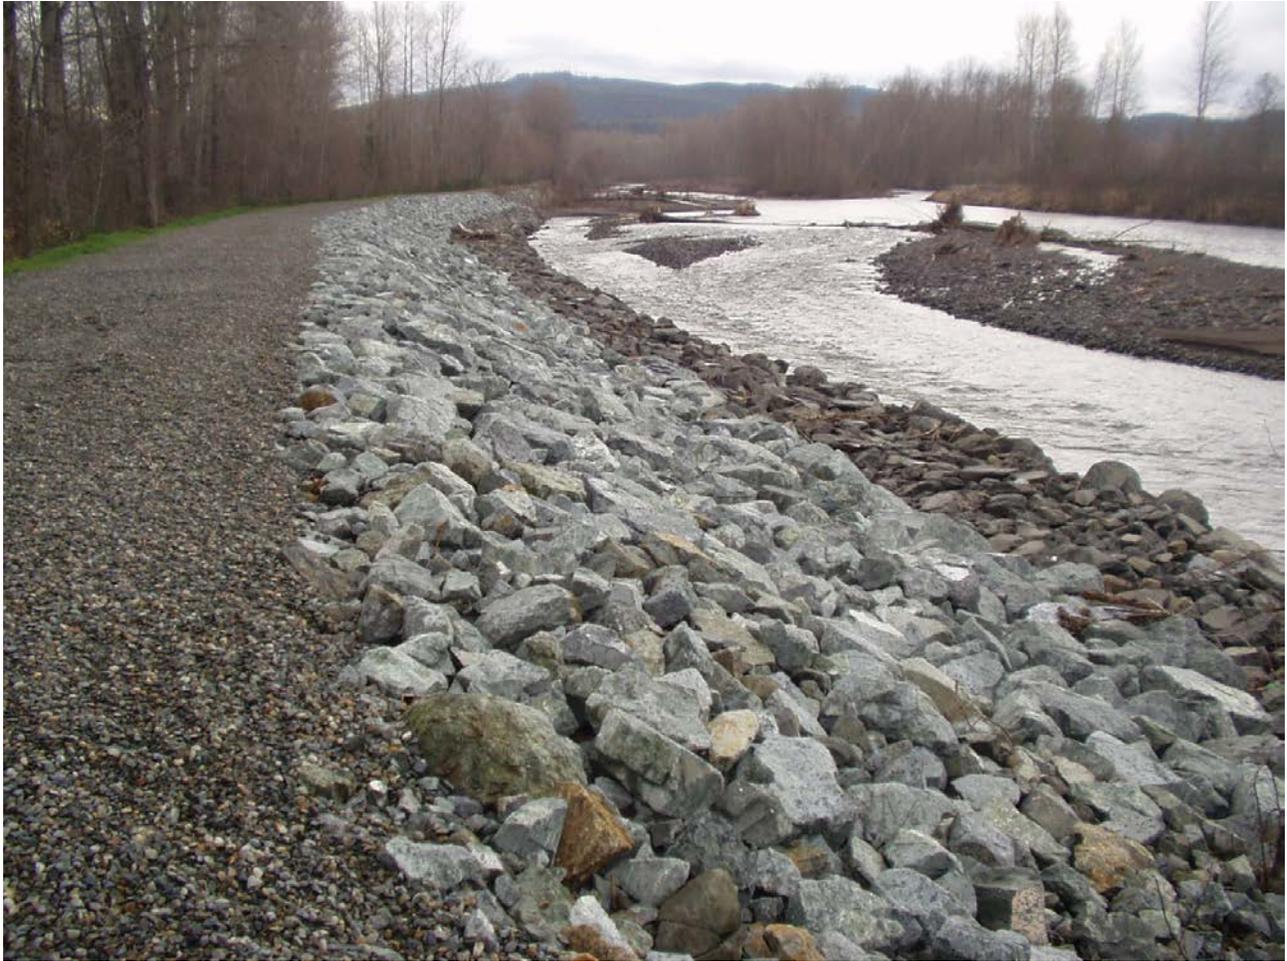
Figure #: 2010 Jones Levee Rehabilitation

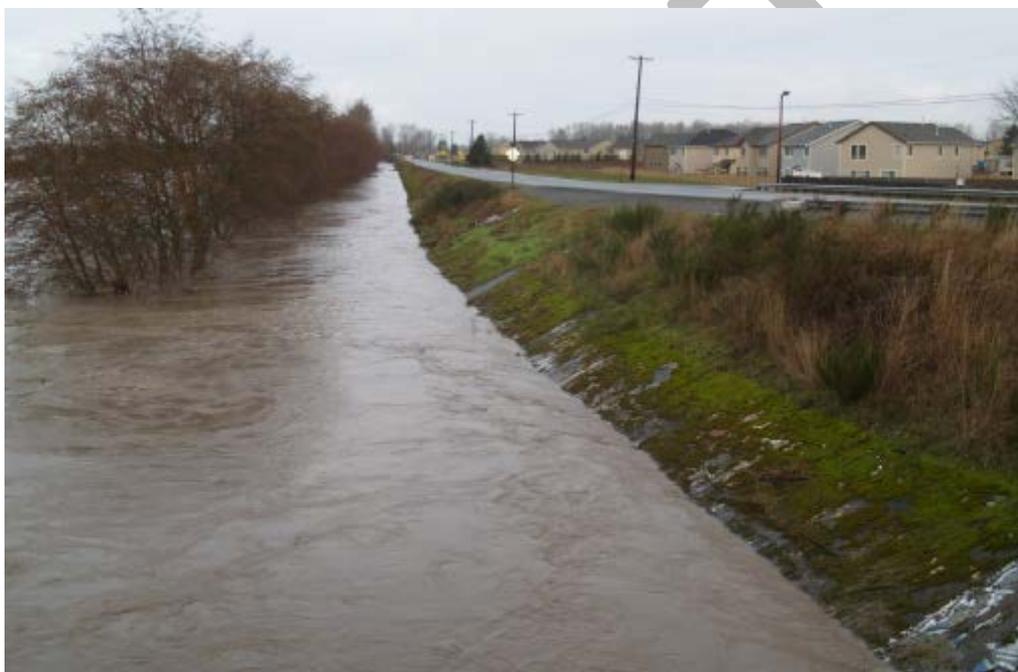
Figure 1: Flood loading on North Levee Road. Note concrete panels along riverside slope for erosion protection. Trees in stream are rooted in a silt bench riverward of panels. (Looking downstream).

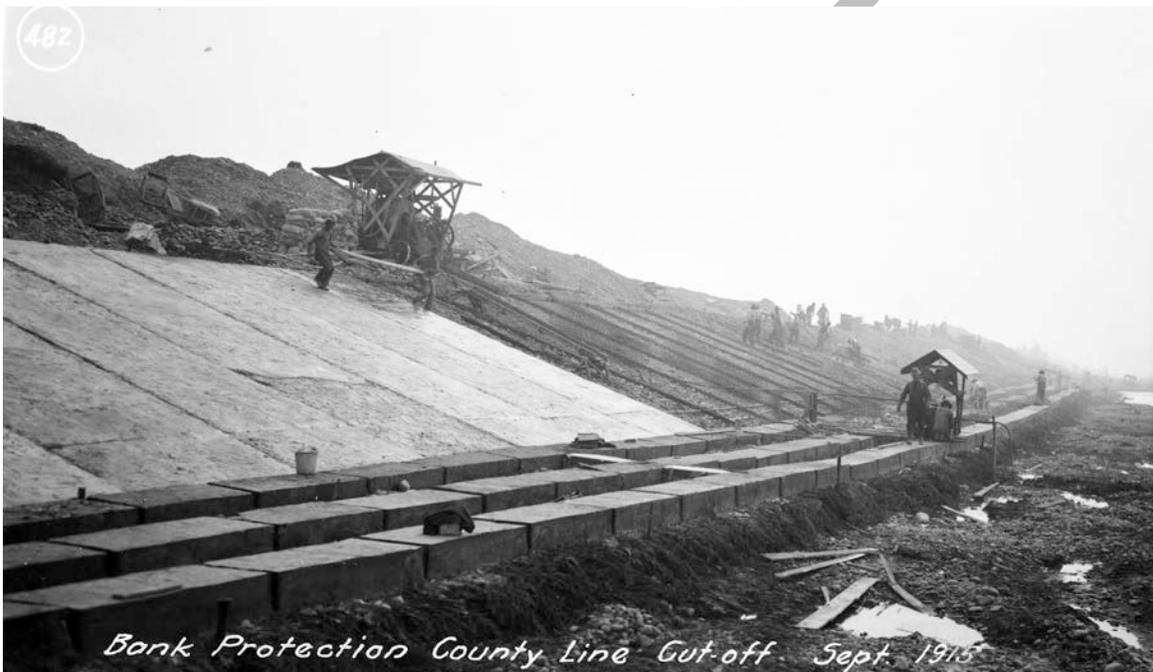
Figure 2: Typical concrete slope revetment, brush mats, and concrete blocks on mats constructed.

Two instances of concrete panel degradation have been noted by Pierce County personnel on the left bank River Road Levee. See Figure 2. Concrete blocks are visible in the channel. These are either from the slope panel protection or from concrete blocks used to weigh the brush mats down during installation.

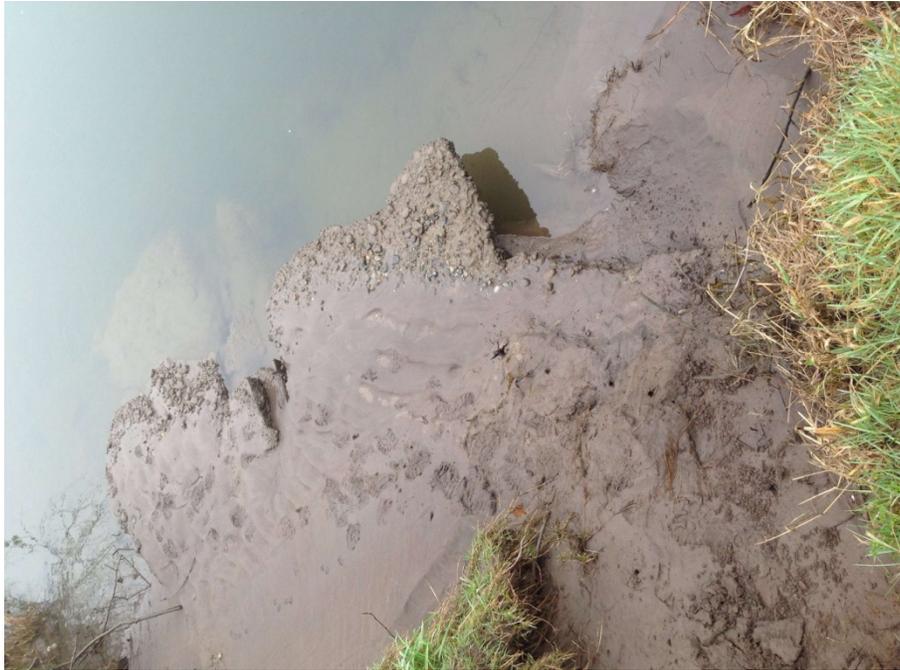
Figure 3: Concrete rubble at the toe of the River Road Levee slope near RM 3.1.

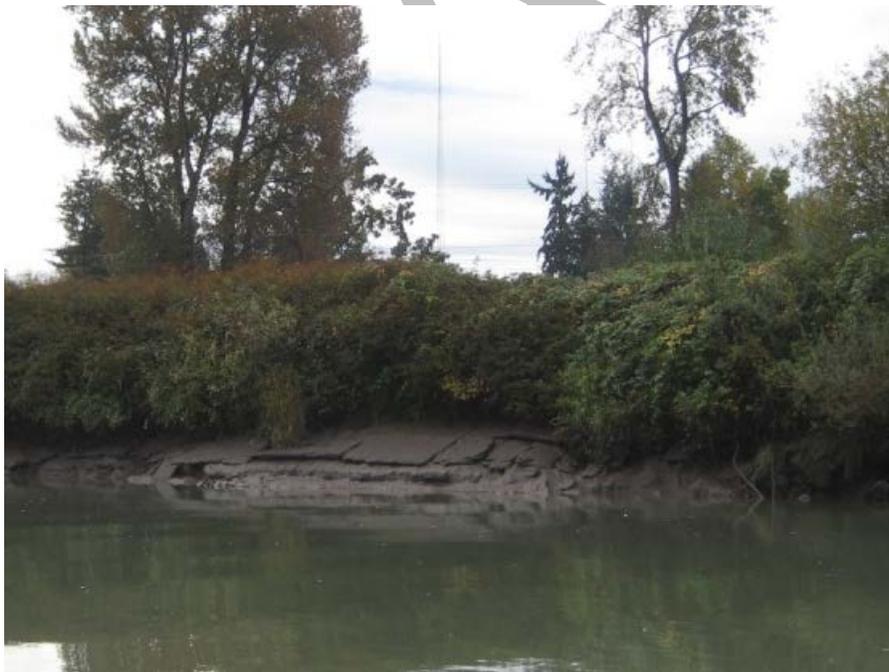
Figure 4: Concrete rubble at the toe of the River Road Levee slope near RM 3.0.
