Appendix B:
Summary of Winslow Levee and Ruby Wash
Diversion Levee, Winslow, AZ (Navajo County):
History, Composition, Foundation
(USACE 2010)

Summary of Winslow Levee and Ruby Wash Diversion Levee, Winslow, AZ (Navajo County): history, composition, foundation

What is known from literature on materials and construction, geotechnical conditions in the levee embankments and their foundations: data to support the Little Colorado River at Winslow feasibility study

12 March 2010

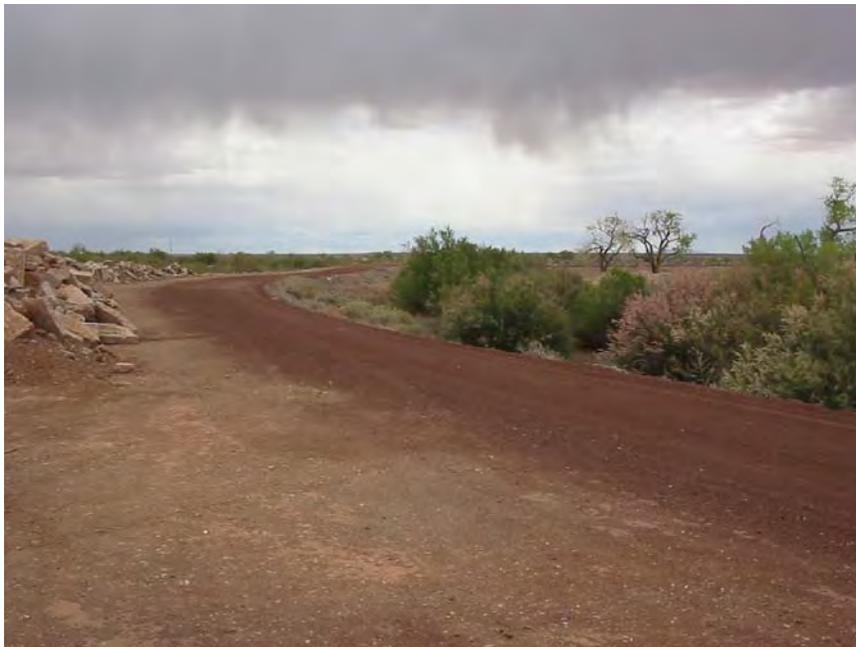
left, Winslow Levee, looking upstream from the “meandering loop” conjunction with the Levee, sta. 163+80. Photograph by US Army Corps of Engineers, 15 May 2008.

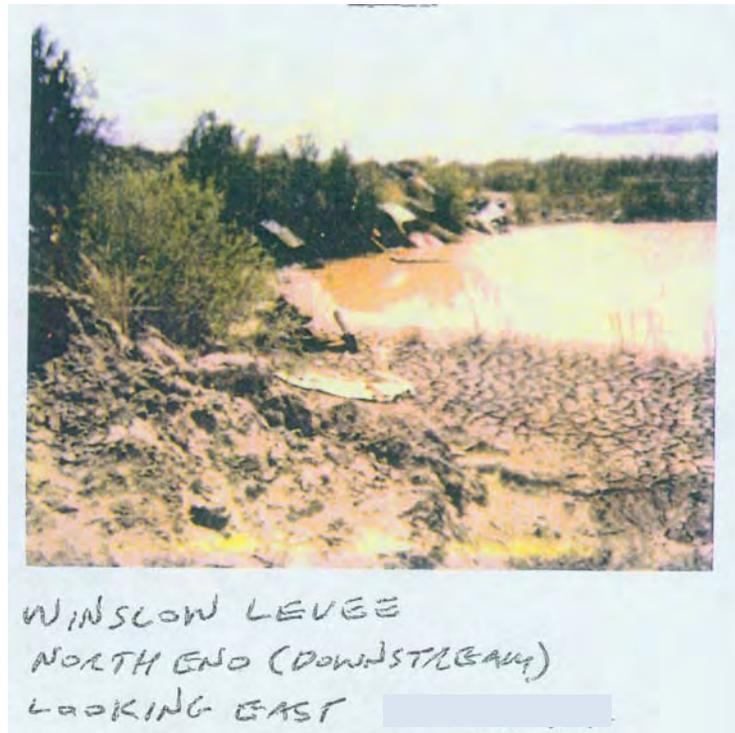
Fig. 7.—(2 frames, one above, one below) Two views that include at least one car body in the Levee on 25 April 1990, which is after the 1989 rebuild was completed. The top frame is Gregory (1990, enclosure no. 8), and is reported to be at station 345+66. The bottom frame, also with Gregory (1990) files, was un-annotated, but appears to be a view of the same location, with better resolution.

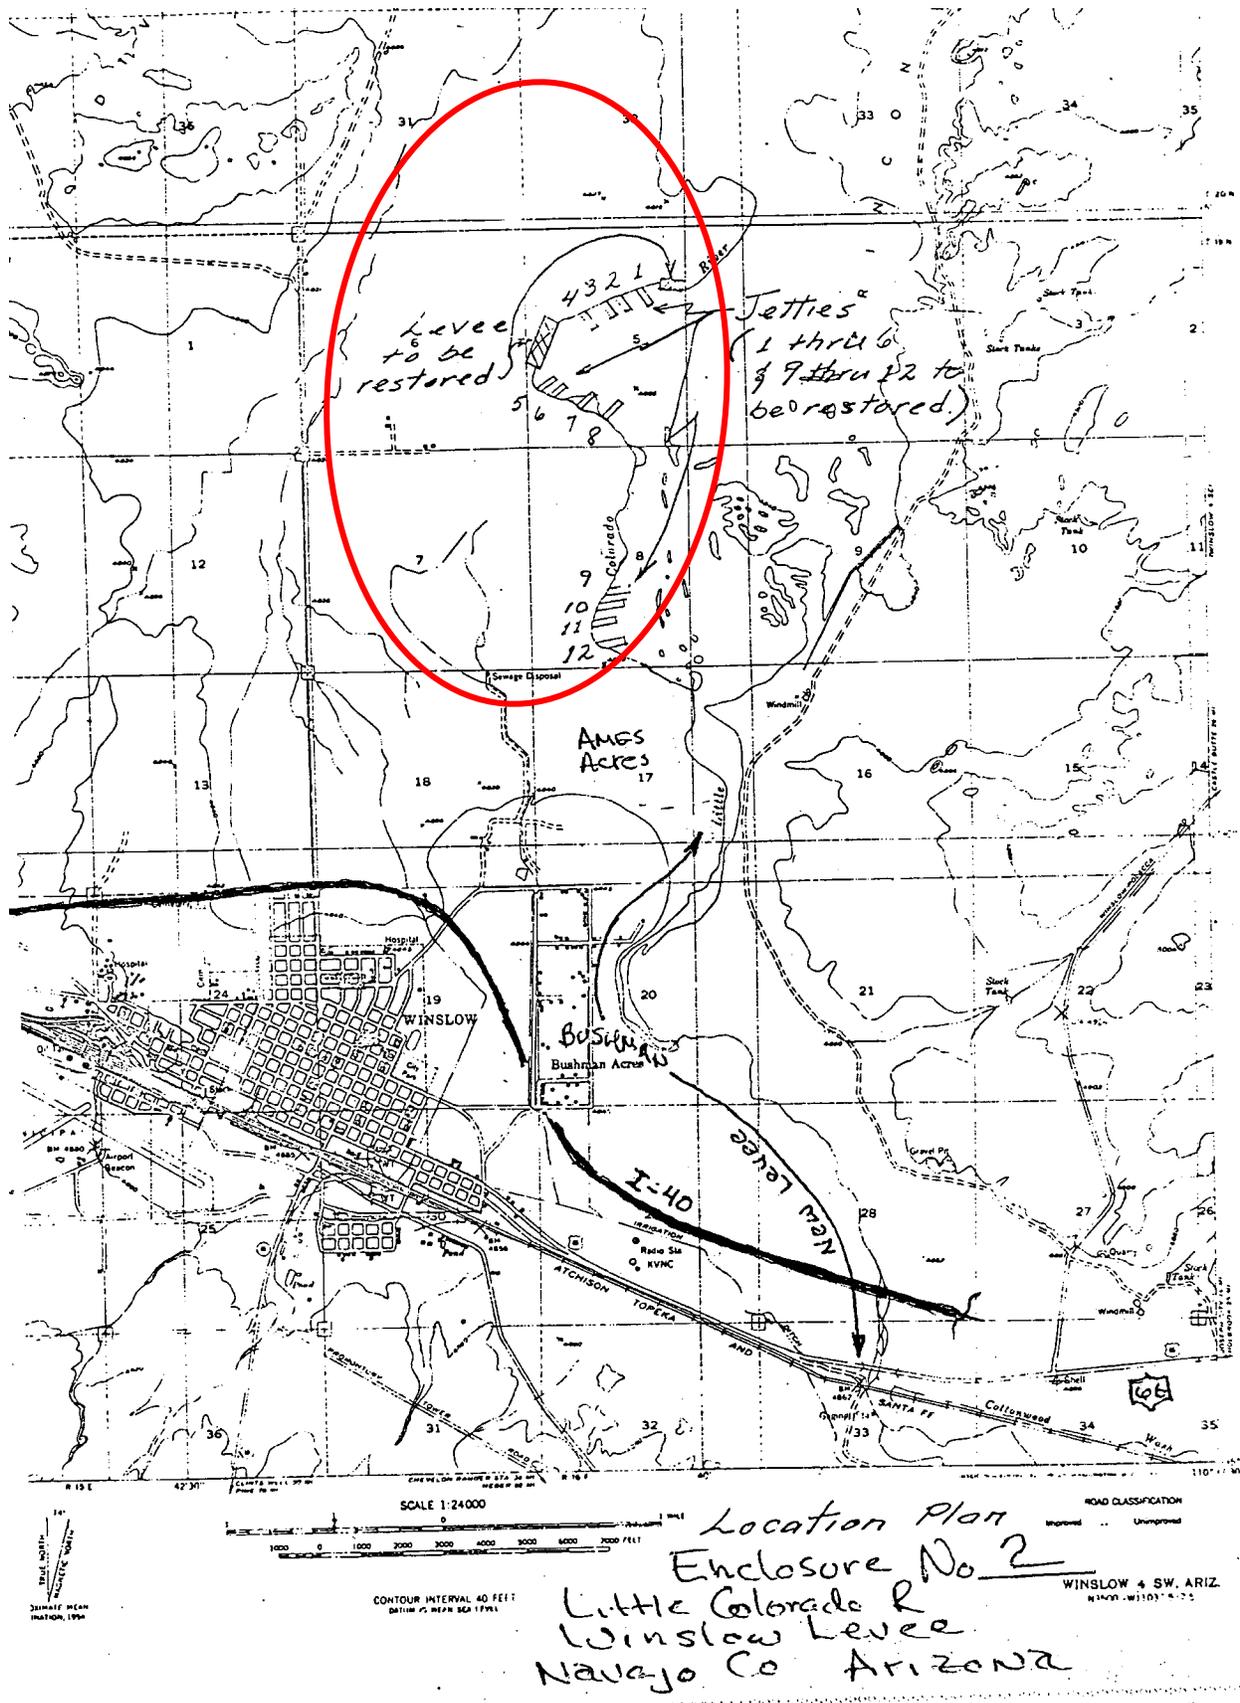
Fig. 9.—Winslow levee, from Gregory (1990, encl. 2). The only known information on locations of 12 jetties (inside red oval) north of sta. 275+00. See also two zones of Levee noted as needing restoration.

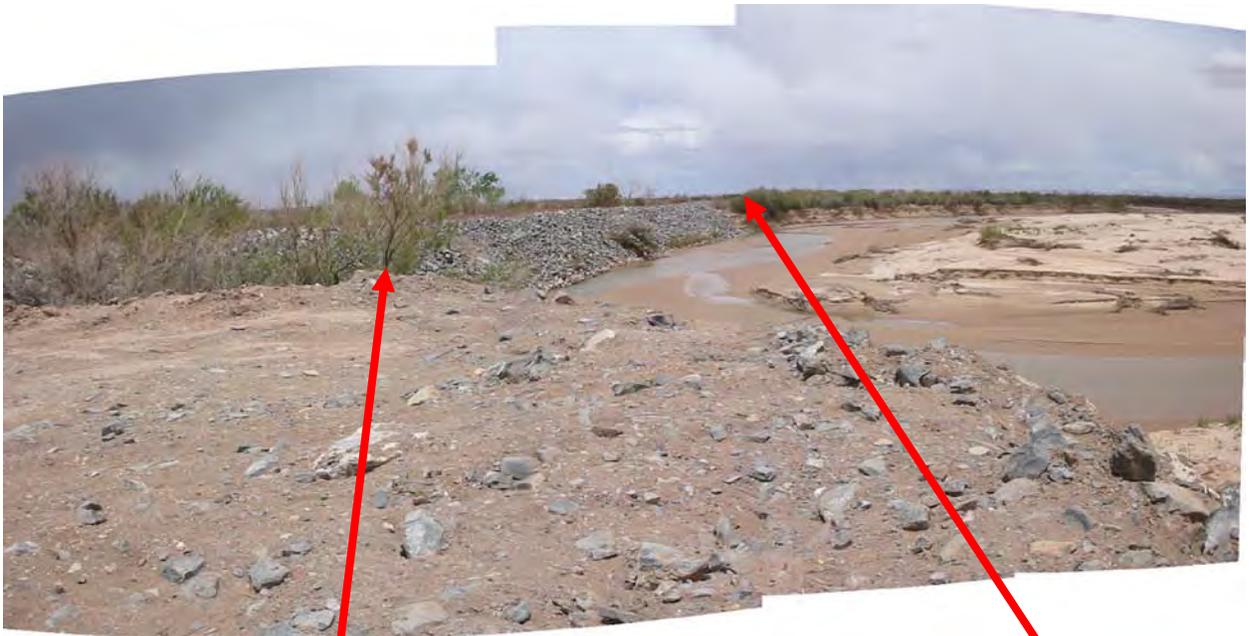
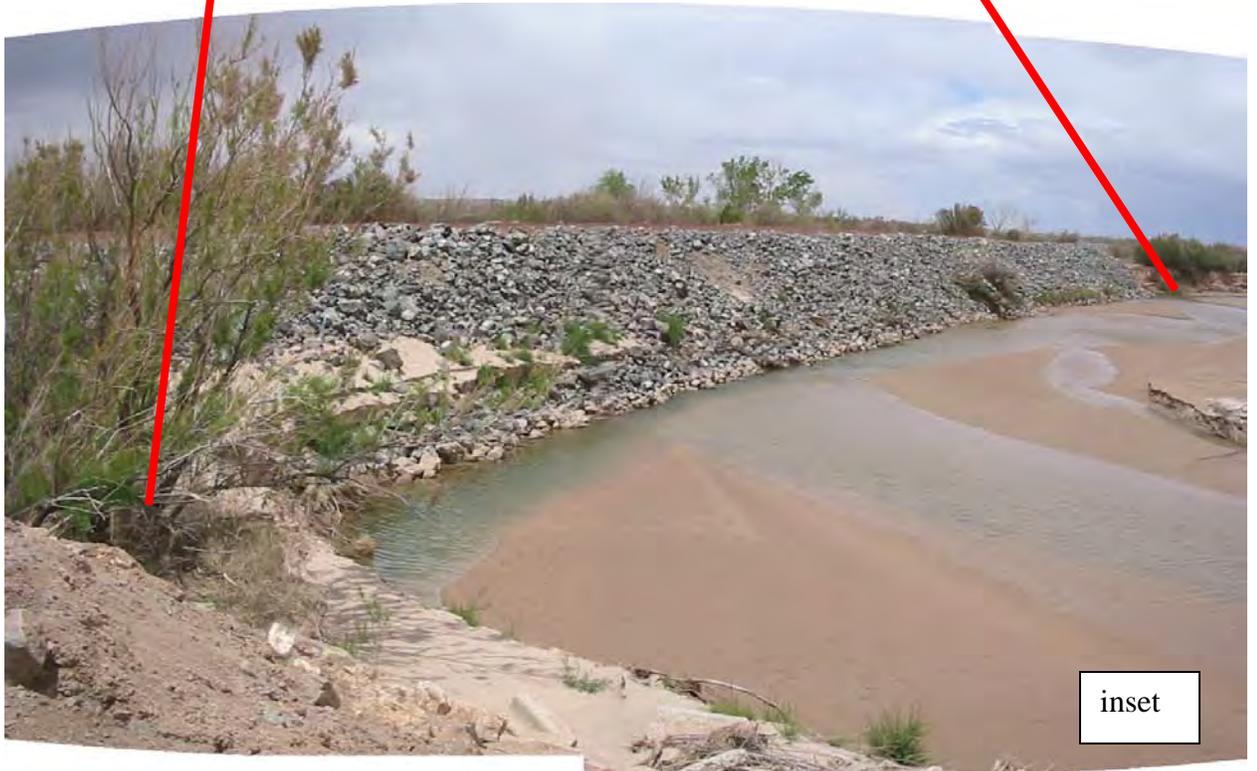
Fig. 13.—(Top) Riprap-protected downstream impingement point, looking downstream from the Winslow Levee crest, and (bottom) inset showing more detail of the same riprap protection site. Note light tan sand and strand line in the left and left-center of frame. Photograph by US Army Corps of Engineers, 15 May 2008.

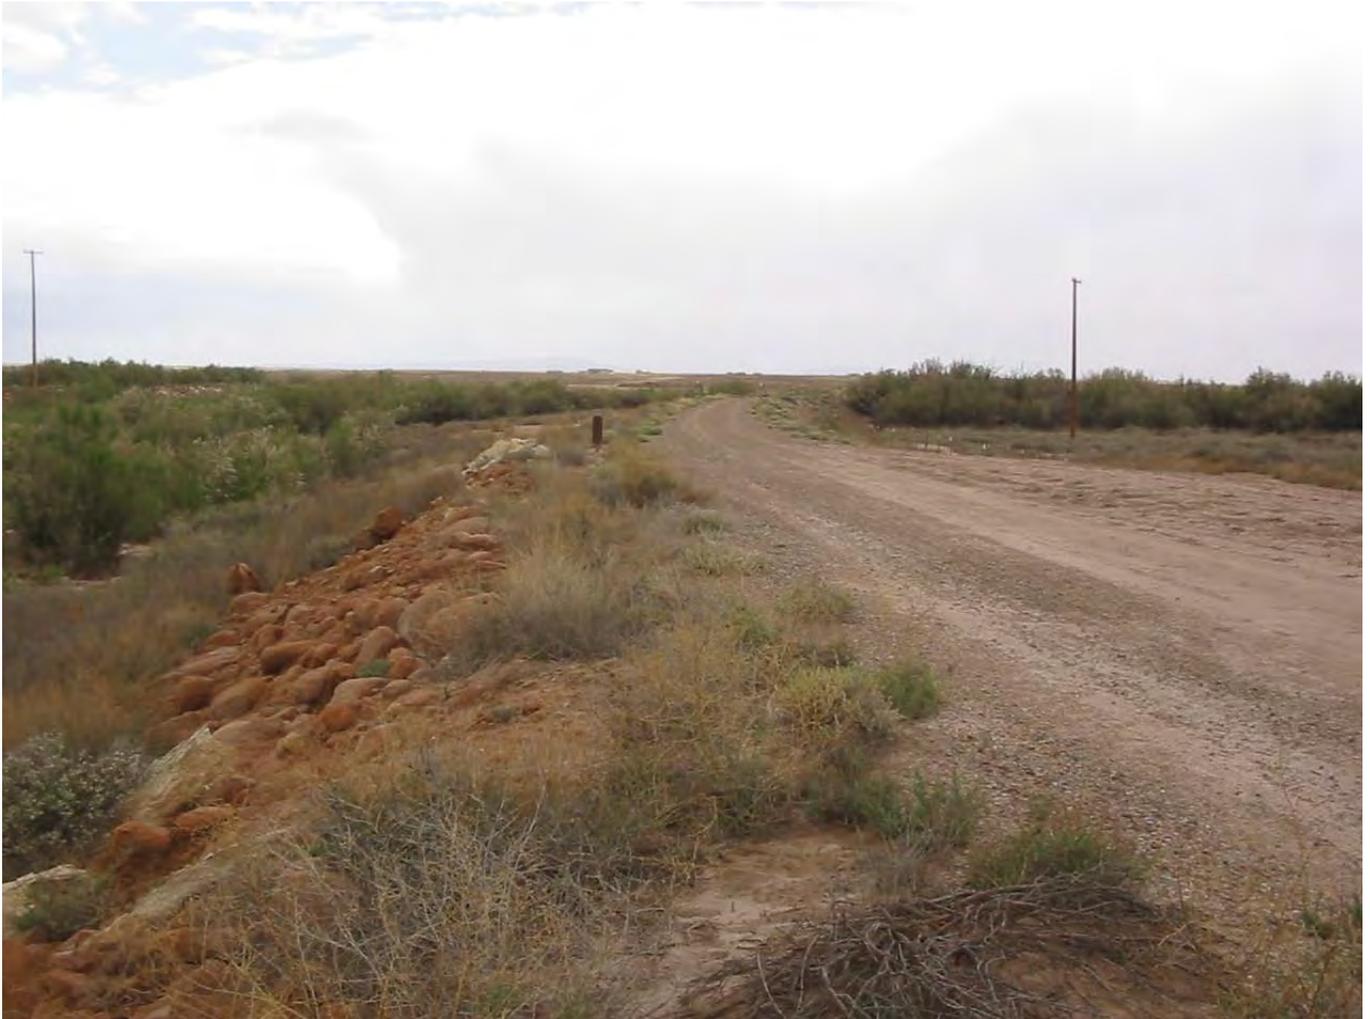
Fig. 15.— Moenkopi Formation riprap (orange) on the inner slope of Winslow levee, near the upstreammost extent of the levee. View is upstream, and the Little Colorado River is to the left. View to the south, 15 May 2008.

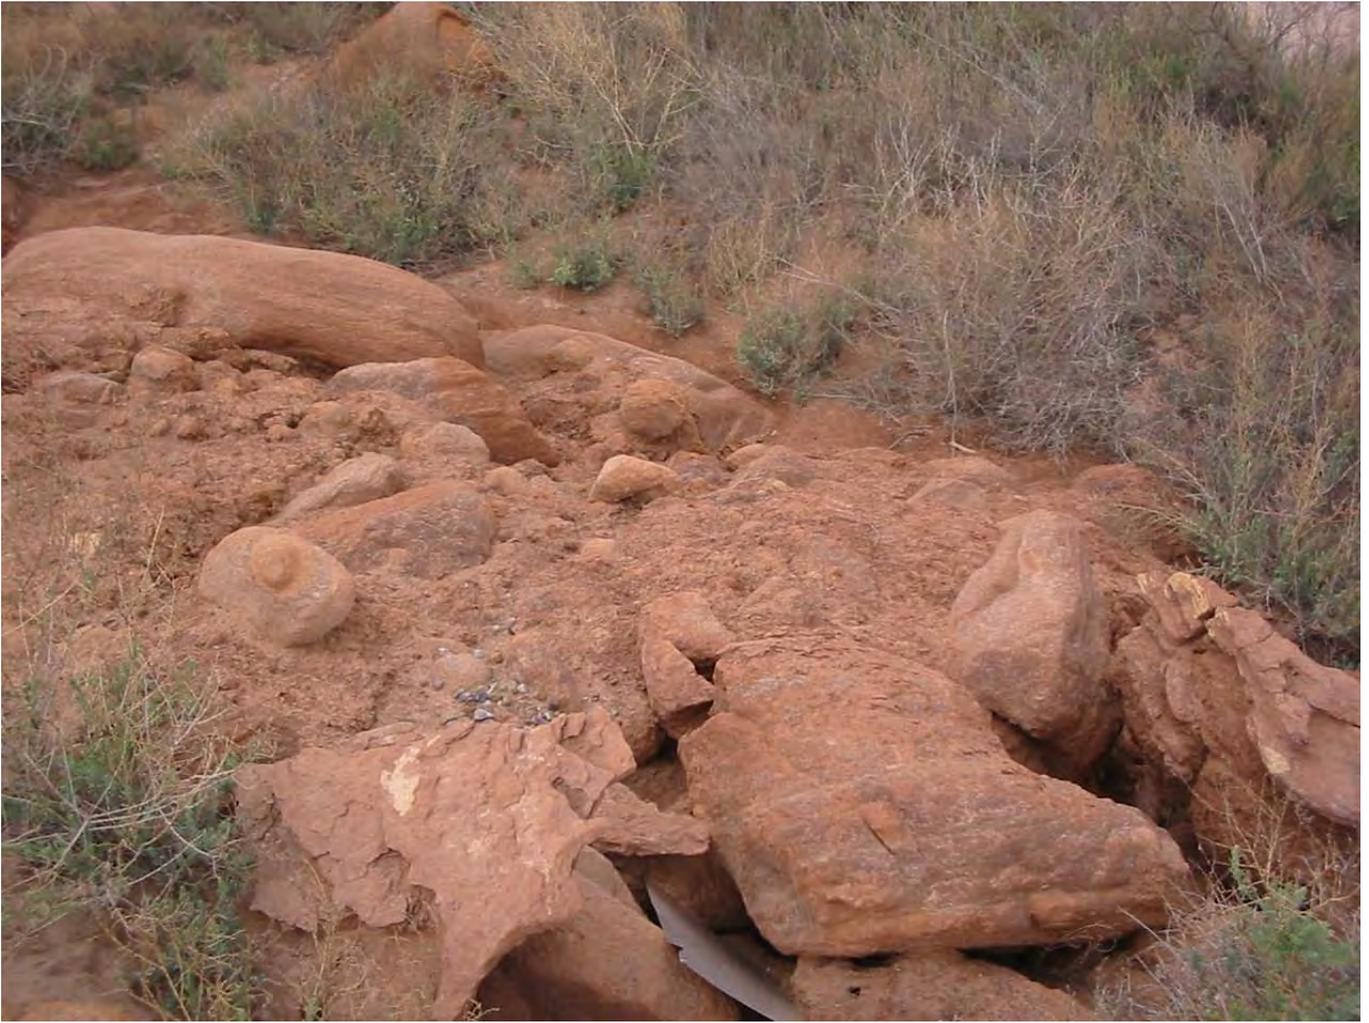
Fig. 16.— Detail of badly deteriorated, crumbling Moenkopi Formation riprap on the inner slope of Winslow levee, near the upstreammost extent of the levee. See also [fig. 15](#). 15 May 2008.

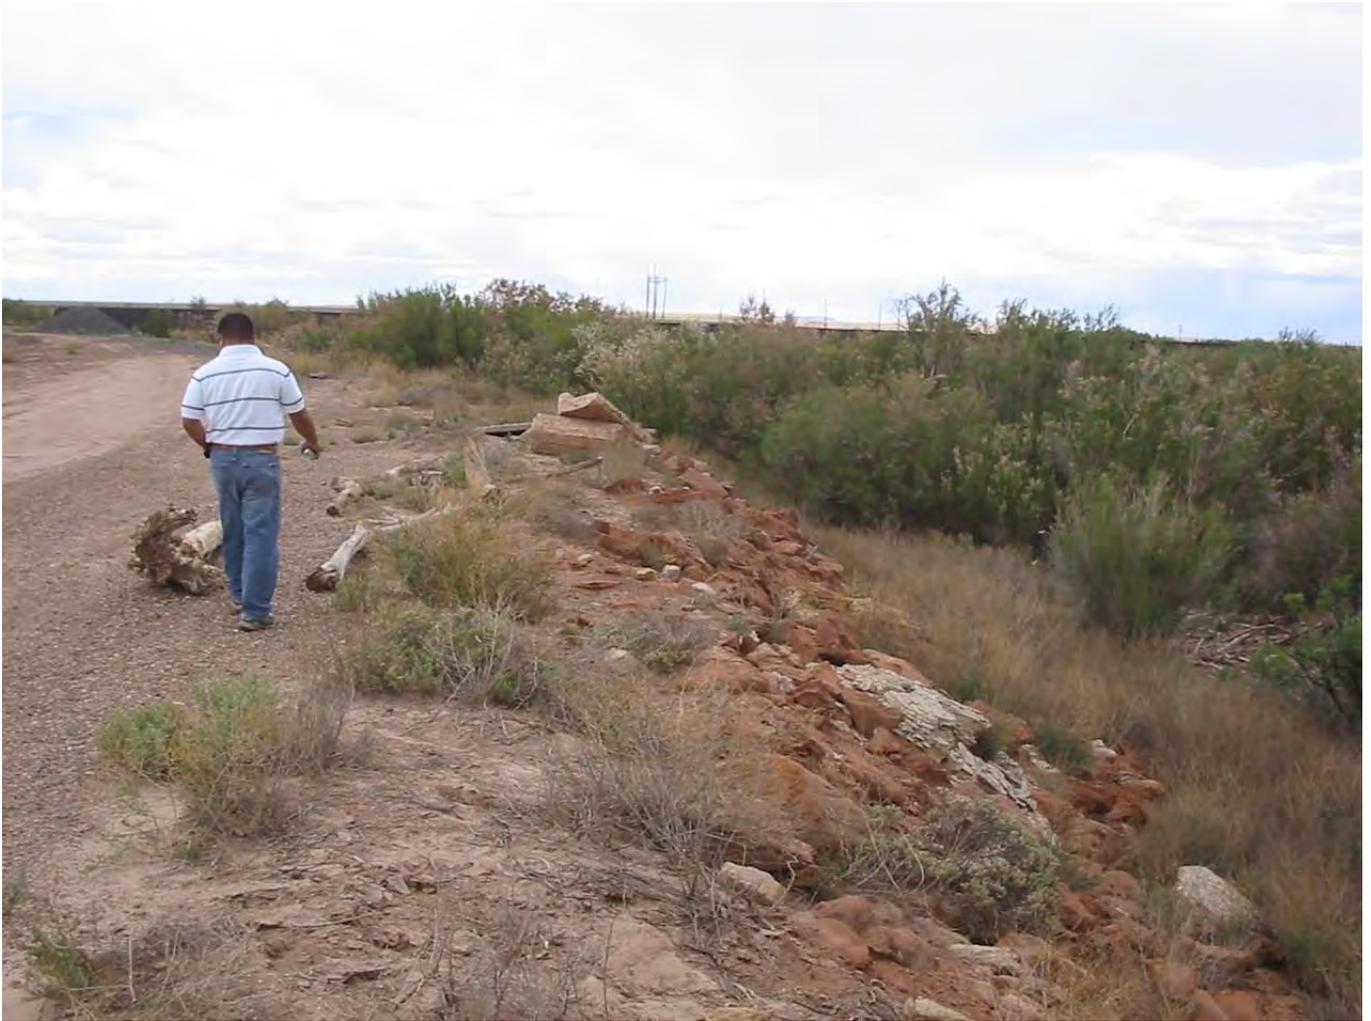
Fig. 17.— Detail of badly deteriorated, crumbling Moenkopi Formation riprap (orange rock) and badly spalling, deteriorating Kaibab Formation riprap (white rock) on the inner slope of Winslow levee, near the upstreammost extent of the levee. See also [figs. 15, 16](#). BNSF railroad bridge ([of fig. 18](#)) is in the background, just left of the person's head. View is downstream (north-northeast), 15 May 2008.

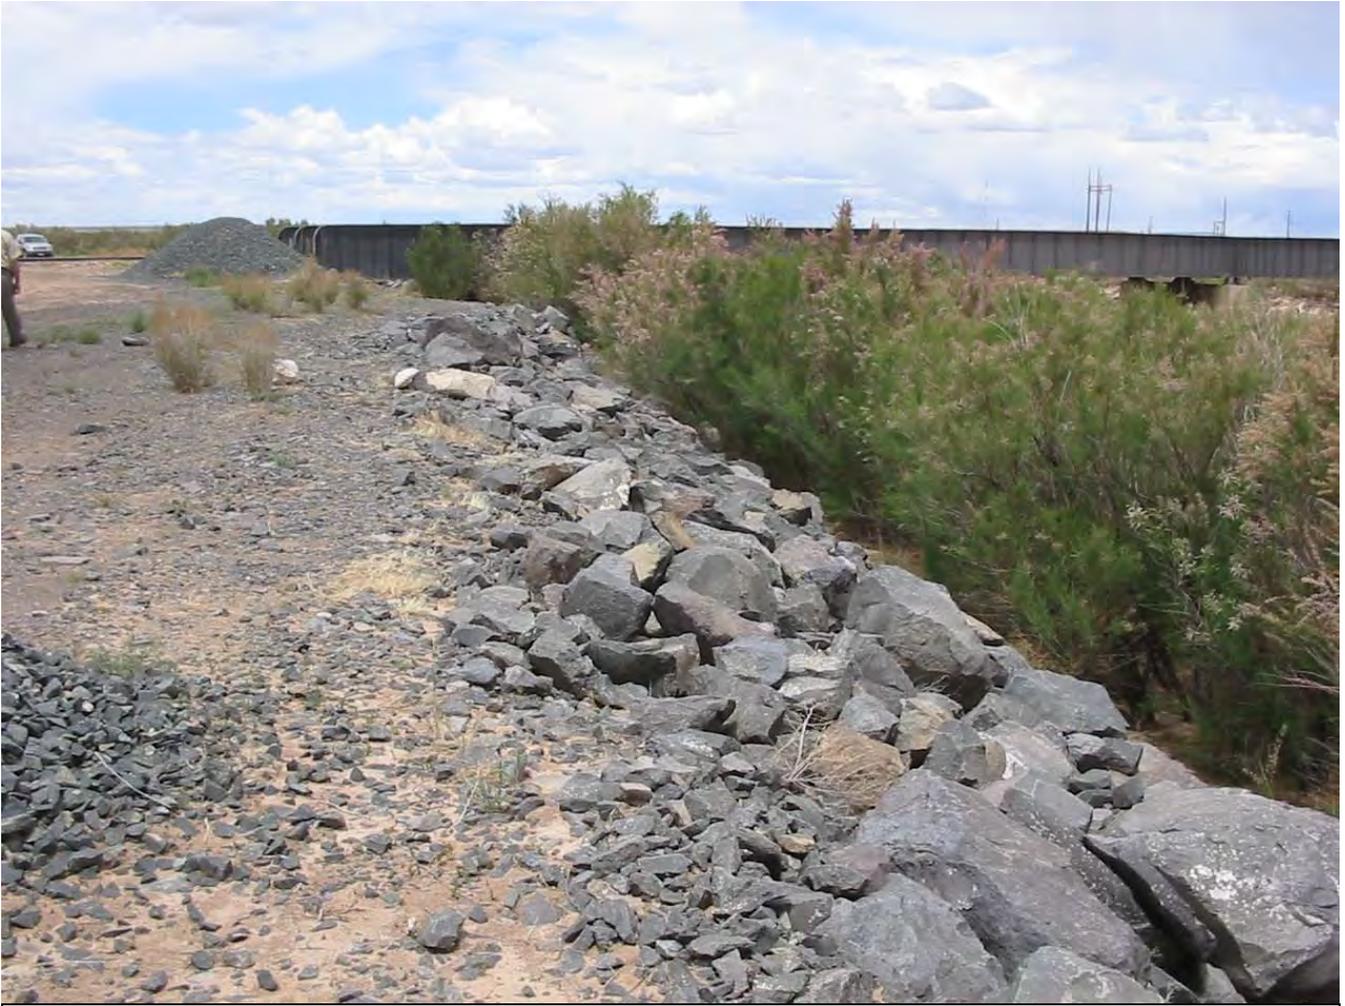
Fig. 18.— Basalt riprap on the inner slope of Winslow levee, near the upstreammost extent of the levee. Note the BNSF Railway Co. bridge in the background. Note stockpiled basalt riprap near the bridge. View to the northeast (downstream), 15 May 2008.

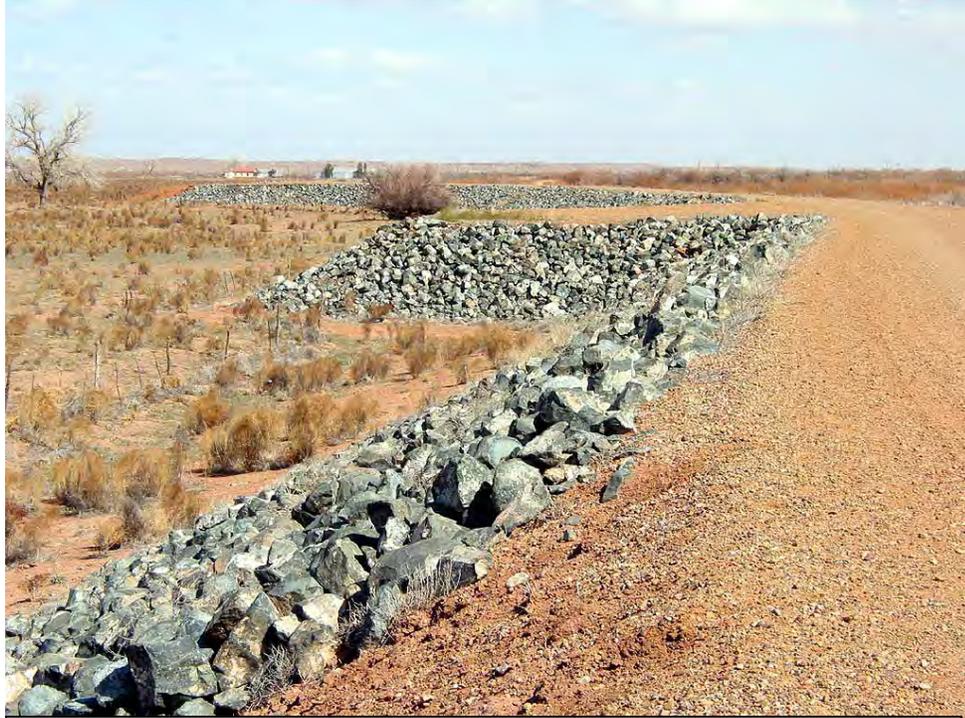
Fig. 19.— Bidahochi basalt in place on the Winslow Levee, a part of the permanent repair of the 1993 breach. Landside, looking downstream (north). Refer to [fig. 6](#) for the breach location.

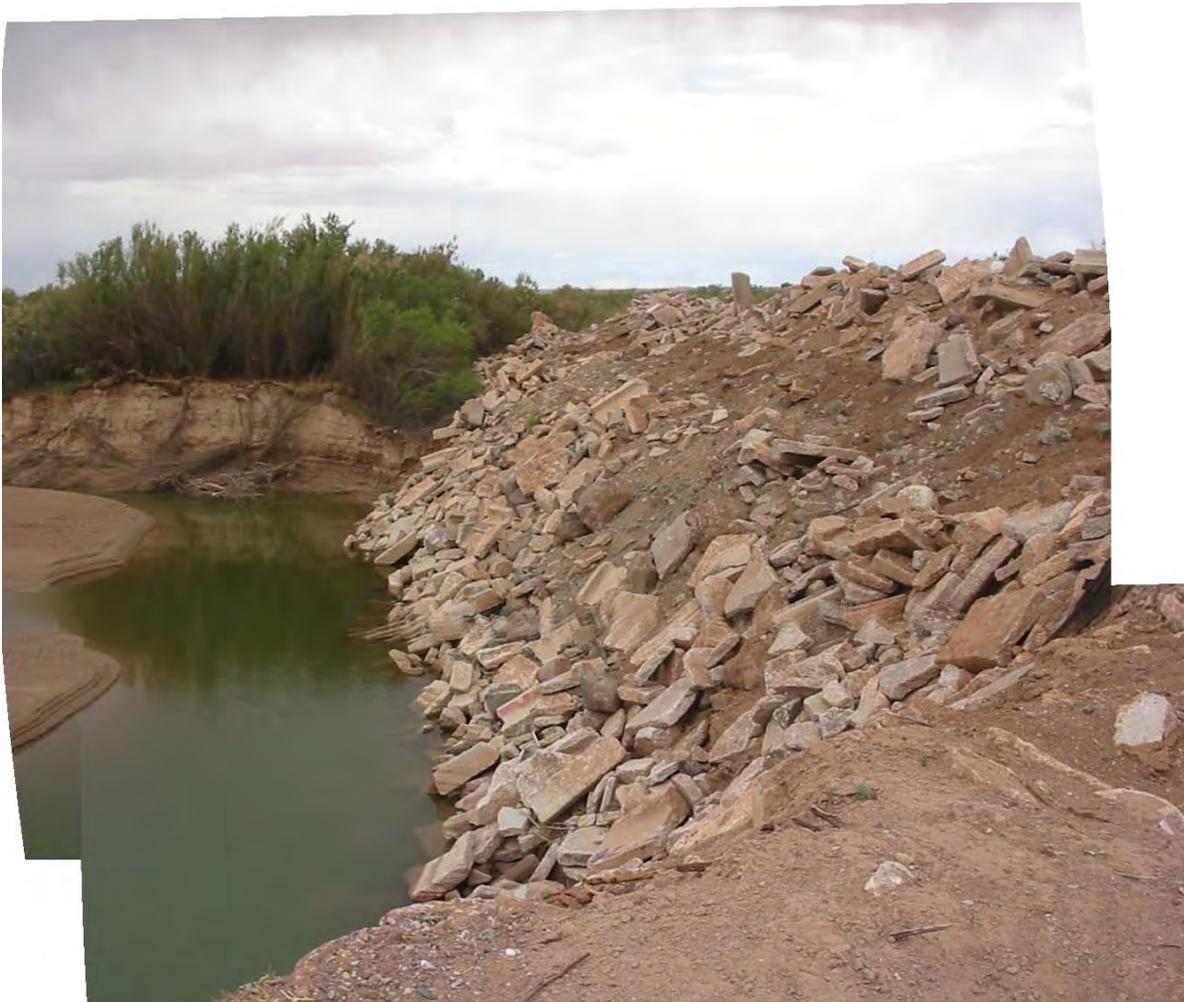
Fig. 22.— Placed waste concrete riprap to arrest toe undercutting by the meandering loop of the Little Colorado River, approximately sta. 163+30, and looking upstream. This emergency placement saved the Levee during an early 2008 flood flight. See also [fig. 23](#). Photo of 15 May 2008.

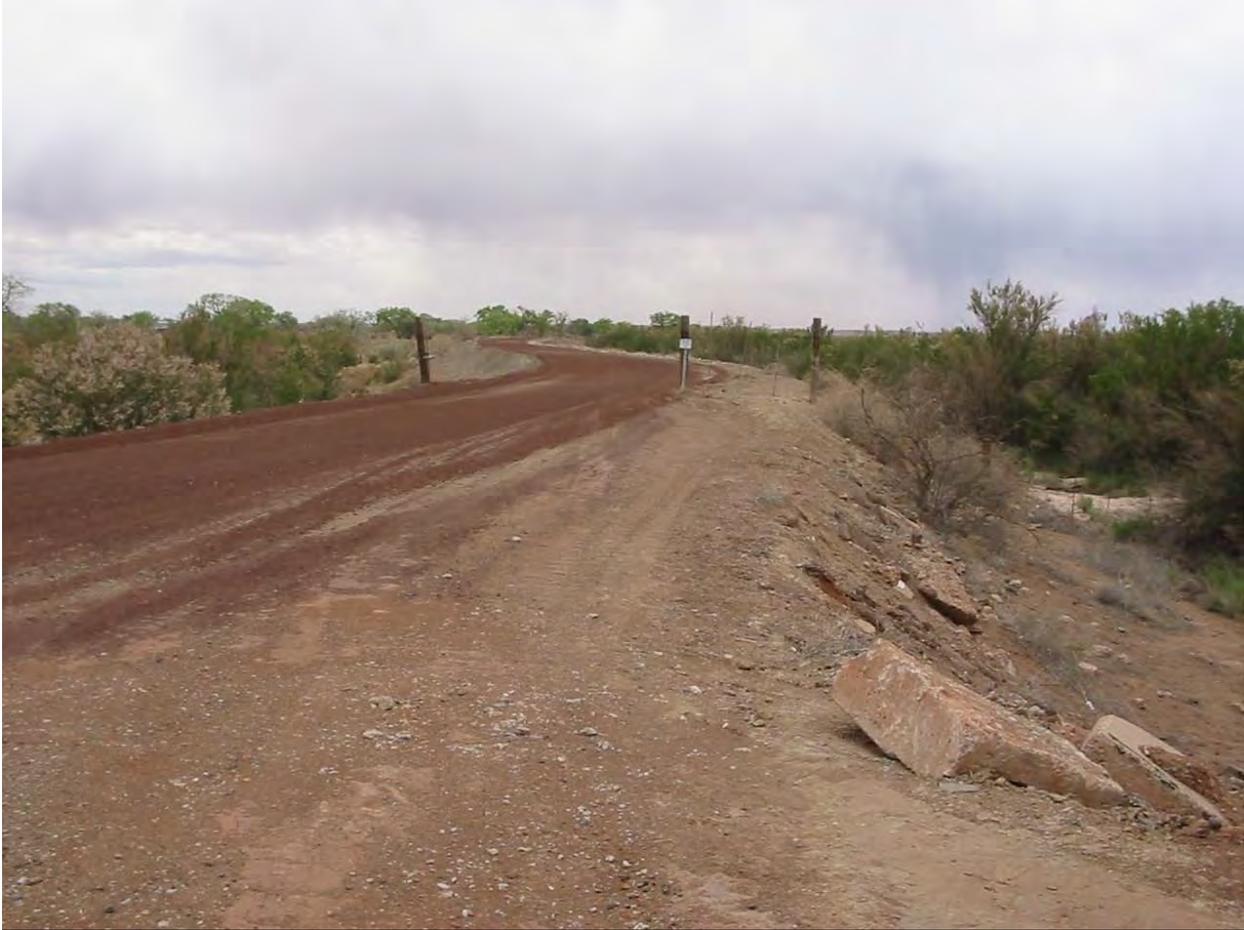
Fig. 24.—Un-armored segment of Winslow Levee at approximately sta. 163+80, looking downstream (north); riverside is to the right. This is part of the Levee segment that was armored with stone riprap in Nov. 2009. Photo taken 15 May 2008.

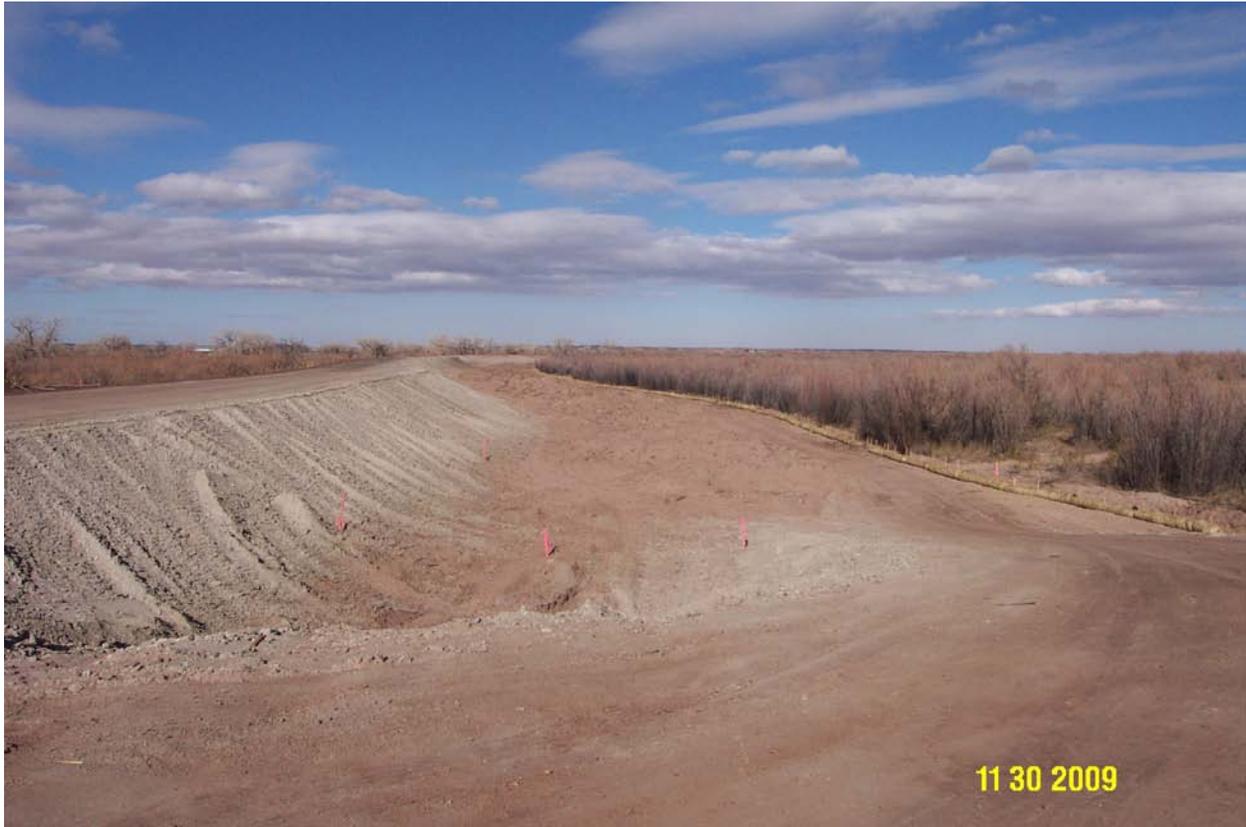
Fig. 25.—Winslow Levee prepared for the filter fabric and riprap addition of 2009, at approximately sta. 163+80, looking downstream. The riprap application during this exercise took place from sta. 163+80 to sta. 176+96.34. Photograph supplied by Navajo County Public Works.

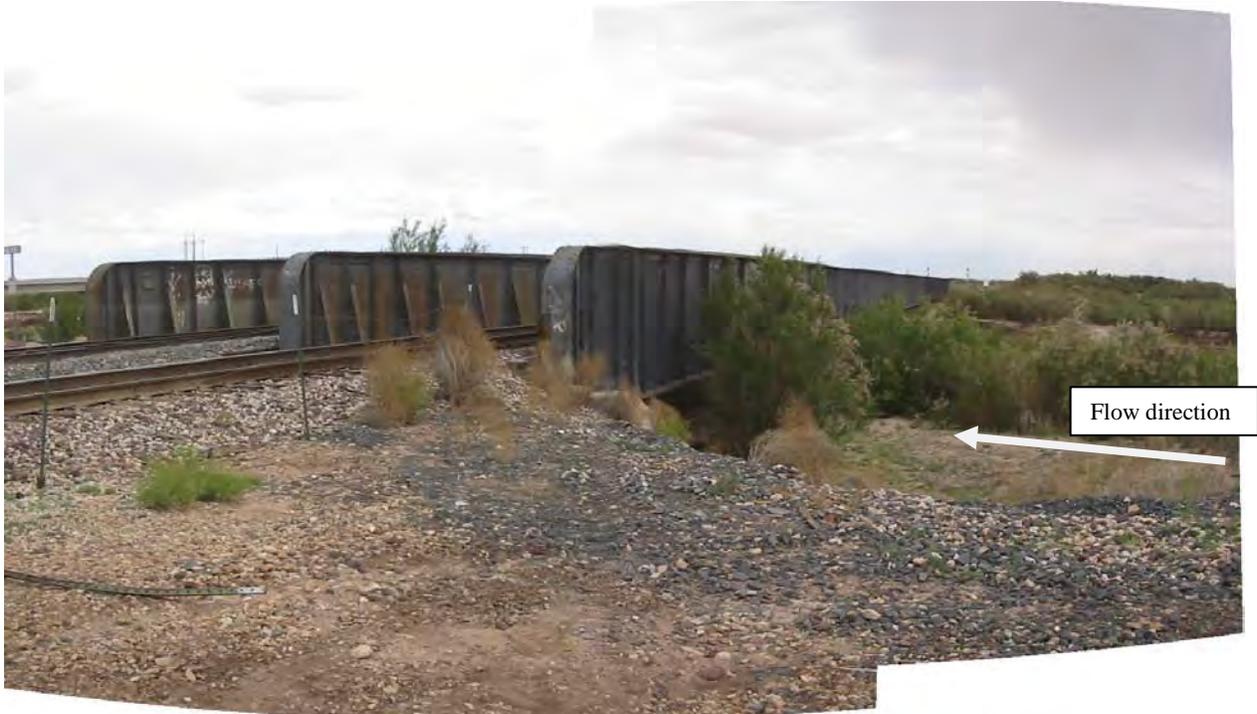
Fig. 27.—BNSF Railway Co. bridge over the Levee and the Little Colorado River, looking east and perpendicularly at the Little Colorado River (vegetation on the right half of frame). The Levee is in the foreground around the bridge abutments. Photograph of 15 May 2008.

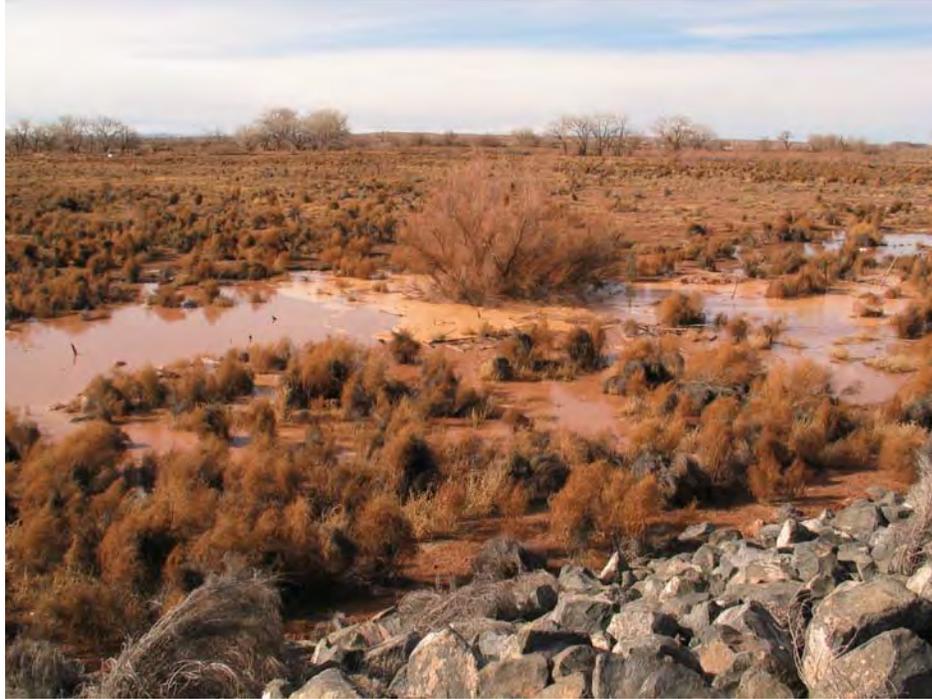
Fig. 28.--Flooding on land side from Dec. 2004 piping failure

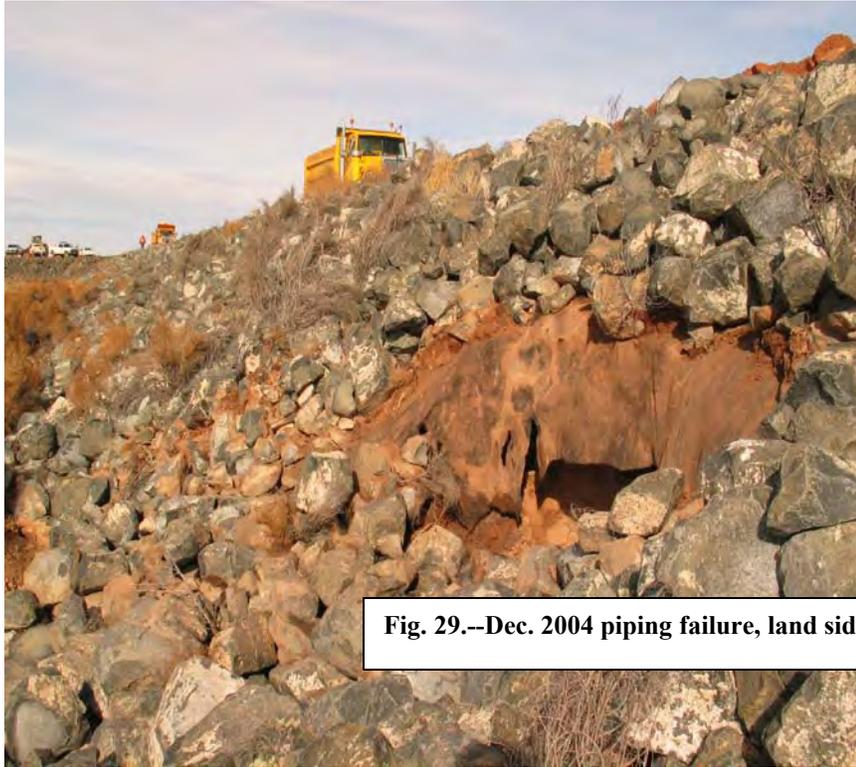
Fig. 29.--Dec. 2004 piping failure, land side, view 1.

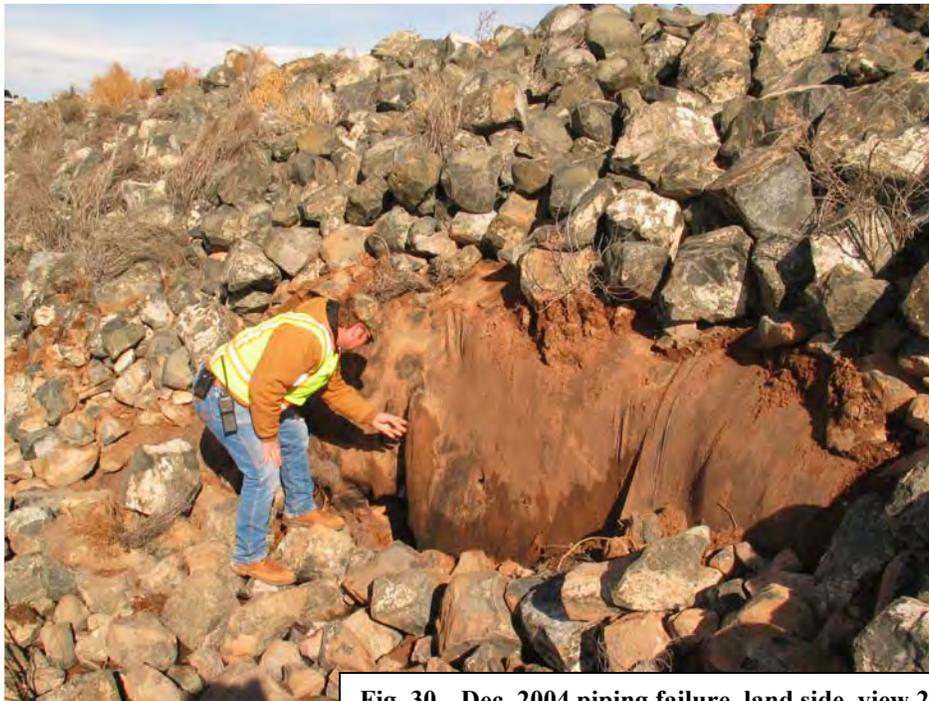
Fig. 30.--Dec. 2004 piping failure, land side, view 2.

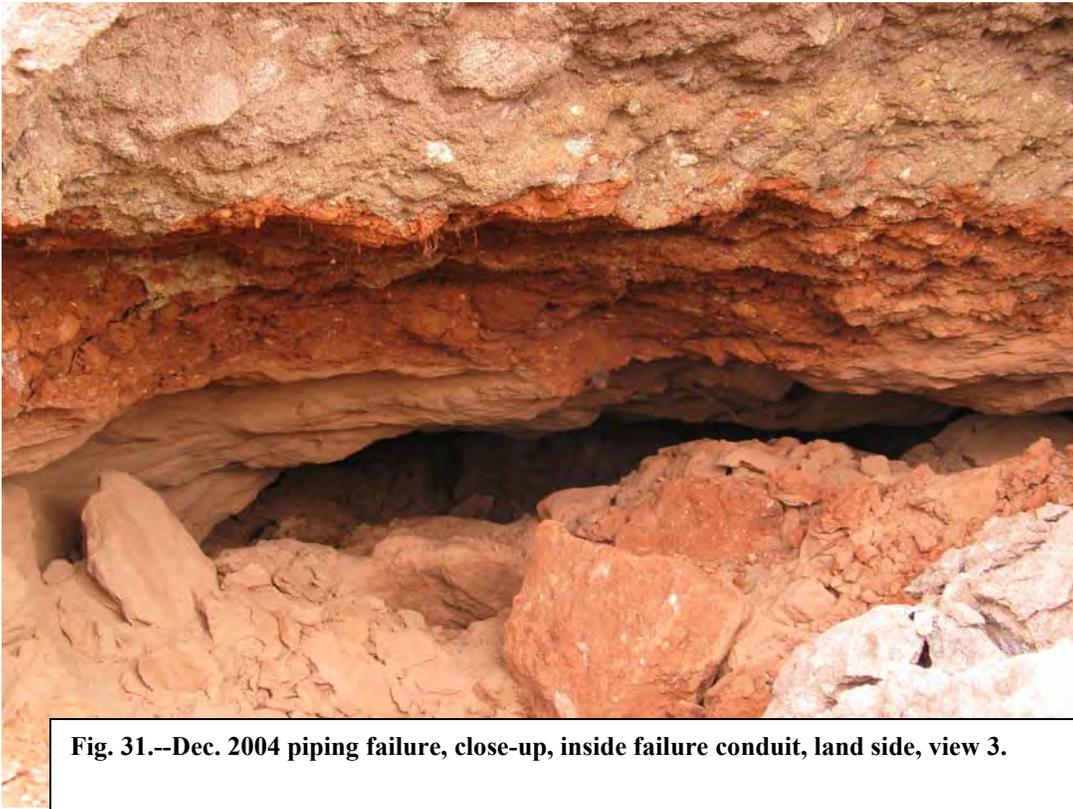
Fig. 31.—Dec. 2004 piping failure, close-up, inside failure conduit, land side, view 3.
