Little Colorado River Feasibility Study Report

APPENDIX F Geotechnical

Geotechnical Appendix: Geotechnical Study Report

Little Colorado River at Winslow Feasibility Study

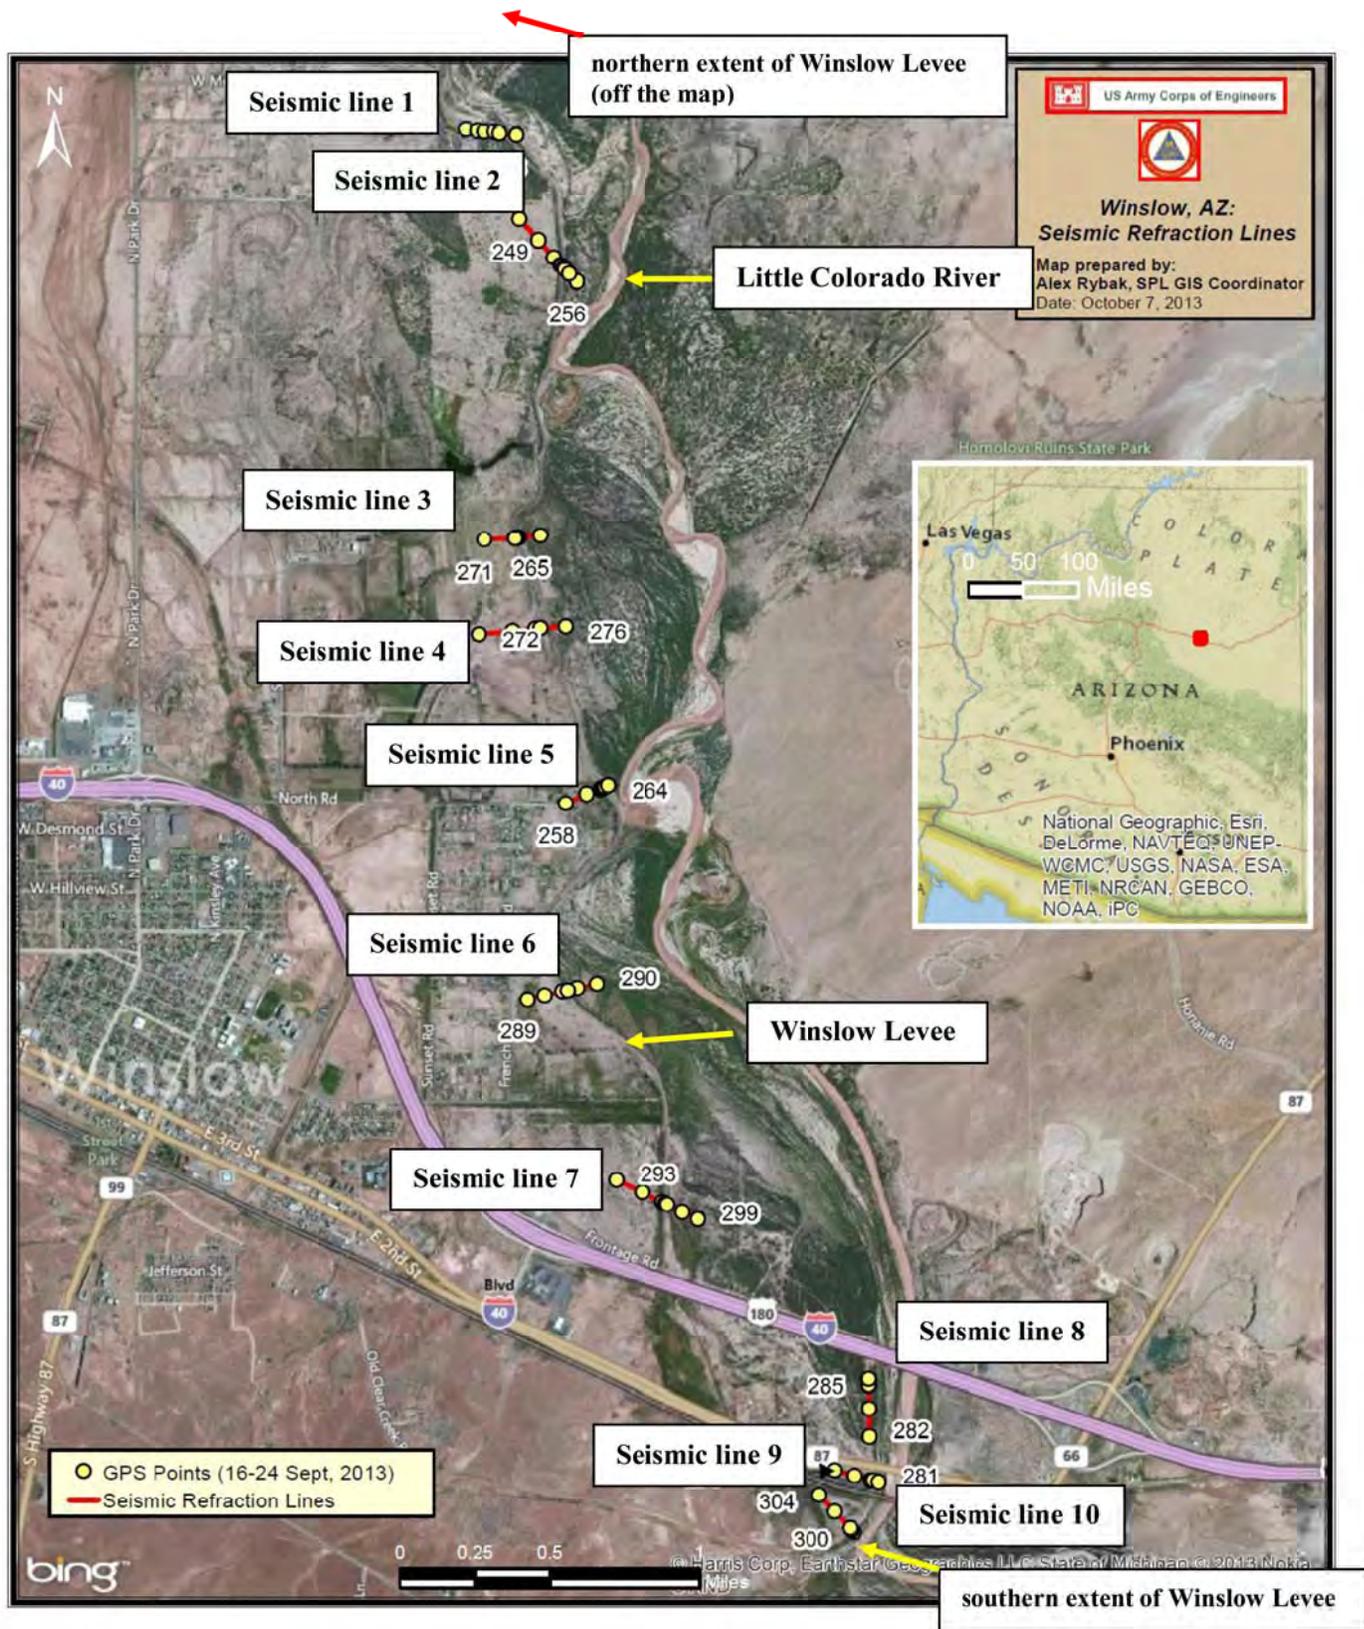
1. AERIAL IMAGE SHOWS THE LOCATIONS OF THE TEN WINSLOW LEVEE SUBSURFACE SEISMIC REFRACTION INVESTIGATION LINES OF SEPTEMBER 2013 AND ONLY LINE 8 PARALLELS THE LEVEE.
2. THE WHITE NUMBERS IN THE 200s AND 300s ARE GPS POINT DESIGNATIONS AND ARE NOT PERTINENT TO THIS DISCUSSION.

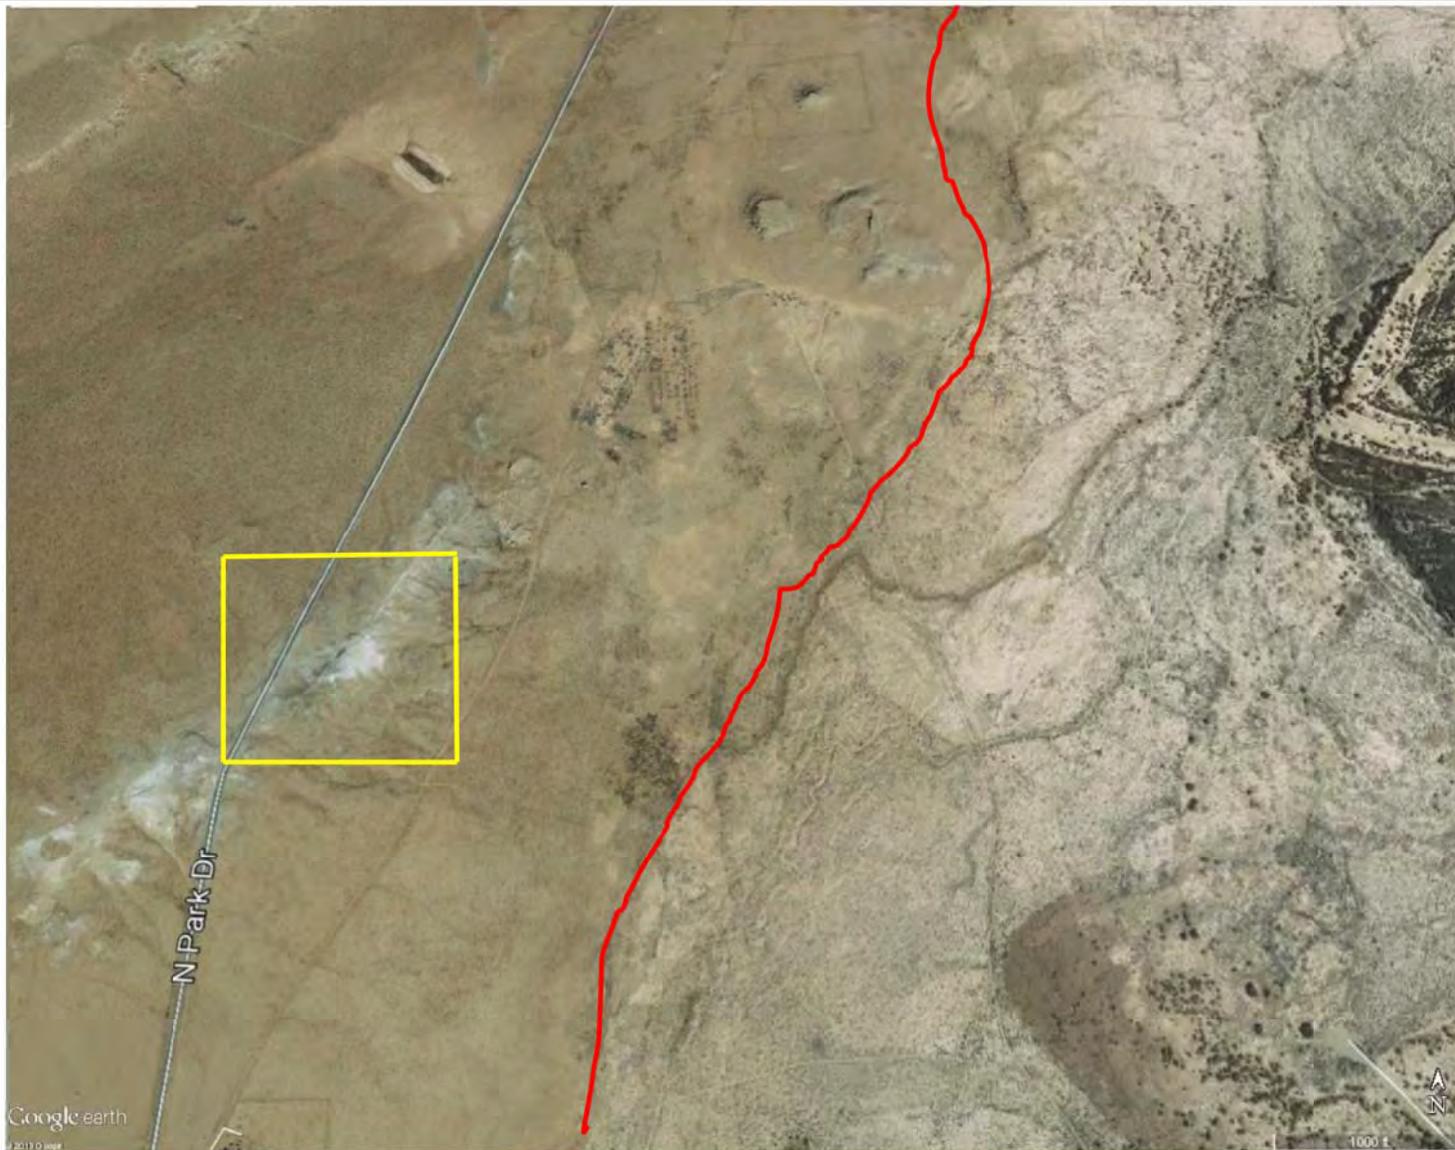
FIGURE
9

1. AERIAL IMAGE SHOWS DETAILS OF THE O'HACO MATERIALS BORROW PIT NUMBER 2 IN WINSLOW, AZ.
2. LOCATION OF OF THE 40 ACRE PROPERTY IS APPROXIMATELY MARKED IN YELLOW.
3. REFER TO FIGURE 8 TO GET AN IDEA HOW FAR AWAY IT IS FROM WINSLOW, AZ.
4. CORPS ESTIMATED MAXIMUM EXTENT OF THE LCR VALLEY WIDTH IS SHOWN IN RED (VALLEY TO THE RIGHT OF THE LINE).
5. AERIAL IMAGE CAME FROM GOOGLE EARTH PRO, JANUARY 2014.

LITTLE COLORADO RIVER
WINSLOW ARIZONA
WINSLOW FEASIBILITY STUDY
AERIAL OF PIT 2

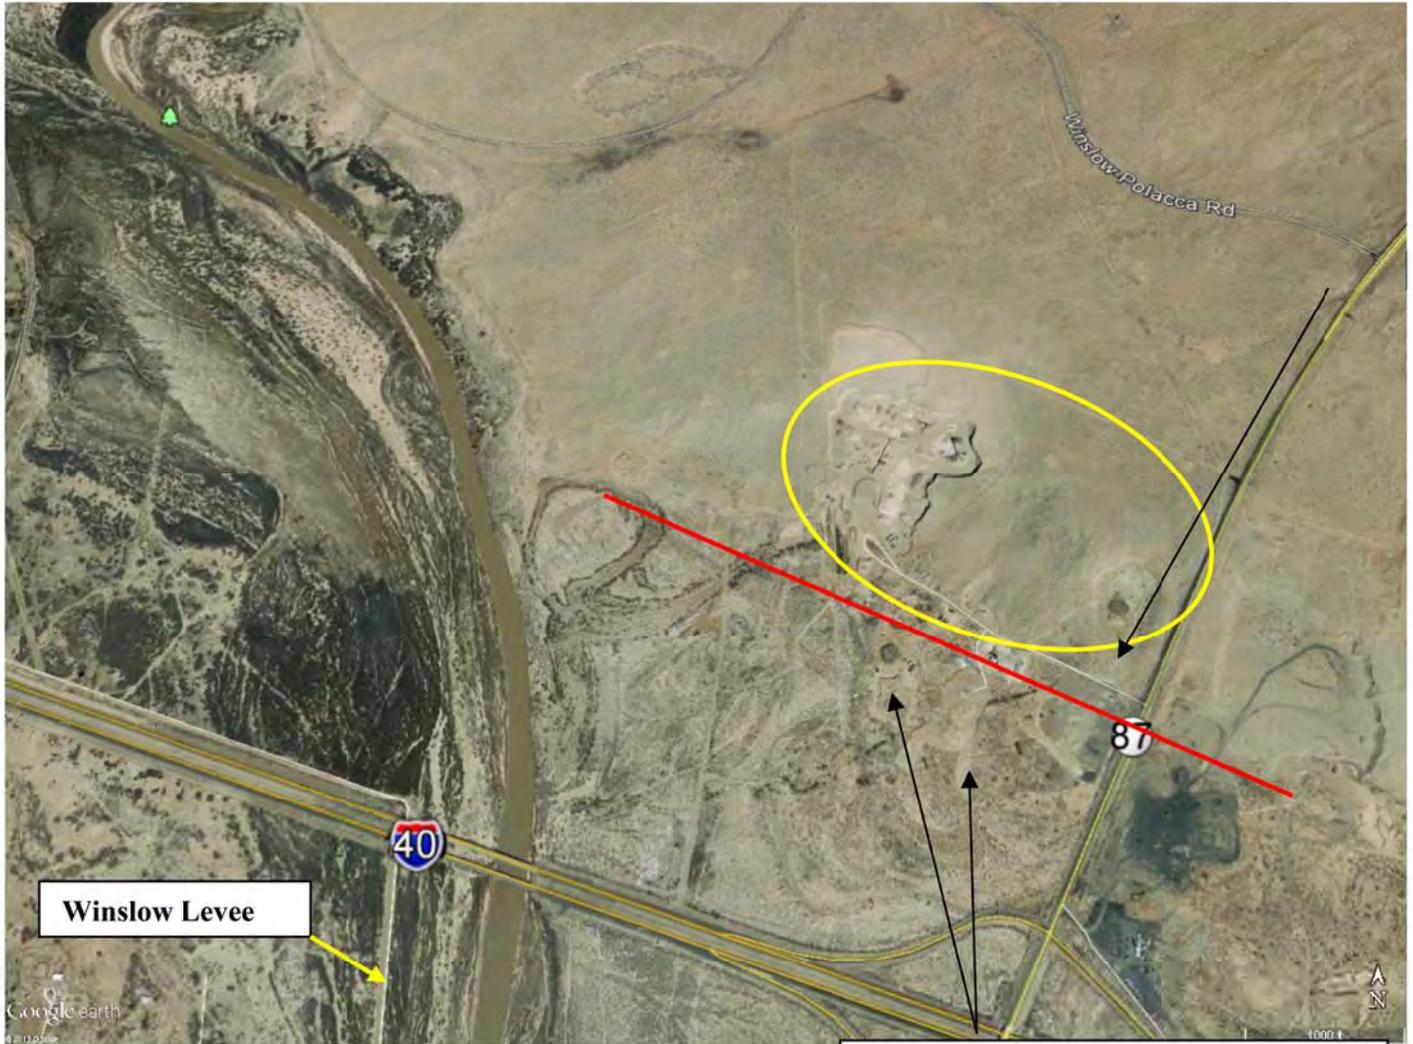
FIGURE
10

LITTLE COLORADO RIVER
WINSLOW ARIZONA
WINSLOW FEASIBILITY STUDY
AERIAL OF PIT 1

Winslow Levee

materials pits in floodplain deposits

The O'Haco no. 1 pit (Figure 10) is, at the closest, approximately 5 miles due west of Winslow Levee. Average haul distances to Winslow Levee would exceed 10 miles, each way. Only 20 acres of the 77-acre tract has been noted as available for mining. The deposit of material has been described as being as much as 30-feet thick and containing 500,000 tons of fill. The precise location of the 20 acres available for mining was not indicated to the USACE. No site geology has been provided. Materials produced are described as "silty sandy clay" by Navajo County.

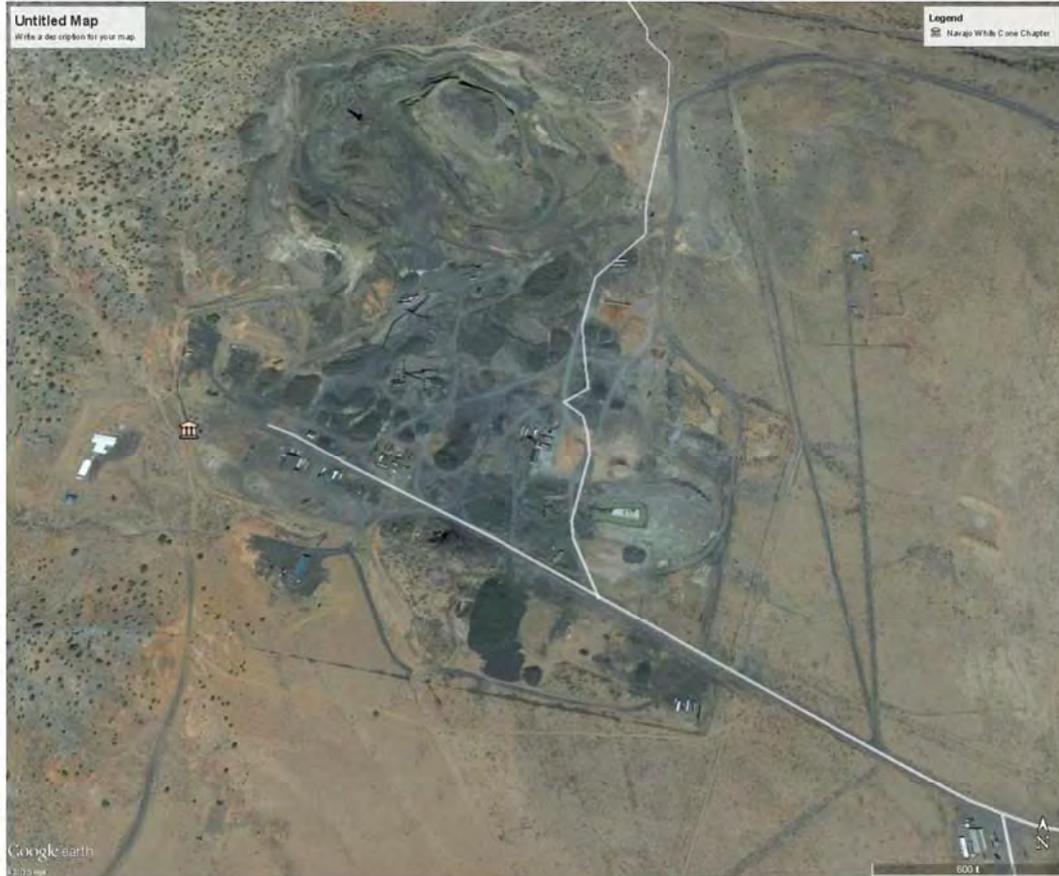
1. AERIAL PHOTOGRAPH SHOWS BRIMHALL HARLUCK STONE QUARRY MINED INTO A MESA OF BIDAHOCHI BASALT. THEY ARE LOCATED 1.2 MILES NORTHEAST OF THE CENTER OF INDIAN WELLS, AZ.
2. BRIMHALL HARLUCK STONE QUARRY IS A VIABLE SOURCE OF NEW BASALT STONE FOR GROUTED STONE ON WINSLOW LEVEE.
3. THIS IS THE SITE OF THE BASALT PROTECTION STONE THAT CURRENTLY IS ON THE LEVEE.
4. AERIAL IMAGE CAME FROM GOOGLE EARTH JANUARY 2014.

There is essentially no salvageable riprap on RWDL, and there is an insufficient quantity of salvageable riprap on the Winslow Levee to meet the existing conceptual Levee redesign stone protection needs. What riprap is present is undersized compared to the grouted stone protection quantities needed in the current conceptual design: approximately 74,000 cubic yards of 24-inch stone for grouted stone and 26,000 cubic yards of 36-inch stone for grouted stone. Existing riprap is smaller than either of those gradations, but should be usable to meet some of the smaller and mid-range gradation segments for the 24-inch grouted stone and some of the smallest gradation ranges for the 36-inch grouted stone. Thus, existing, salvageable riprap on Winslow Levee should be usable in the conceptual rebuild design, while overall, there will be a shortage of stone for grouted stone of at least 75,000 cubic yards. There are only 25,000 cubic yards of salvageable riprap on the existing Levee. There are no suitable, nearby stone sources to make this type of riprap and grouted stone. The nearby sources are too low in density and durability to pass the USACE stone quality acceptance criteria. The lack of durability in local sandstone and limestone and the low density of local sandstones requires that basalt stone be sought for protection stone. The closest source for large basalt is the existing, operating Brimhall Hardluck Quarry (Figure 13), in Indian Wells, AZ, 40 miles north of Holbrook on SR 77. This location is 43 straight-line miles northeast of Winslow Levee, but alignment of existing roads will require actual hauling distances to be substantially longer: approximately 60 miles, one way, to the southern end of Winslow Levee.

This apparently is the same quarry that was used to supply the existing riprap on the Levee, albeit at a time when the quarry was operated under the name ‘Bidahochi quarry’ in ‘Bidahochi, AZ’. A search of current aerial photographs finds that Indian Wells, AZ, and ‘Bidahochi, AZ,’ are the same place, and that there is only one quarry in the region west of SR 77 and southwest of Indian Route 15, not two. The conclusion is that Brimhall has to be mining the same deposit that was used for basalt stone on the existing Levee.
