UPPER OHIO NAVIGATION STUDY, PENNSYLVANIA
ENVIRONMENTAL APPENDIX

Final Natural Resources Assessment
Upper Ohio Navigation Study, Pennsylvania
Potential Work and Laydown Areas
Environmental and Cultural Resource Assessments
December 2009

**UPPER OHIO NAVIGATION STUDY, PENNSYLVANIA
POTENTIAL WORK AND LAYDOWN AREAS
ENVIRONMENTAL AND CULTURAL RESOURCE ASSESSMENTS**

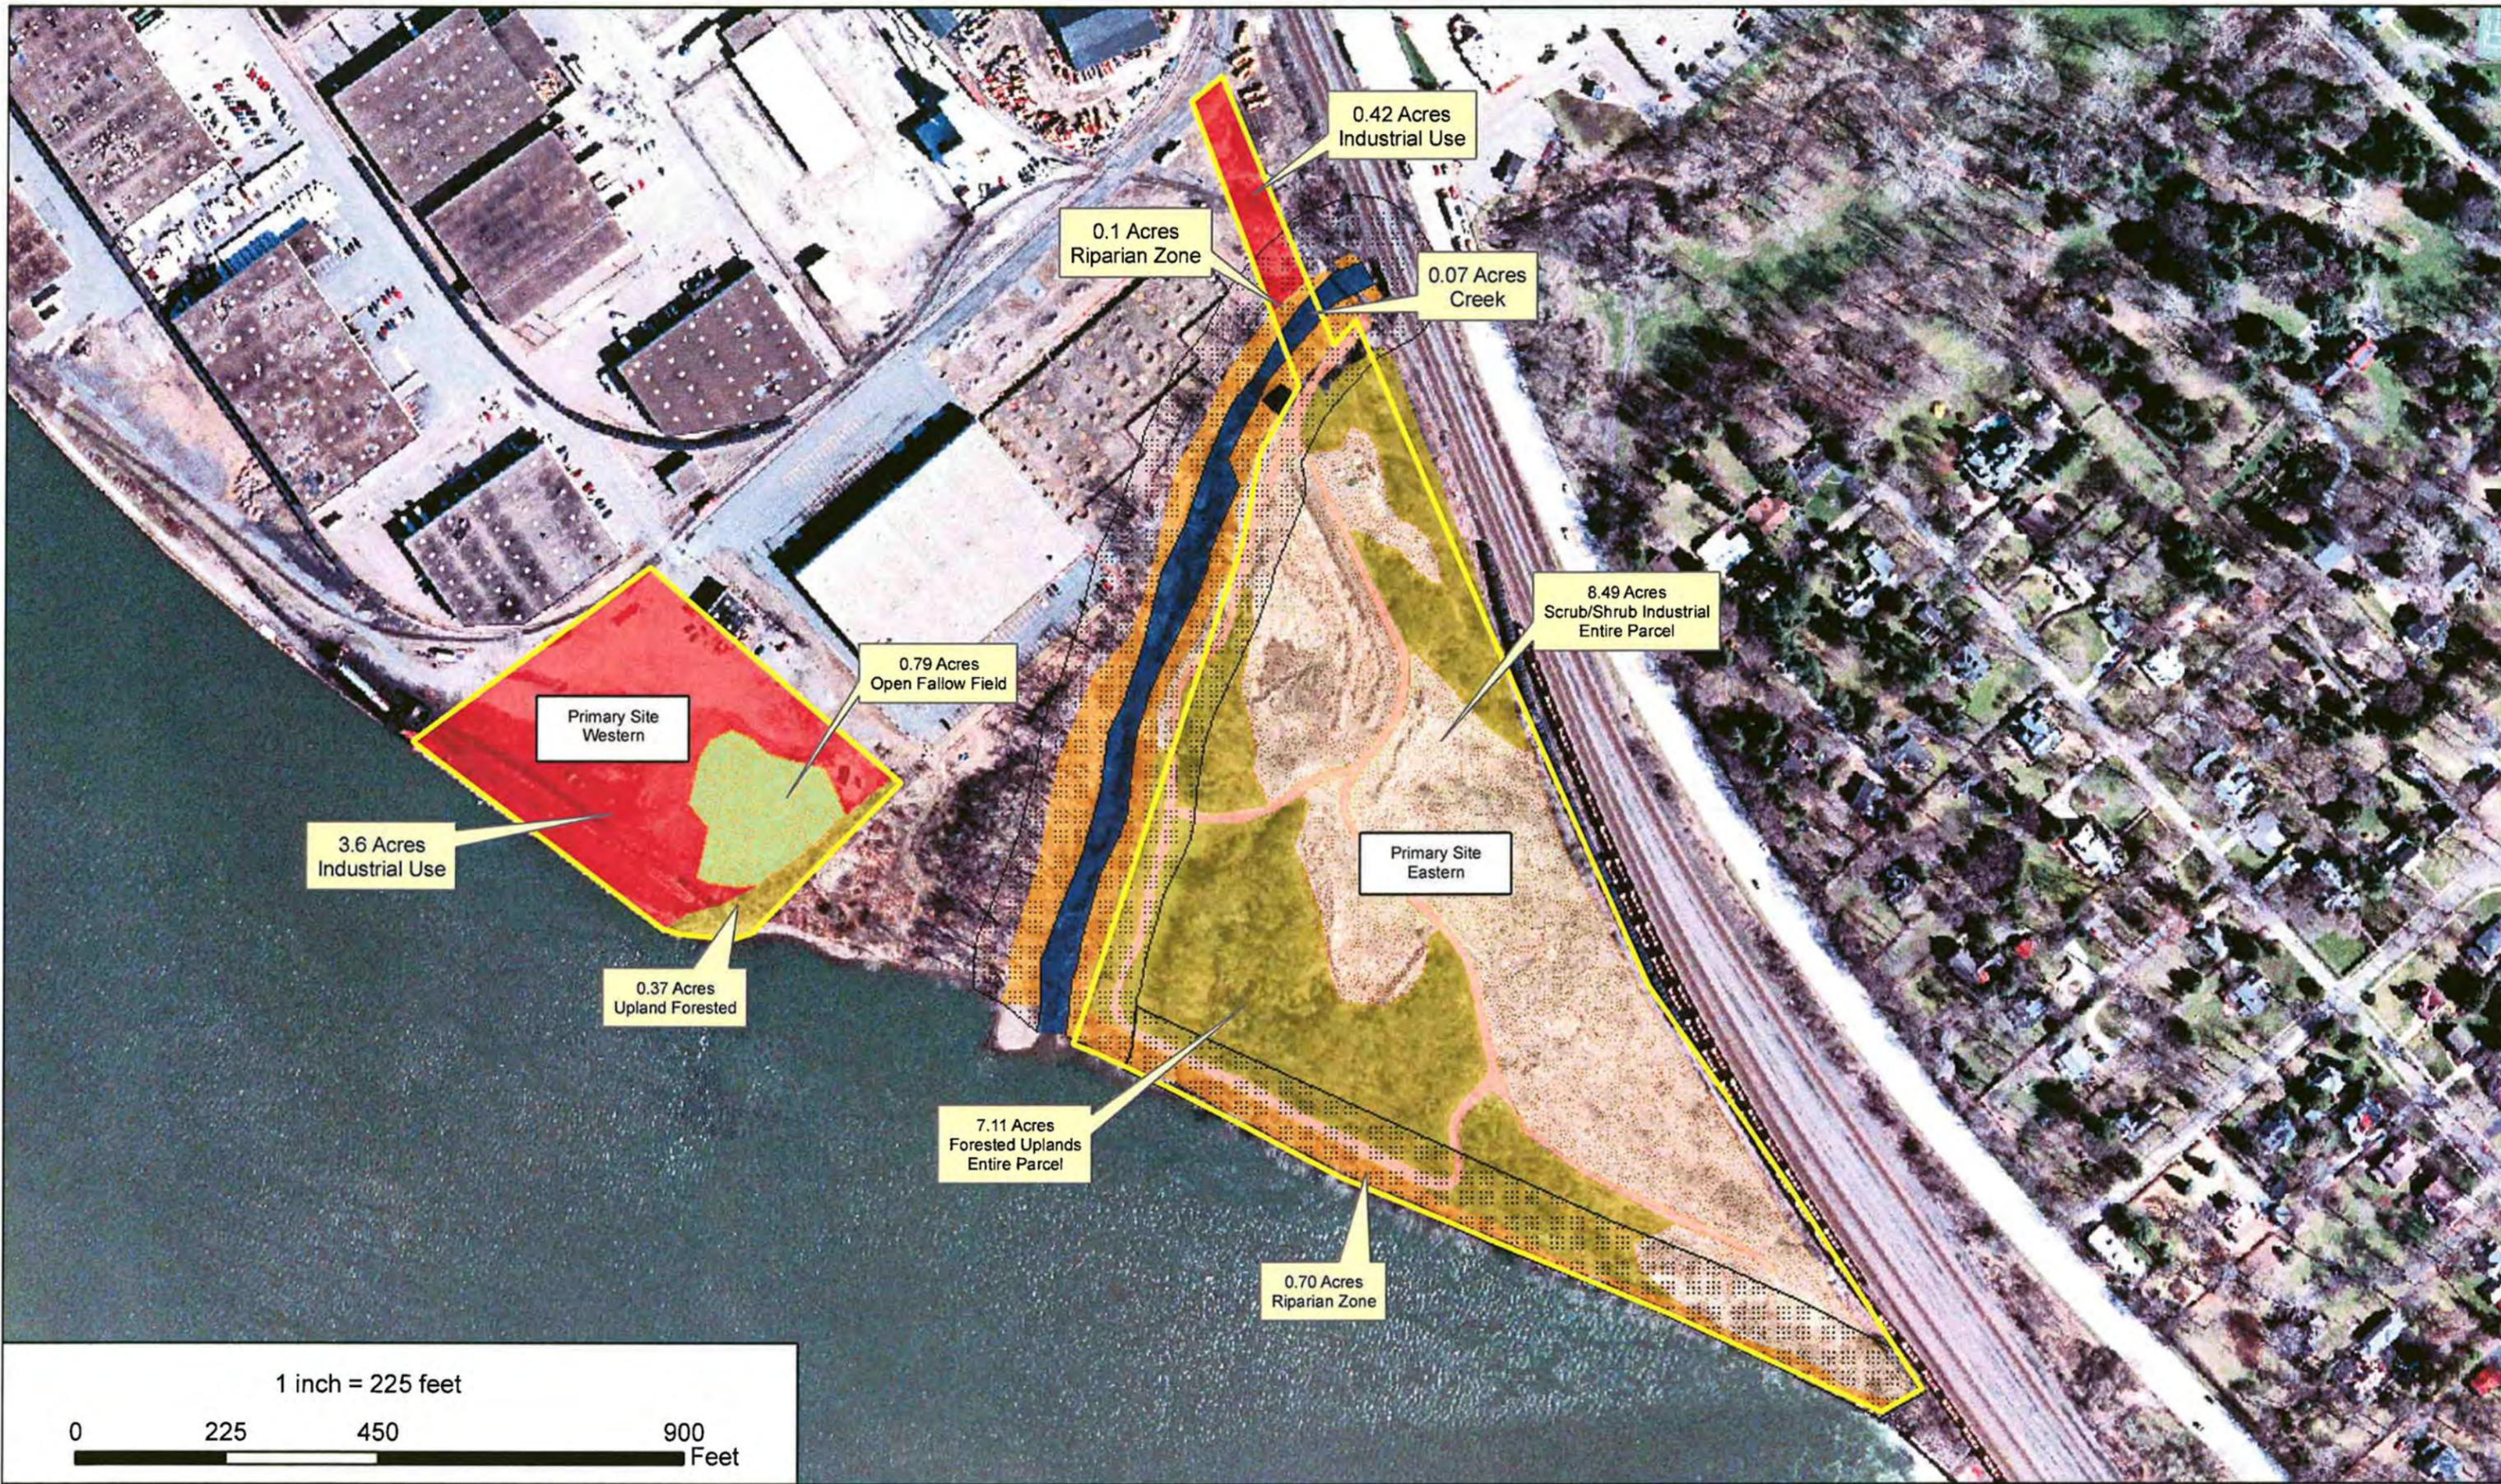
Figure 7A - Dashields Eastern Site - Land Use and Natural Habitats

The eastern and western sites currently consist of two non-contiguous sites of wooded and grassy land and cleared land, respectively (**Figure 7A**). Storage piles of rock, wood, and composting leaves and wood chips maintained by the Borough of Edgeworth were observed throughout the eastern site. Storage piles of wood, miscellaneous debris, steel, railroad ties, and asphalt were observed on the western site along with two small mobile construction containers. In addition, a railroad spur and a coal off-loading facility and a concrete retaining wall adjacent to the river and railroad track were observed in the southwestern portion of the Primary Western site. The two sites are located along Ohio River Boulevard and the western and eastern sites are 5.2 and 19.2 acres, respectively. Access to the site is available via Ohio River Boulevard to the east and Avenues A, B, and C to the north. Current vehicular access to the Primary Eastern site is gained via an existing private road through Marrow-Pontefract Park, a 10-acre recreational area owned and maintained by Edgeworth Borough. An existing sanitary sewer line and lift station is located along the northwestern boundary of the site.

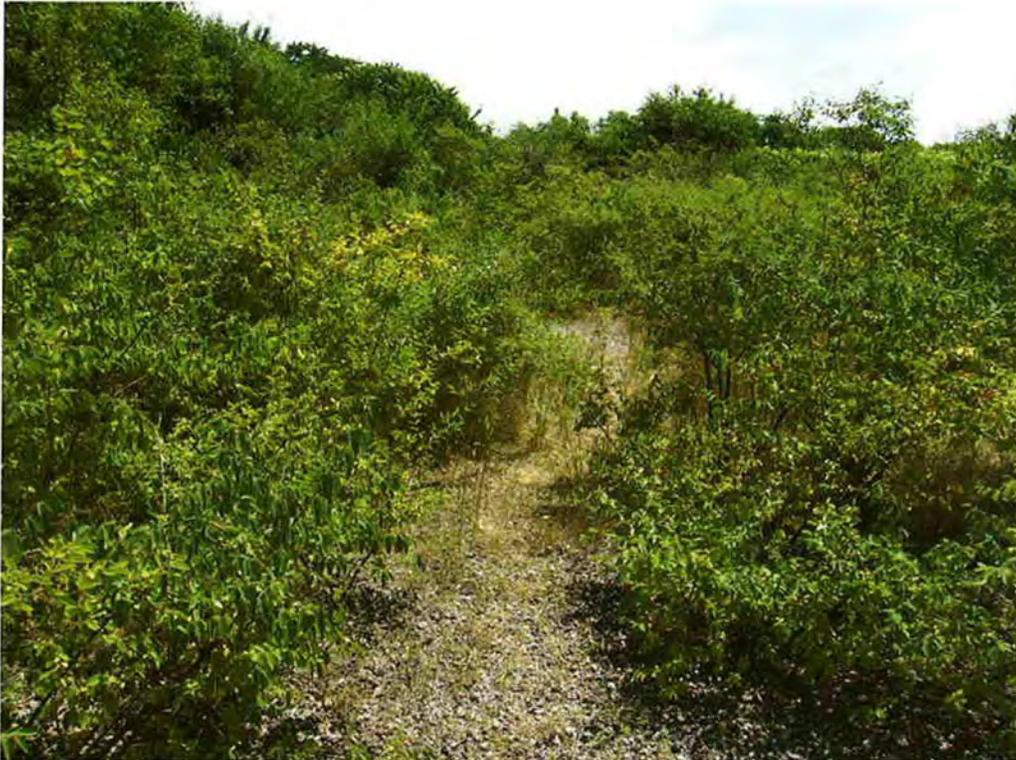
Photo 5 – Emsworth Primary: View of the vegetation and gravel material found throughout the middle of the parcel.

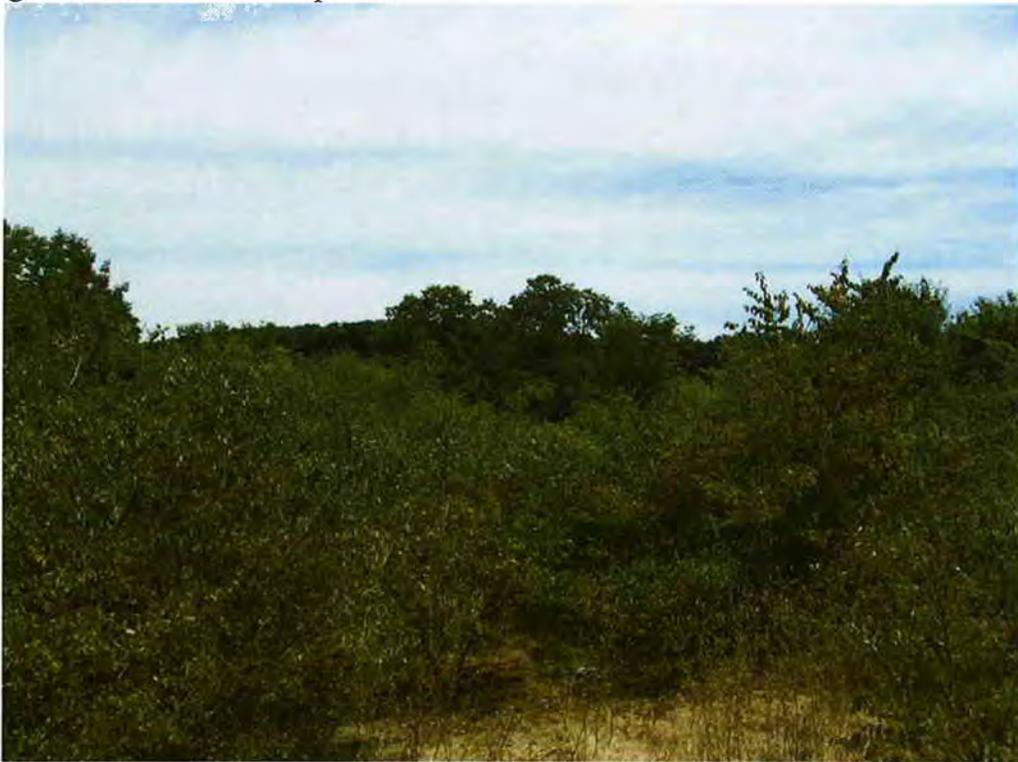
Photo 6 – Emsworth Primary: View of the vegetation the middle of the parcel.

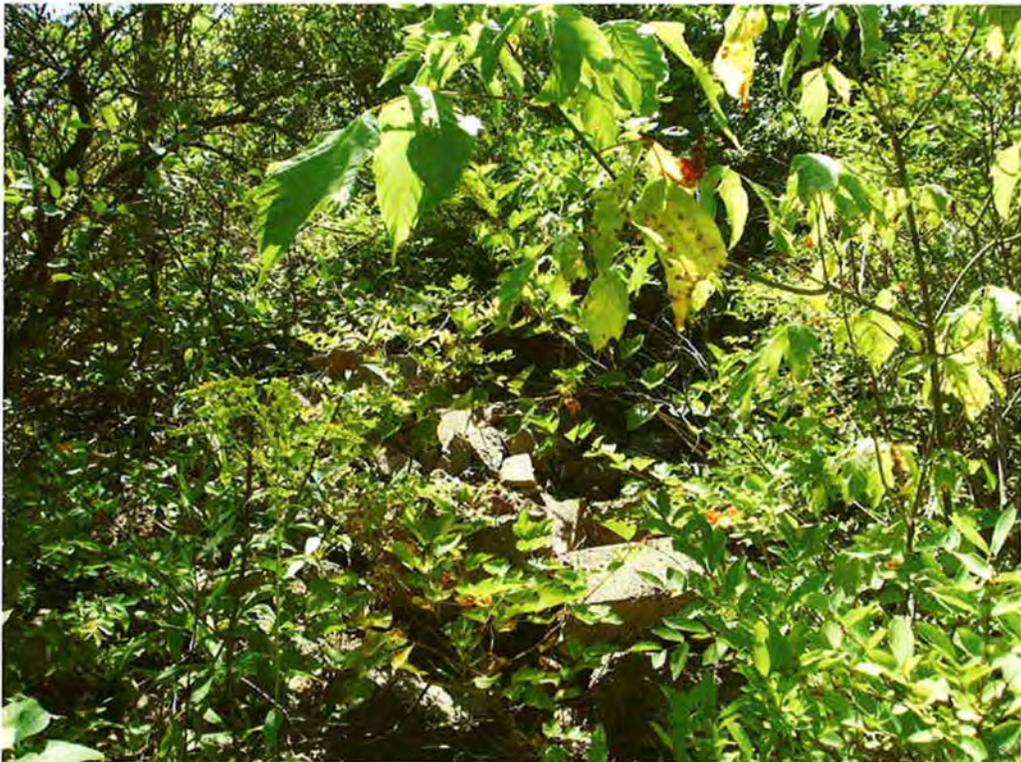
Photo 22 – Dashields Primary East: An example of debris piles found throughout the vegetated areas of the parcel.

The site is bordered to the south by the Ohio River and is currently used by the Borough of Edgeworth for storing compost. The on-site inspection revealed that demolition materials such as brick and concrete have been dumped at this site (**Appendix F, Photos 15-23**). Several piles of debris were found within the wooded areas and contained brick, concrete, tile, bathroom porcelain materials, etc. Vegetated areas identified onsite include forested uplands (7.1 acres), the riparian zone adjacent to the Little Sewickley Creek (0.1 acres), and the riparian zone adjacent to the Ohio River (0.7 acres) illustrated in **Figure 7A**. The vegetation in the forested upland areas (7.11 acres) is primarily comprised of Norway maple (*Acer platanoides*), mockernut hickory (*Carya tomentosa*), box elder (*Acer negundo*), Tree of Heaven, smooth sumac, common privet (*Ligustrum vulgare*), and common buckthorn. Some of the trees, located along the river, (Norway maples and hickories) are at least 70 years of age, as indicated by review of historical aerials and on-site inspection. The riparian zone is comprised primarily of sycamore, silver maples, black locust, Tree of Heaven and Japanese knotweed. In addition to these areas, non-forested areas (8.49 acres) where storage of compost and demolition materials occur on the site include shrubs (common buckthorn, common privet, barberry), herbaceous and forb species (Japanese knotweed, Joe-pye weed, thistles, ragweed [*Ambrosia spp.*], goldenrod), and grass species (broom sedge, *Panicum sp.*, Johnson grass etc.), typical of disturbed areas. This site is subjected to irregular industrial equipment activity, and vehicular traffic due to compost and material storage. Habitat connectivity would occur with the riparian habitat adjacent to Little Sewickley Creek located to the west.

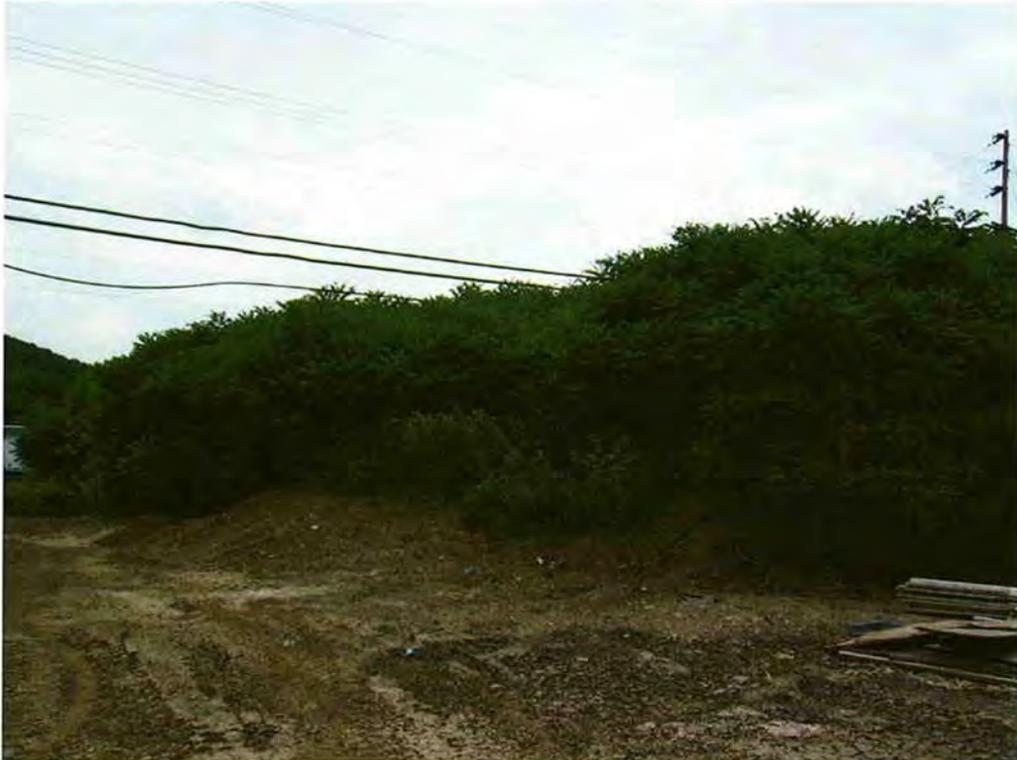
Photo 23– Dashiels Primary East: View of vegetation on this parcel next to a ditch and railroad in the northwestern section.
