Scoping Document - Mouse River Enhanced Flood Protection Plan Environmental Impact Statement

MOUSE RIVER ENHANCED FLOOD PROTECTION PLAN ENVIRONMENTAL IMPACT STATEMENT

Version – February 29, 2016

WETLANDS, WATERS, and BIOLOGICAL INVENTORY REPORT

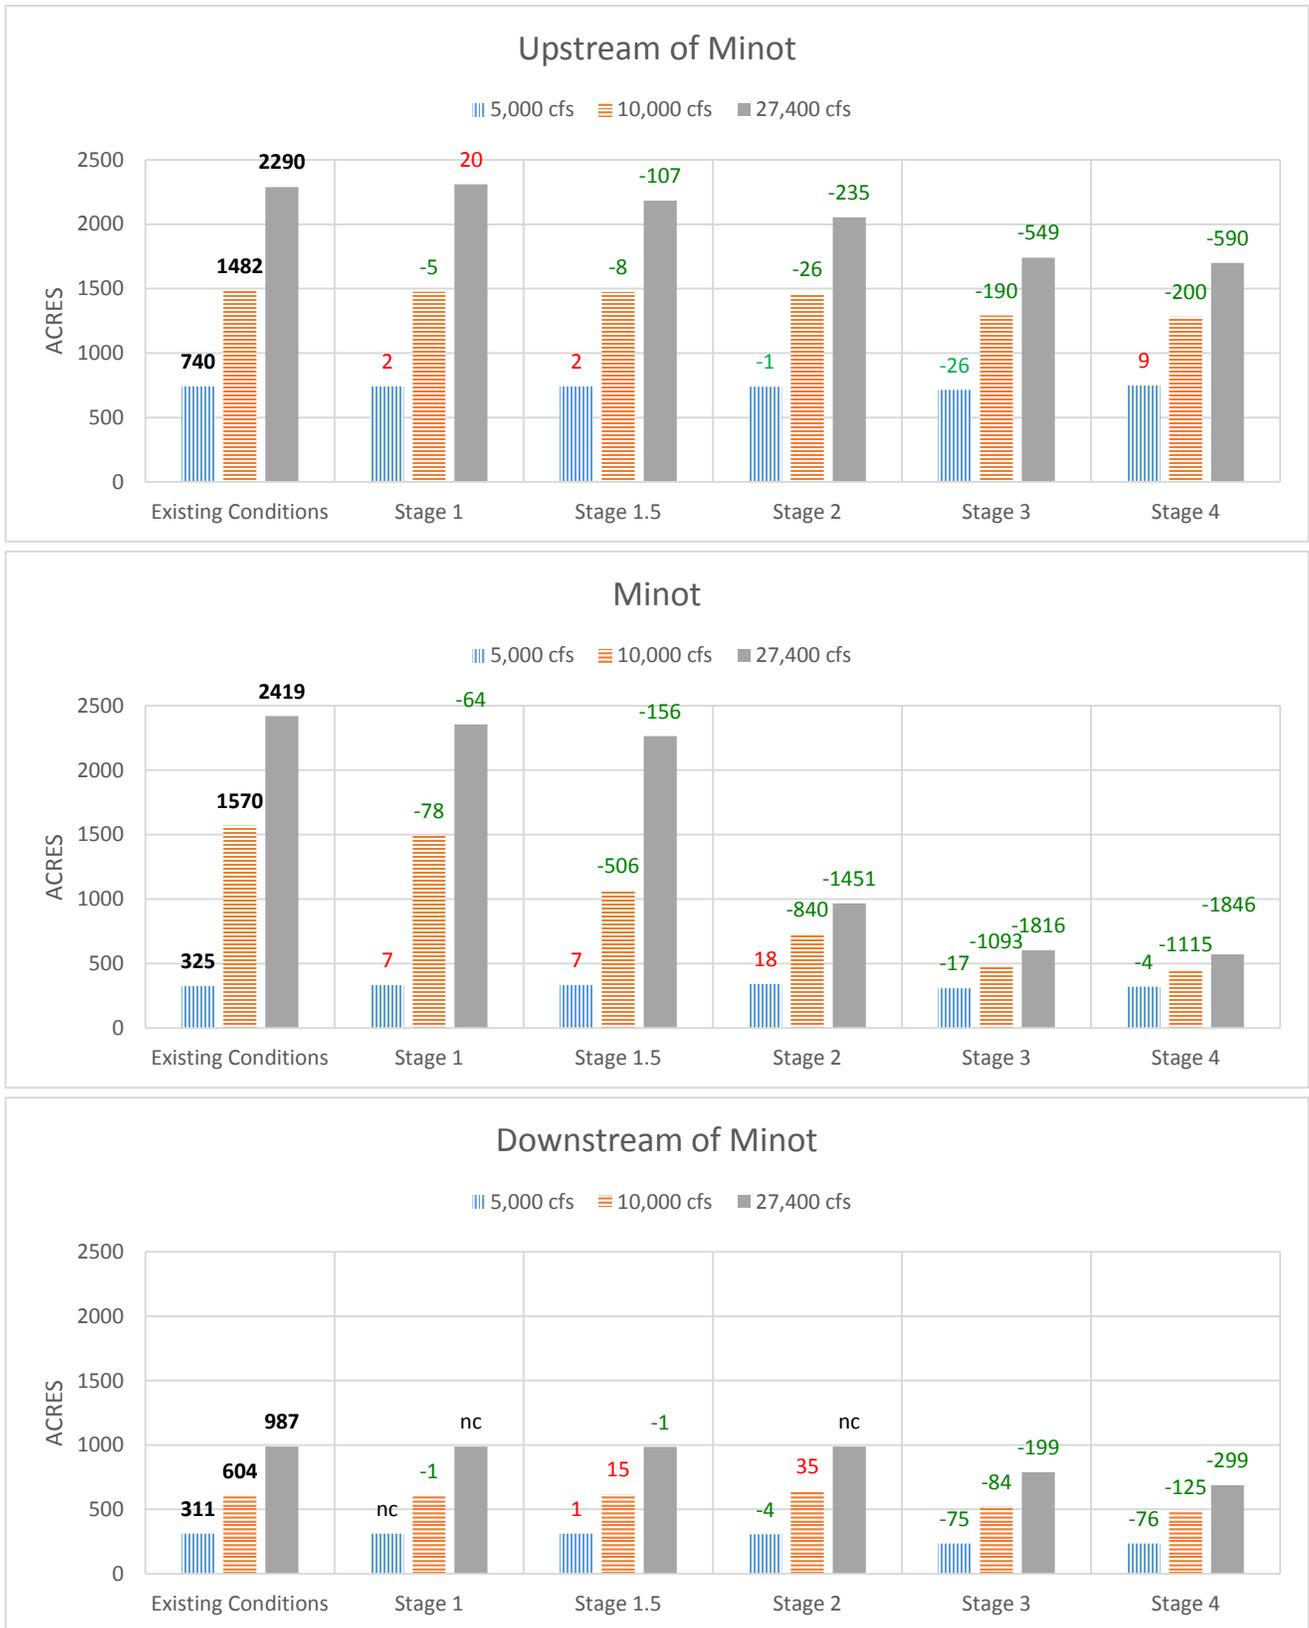
Figure B4-1 Net Inundation Area Changes Relative to No Action Alternative 2 - No Flood Fight

n.c.: no change from existing conditions

-5: inundation area decreases by 5 acres compared to existing conditions

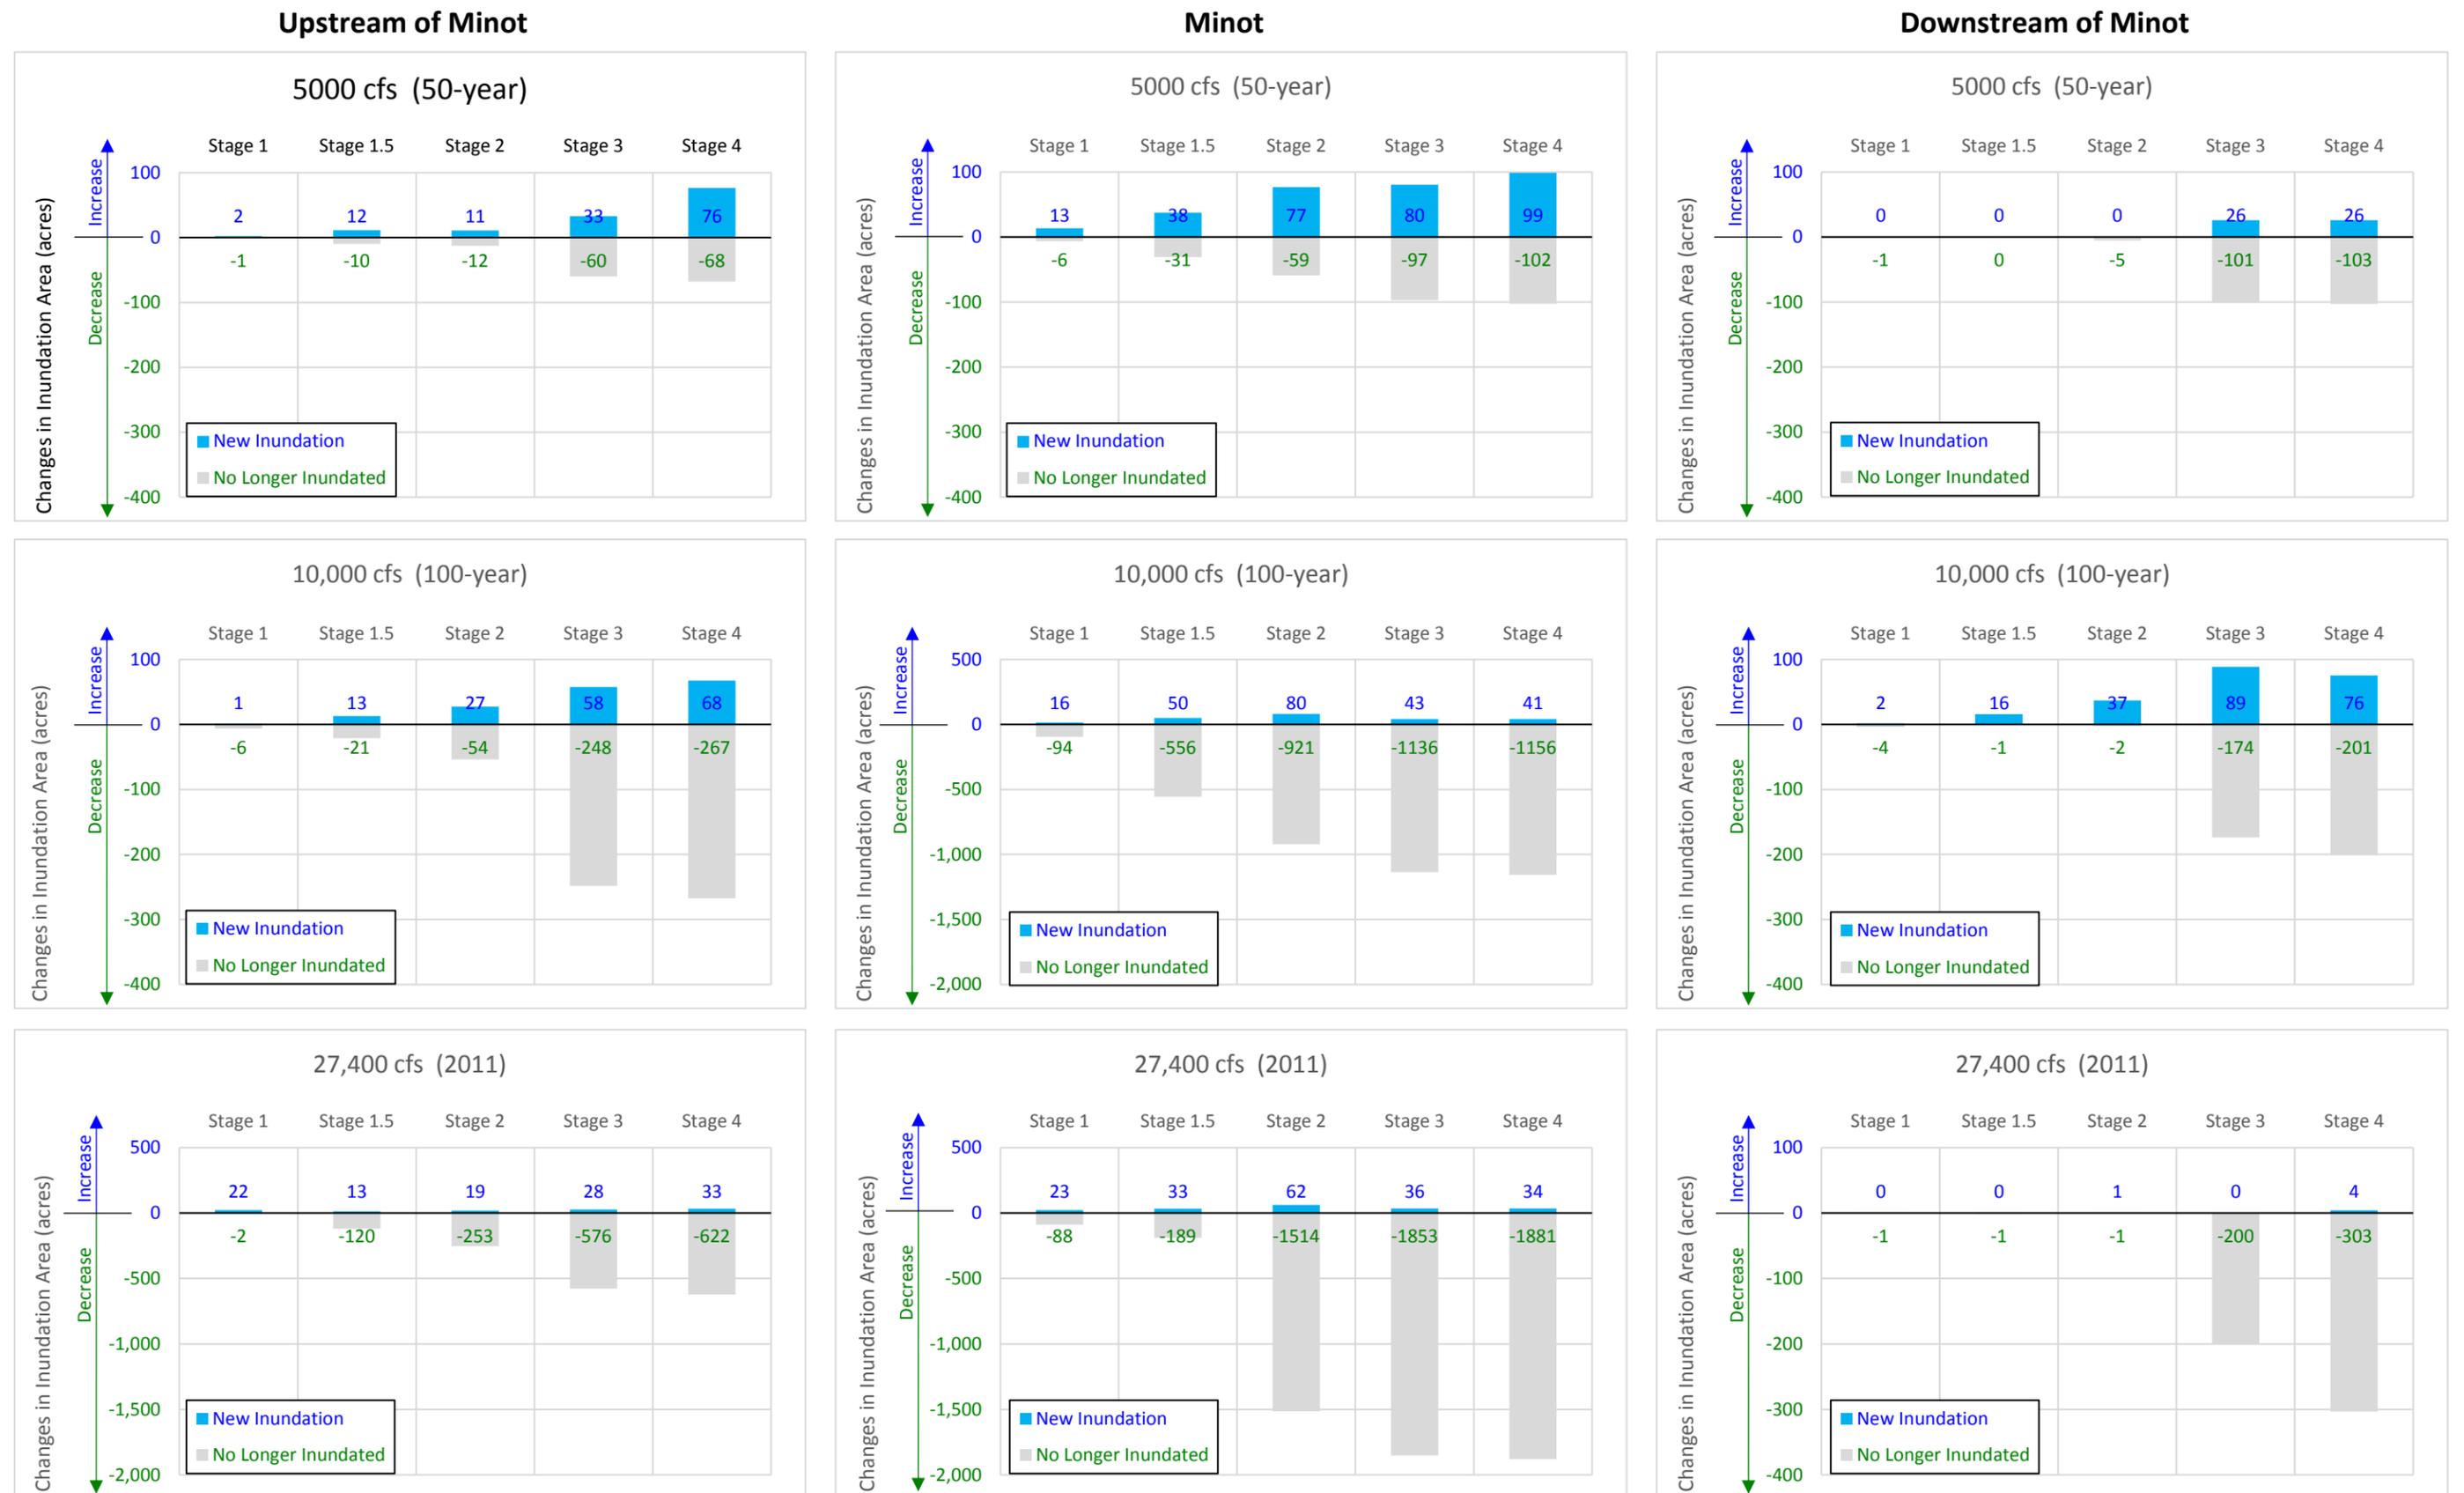
Figure B4-2 Net Inundation Area Impacts Relative to No Action Alternative 2 - No Flood Fight

50-year, 100-year, 2011

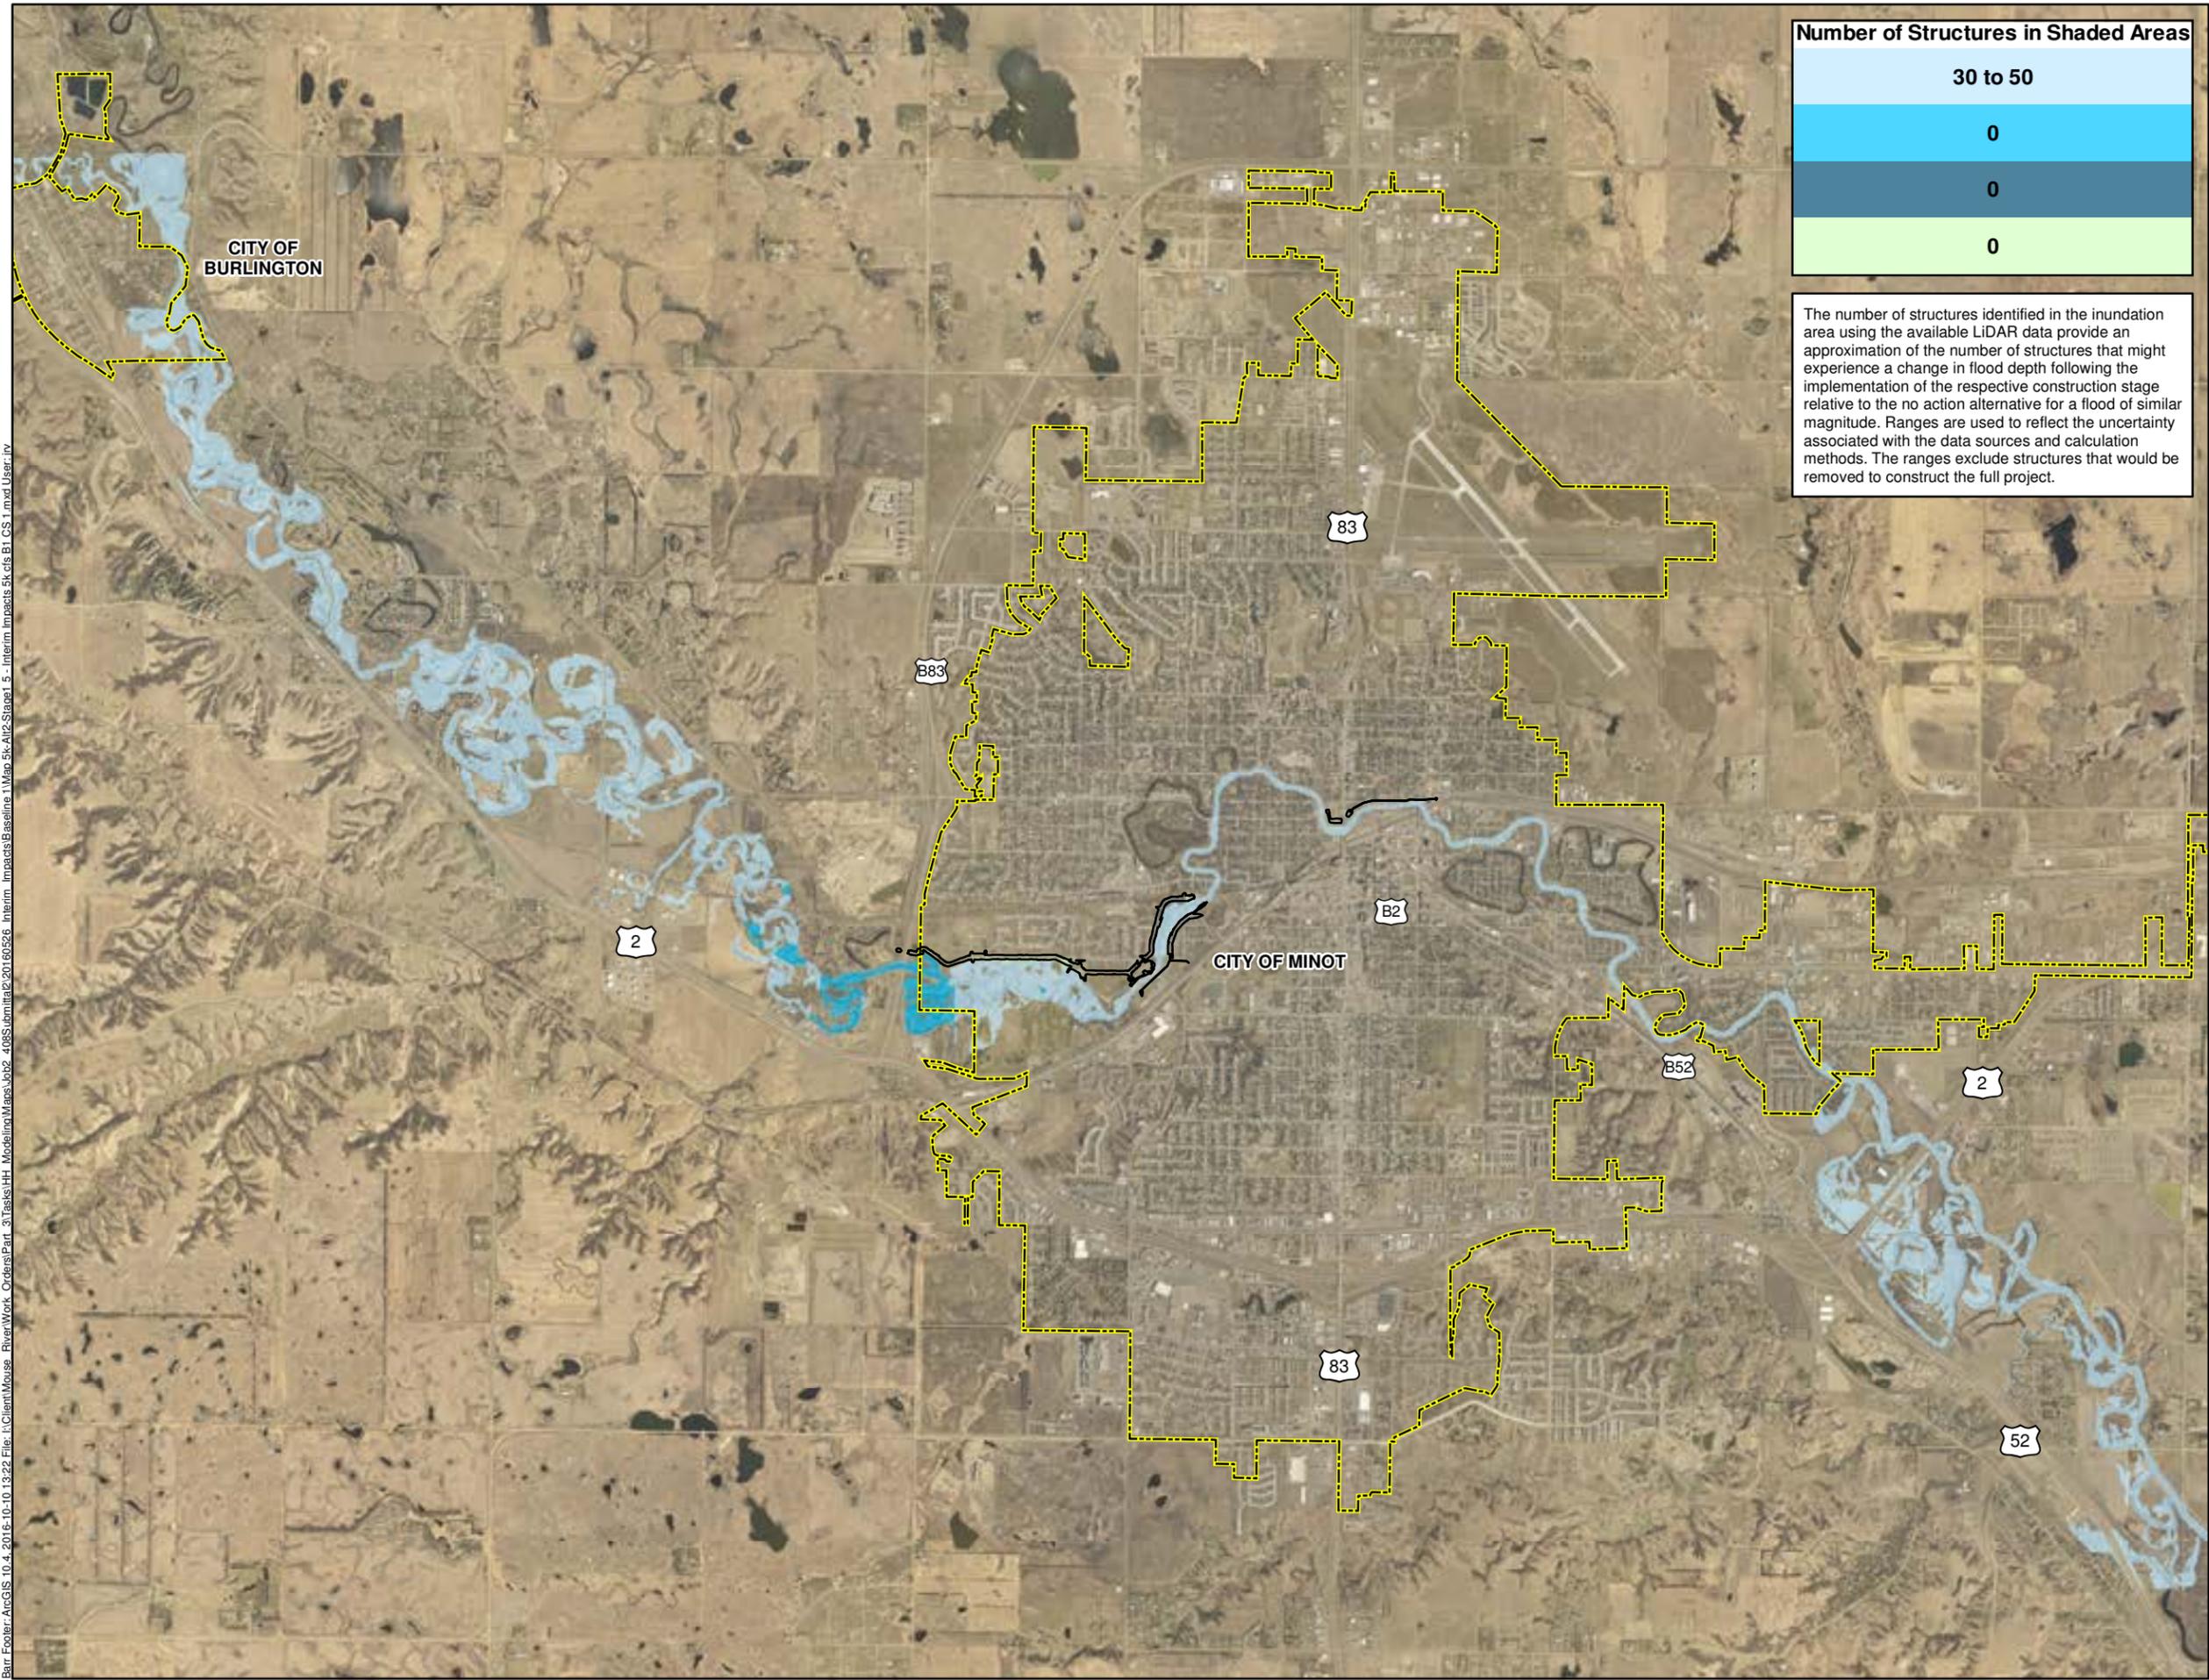
Number of Structures in Shaded Areas	
30 to 50	
0	
0	
0

The number of structures identified in the inundation area using the available LIDAR data provide an approximation of the number of structures that might experience a change in flood depth following the implementation of the respective construction stage relative to the no action alternative for a flood of similar magnitude. Ranges are used to reflect the uncertainty associated with the data sources and calculation methods. The ranges exclude structures that would be removed to construct the full project.

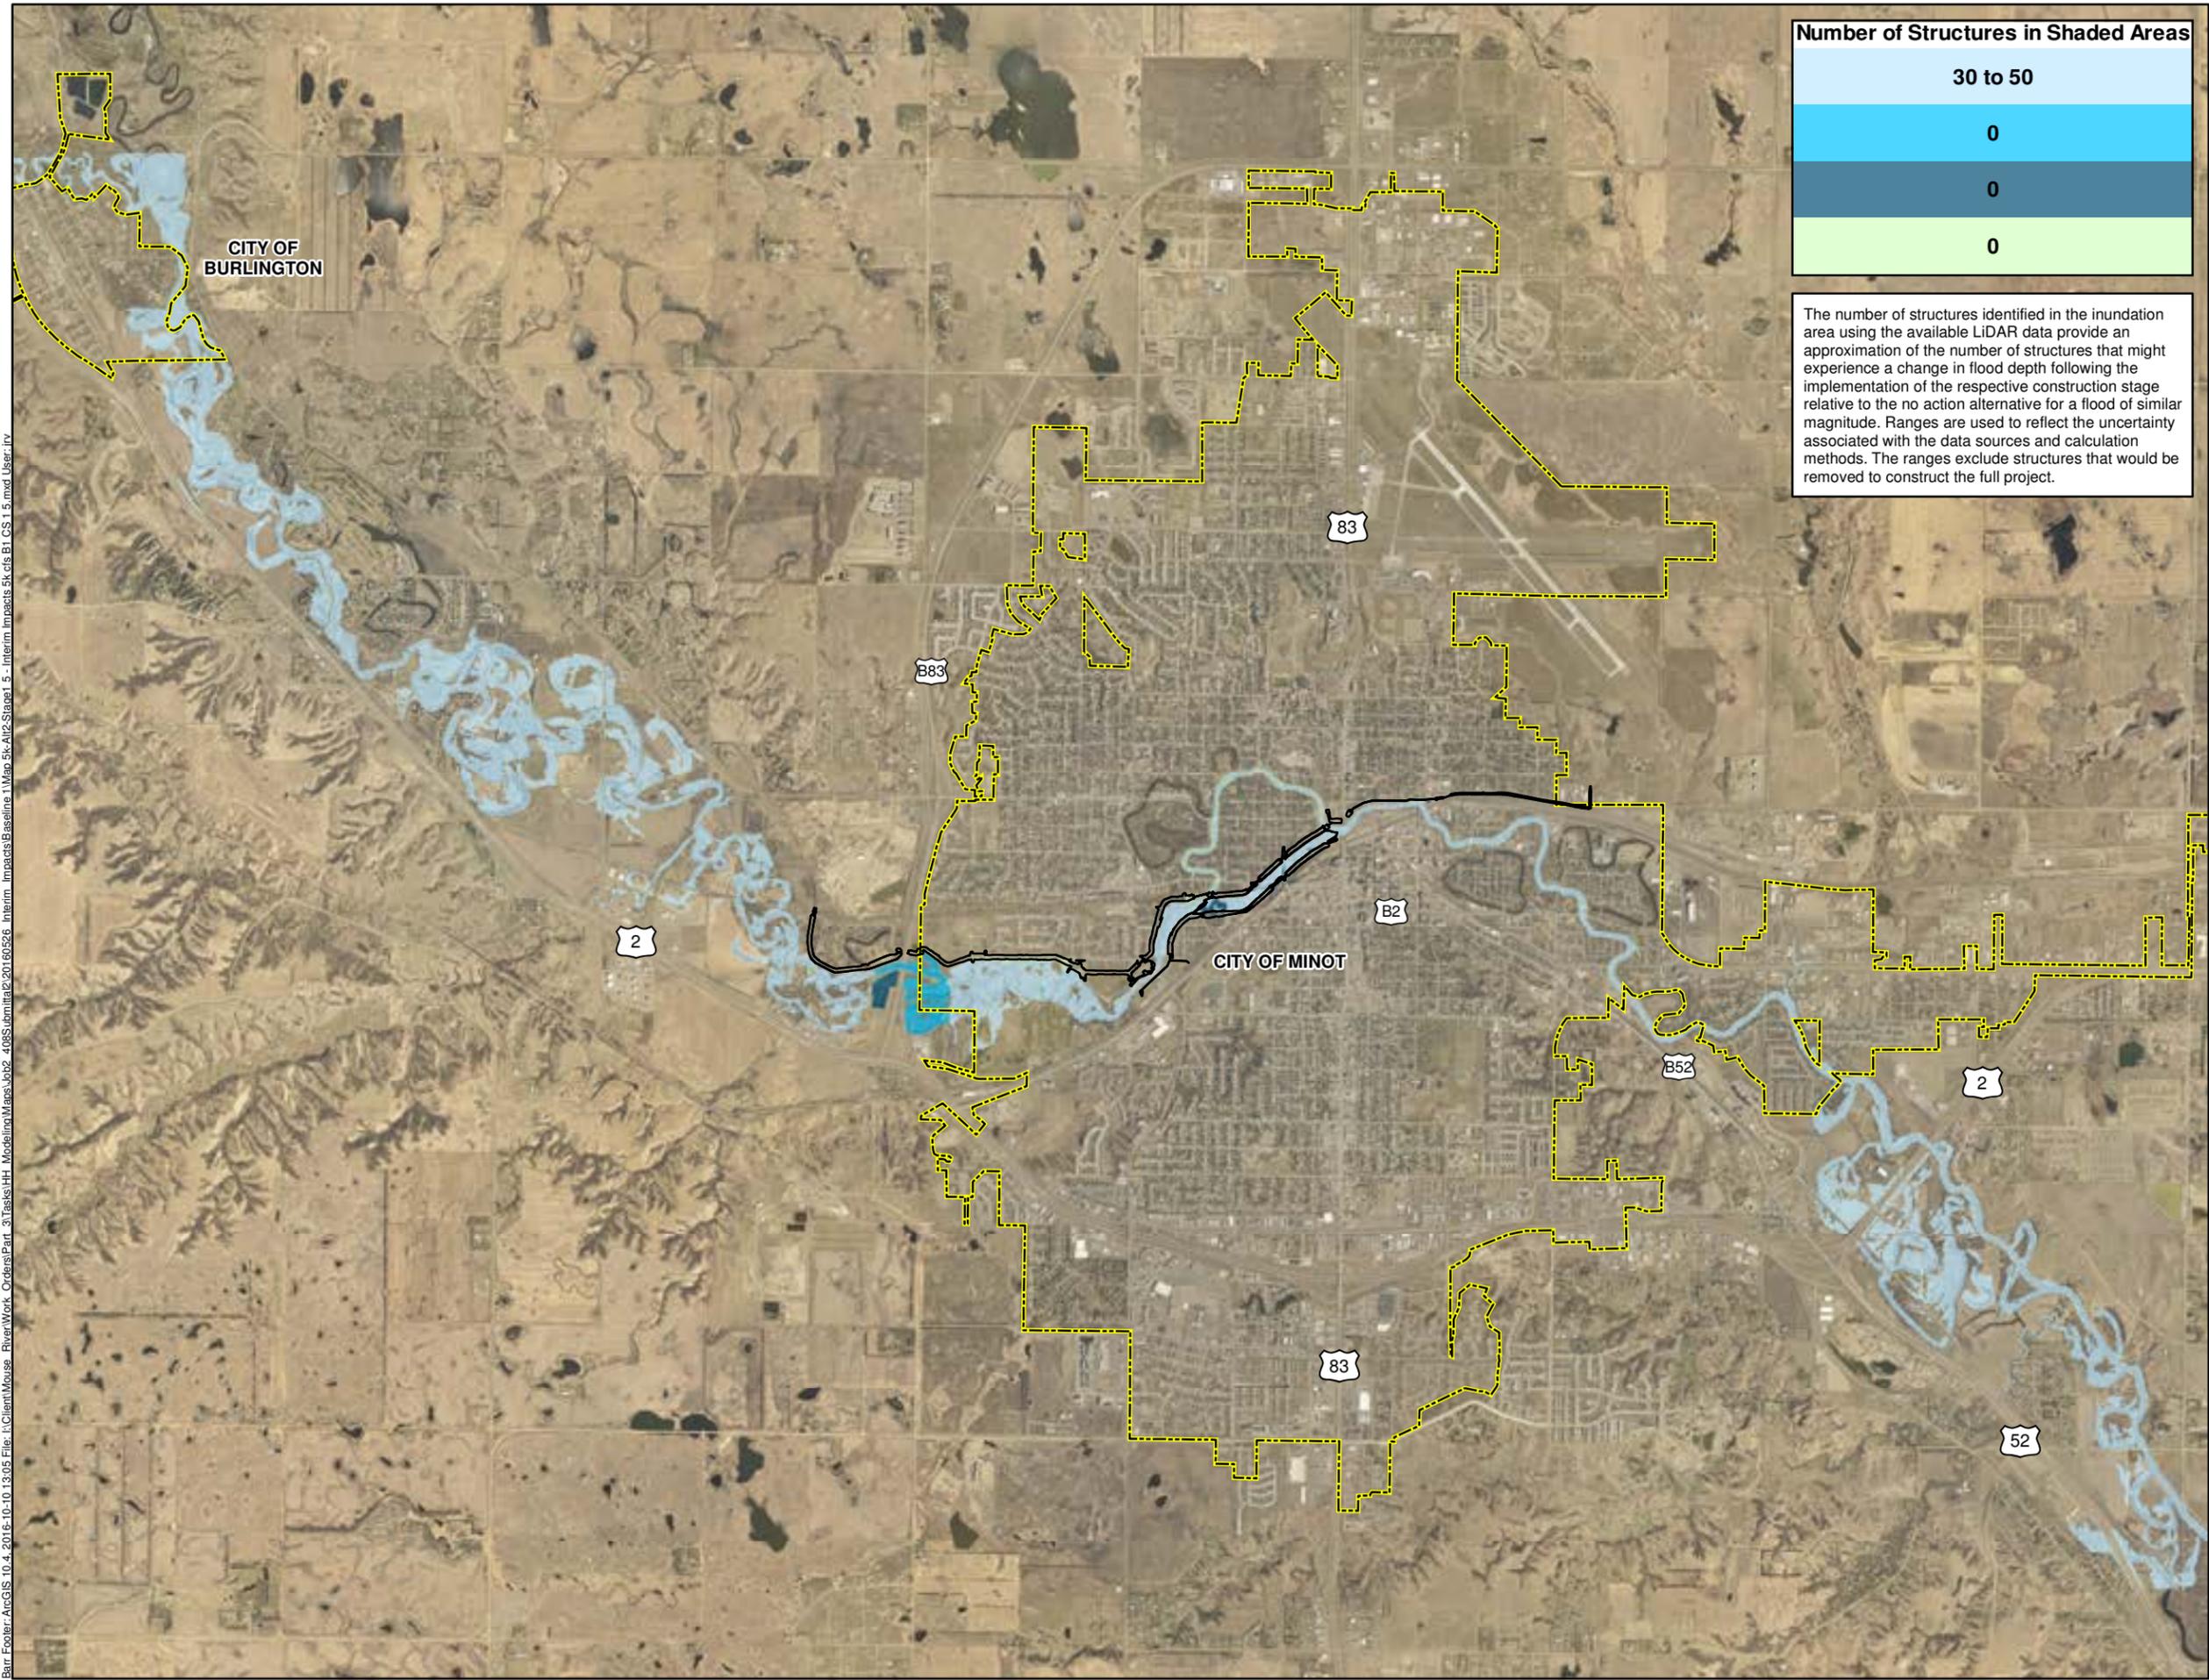
Number of Structures in Shaded Areas	
30 to 50	
0	
0	
0

The number of structures identified in the inundation area using the available LIDAR data provide an approximation of the number of structures that might experience a change in flood depth following the implementation of the respective construction stage relative to the no action alternative for a flood of similar magnitude. Ranges are used to reflect the uncertainty associated with the data sources and calculation methods. The ranges exclude structures that would be removed to construct the full project.

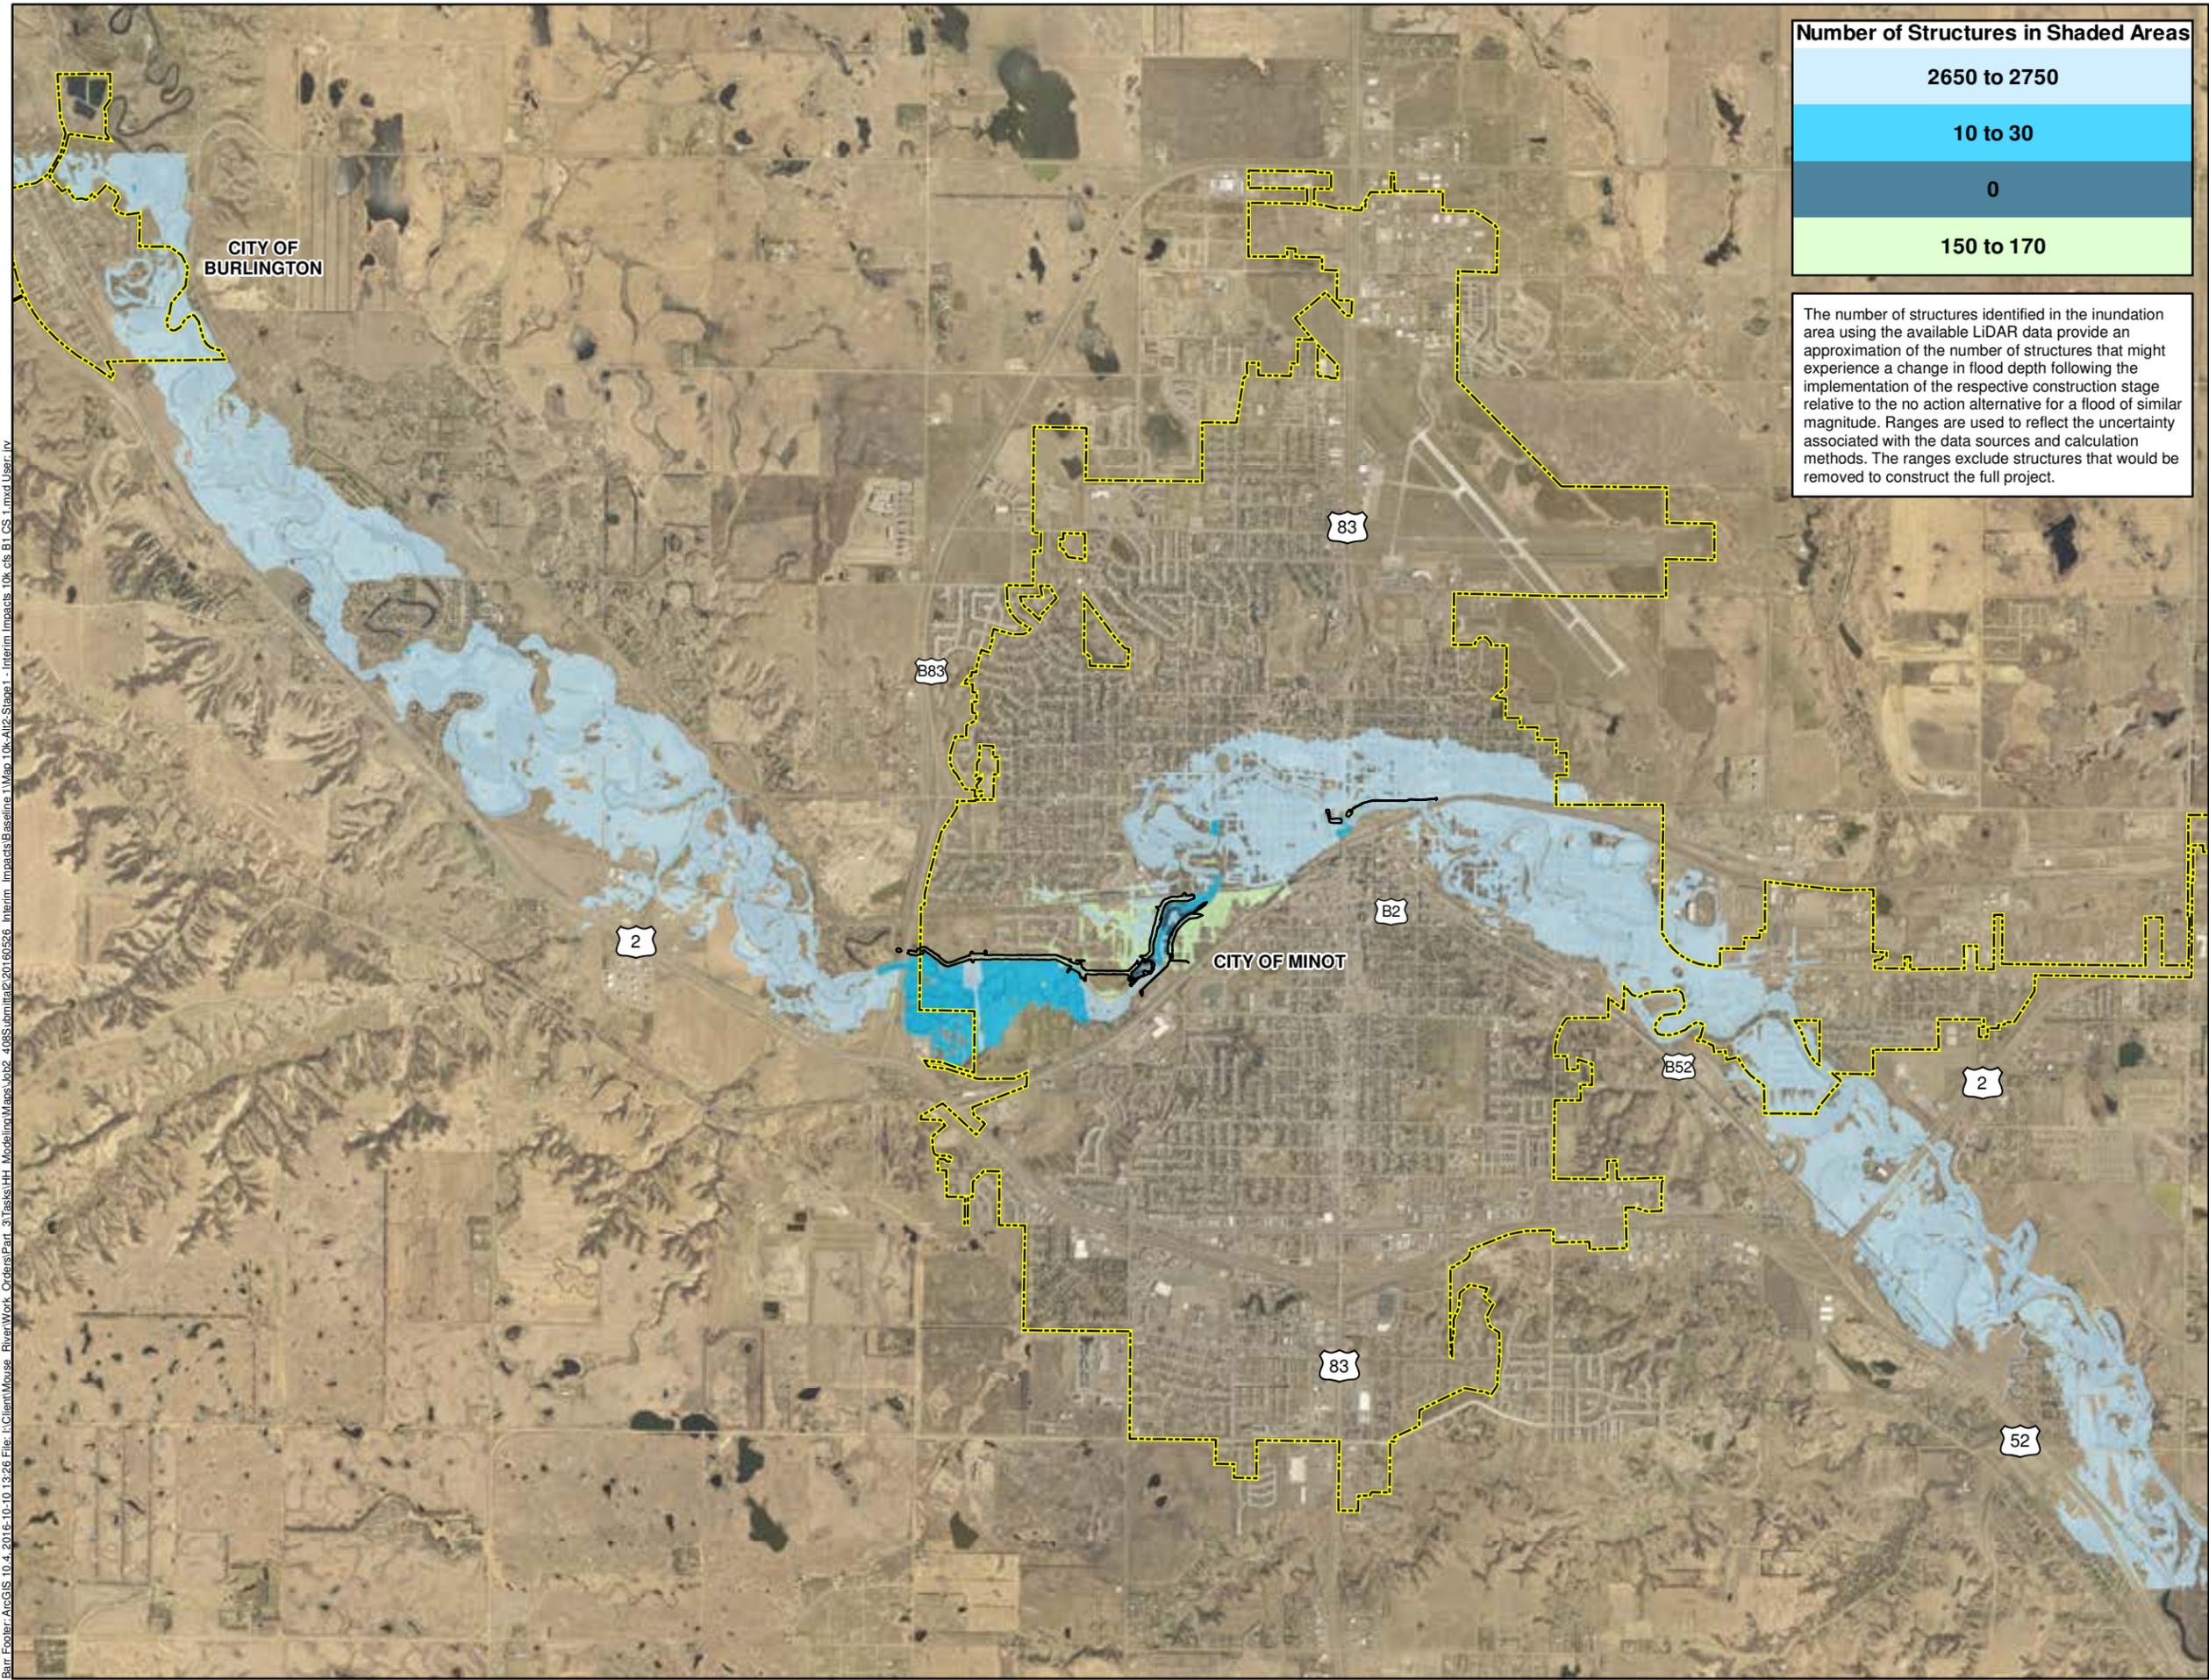
Number of Structures in Shaded Areas	
	2650 to 2750
	10 to 30
	0
	150 to 170

The number of structures identified in the inundation area using the available LIDAR data provide an approximation of the number of structures that might experience a change in flood depth following the implementation of the respective construction stage relative to the no action alternative for a flood of similar magnitude. Ranges are used to reflect the uncertainty associated with the data sources and calculation methods. The ranges exclude structures that would be removed to construct the full project.

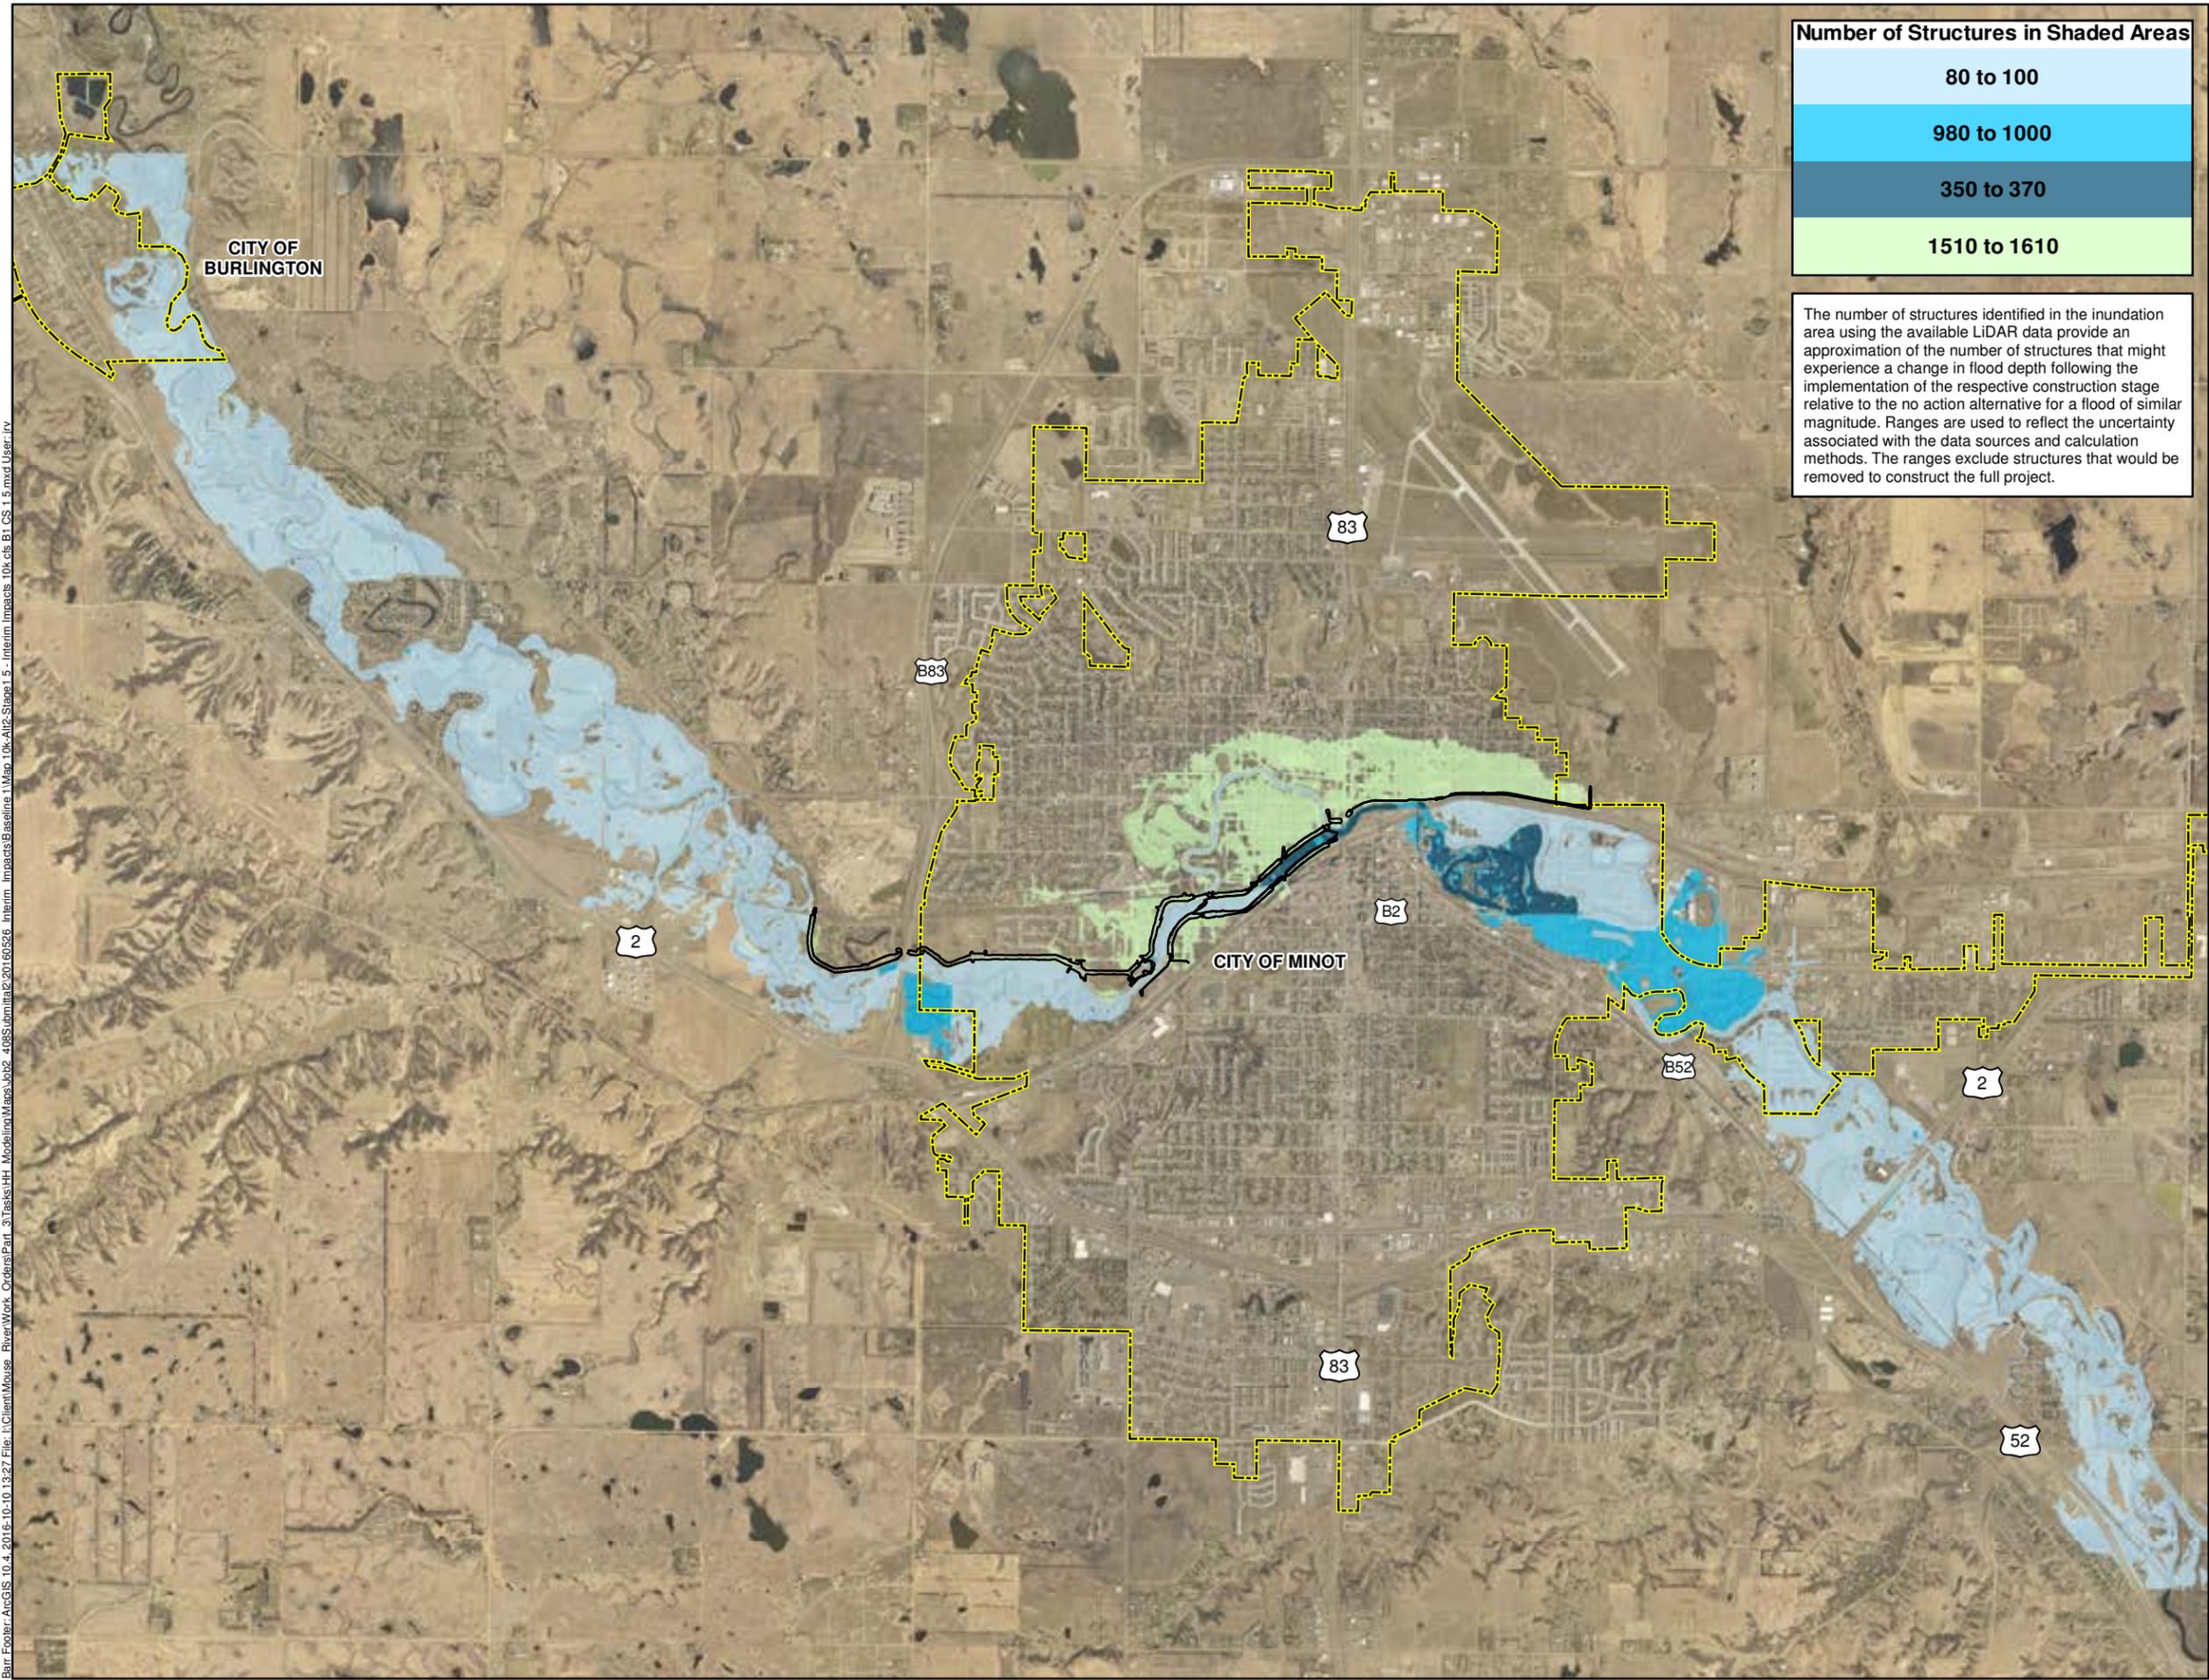
Number of Structures in Shaded Areas	
80 to 100	Lightest Blue
980 to 1000	Medium Blue
350 to 370	Dark Blue
1510 to 1610	Light Green

The number of structures identified in the inundation area using the available LIDAR data provide an approximation of the number of structures that might experience a change in flood depth following the implementation of the respective construction stage relative to the no action alternative for a flood of similar magnitude. Ranges are used to reflect the uncertainty associated with the data sources and calculation methods. The ranges exclude structures that would be removed to construct the full project.
