Scoping Document - Mouse River Enhanced Flood Protection Plan Environmental Impact Statement

MOUSE RIVER ENHANCED FLOOD PROTECTION PLAN ENVIRONMENTAL IMPACT STATEMENT

Version – February 29, 2016

WETLANDS, WATERS, and BIOLOGICAL INVENTORY REPORT

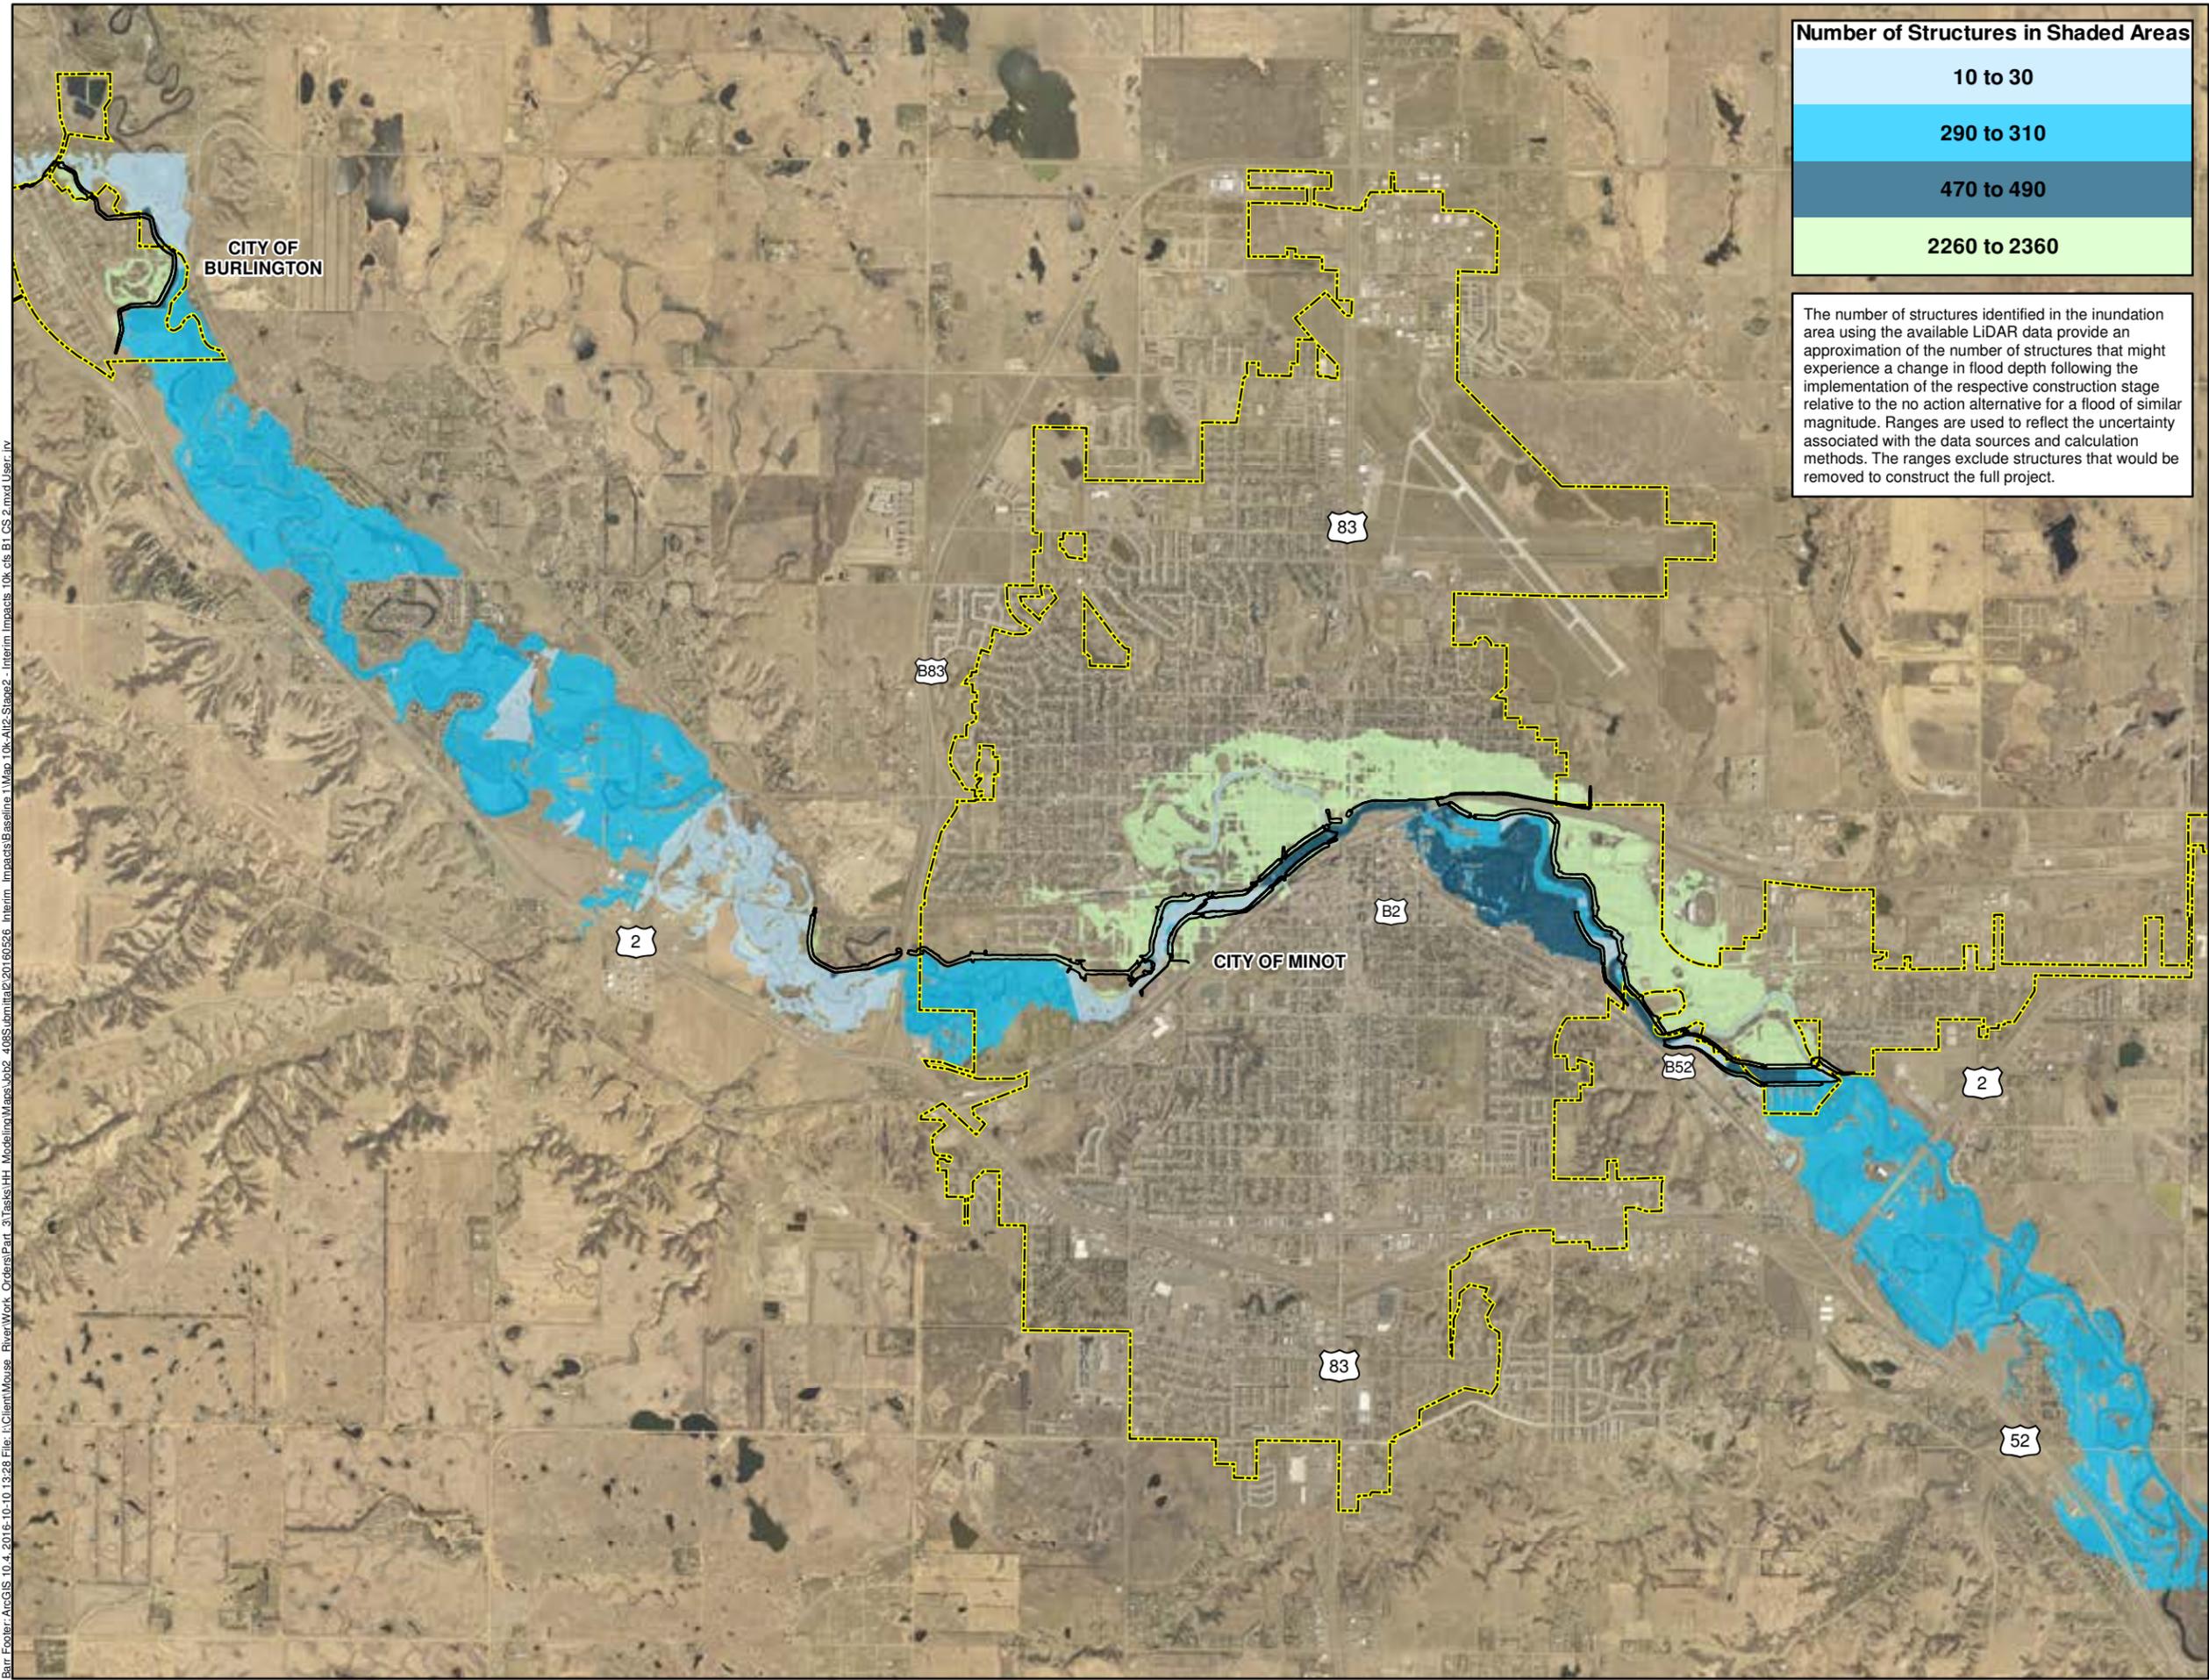
Number of Structures in Shaded Areas	
10 to 30	
290 to 310	
470 to 490	
2260 to 2360

The number of structures identified in the inundation area using the available LIDAR data provide an approximation of the number of structures that might experience a change in flood depth following the implementation of the respective construction stage relative to the no action alternative for a flood of similar magnitude. Ranges are used to reflect the uncertainty associated with the data sources and calculation methods. The ranges exclude structures that would be removed to construct the full project.

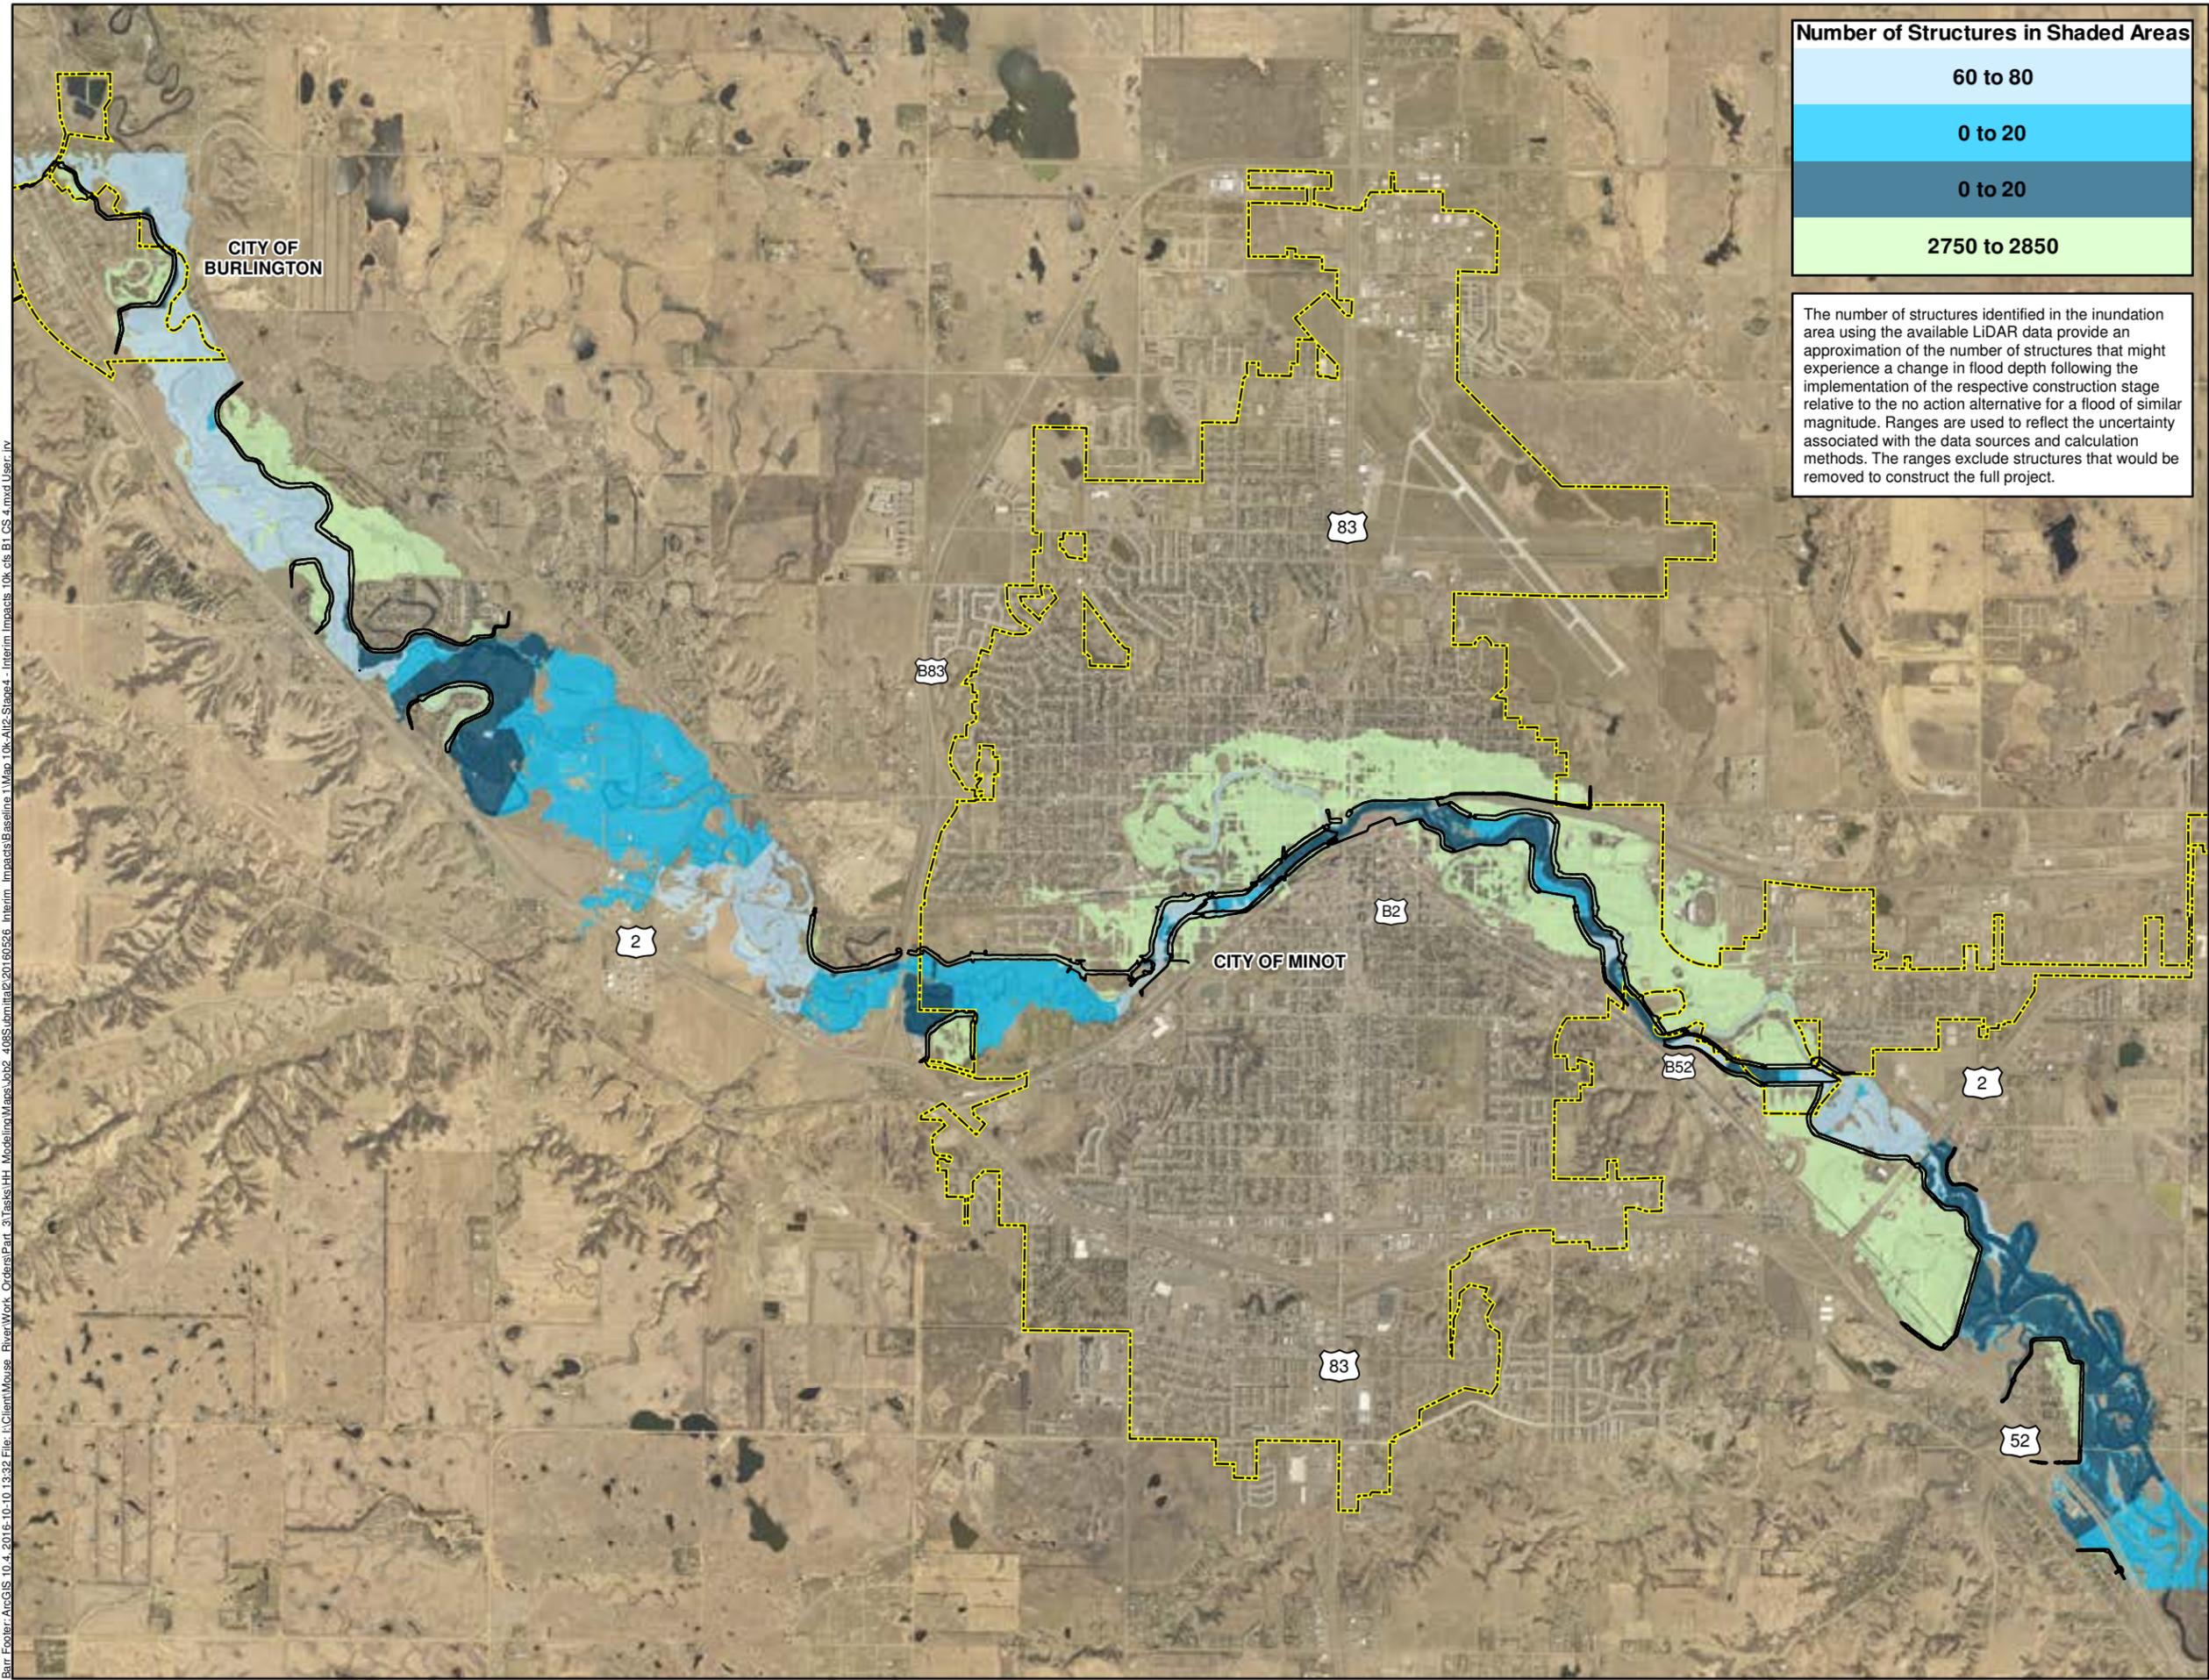
Number of Structures in Shaded Areas	
60 to 80	(Lightest Blue)
0 to 20	(Medium Blue)
0 to 20	(Darkest Blue)
2750 to 2850	(Light Green)

The number of structures identified in the inundation area using the available LIDAR data provide an approximation of the number of structures that might experience a change in flood depth following the implementation of the respective construction stage relative to the no action alternative for a flood of similar magnitude. Ranges are used to reflect the uncertainty associated with the data sources and calculation methods. The ranges exclude structures that would be removed to construct the full project.

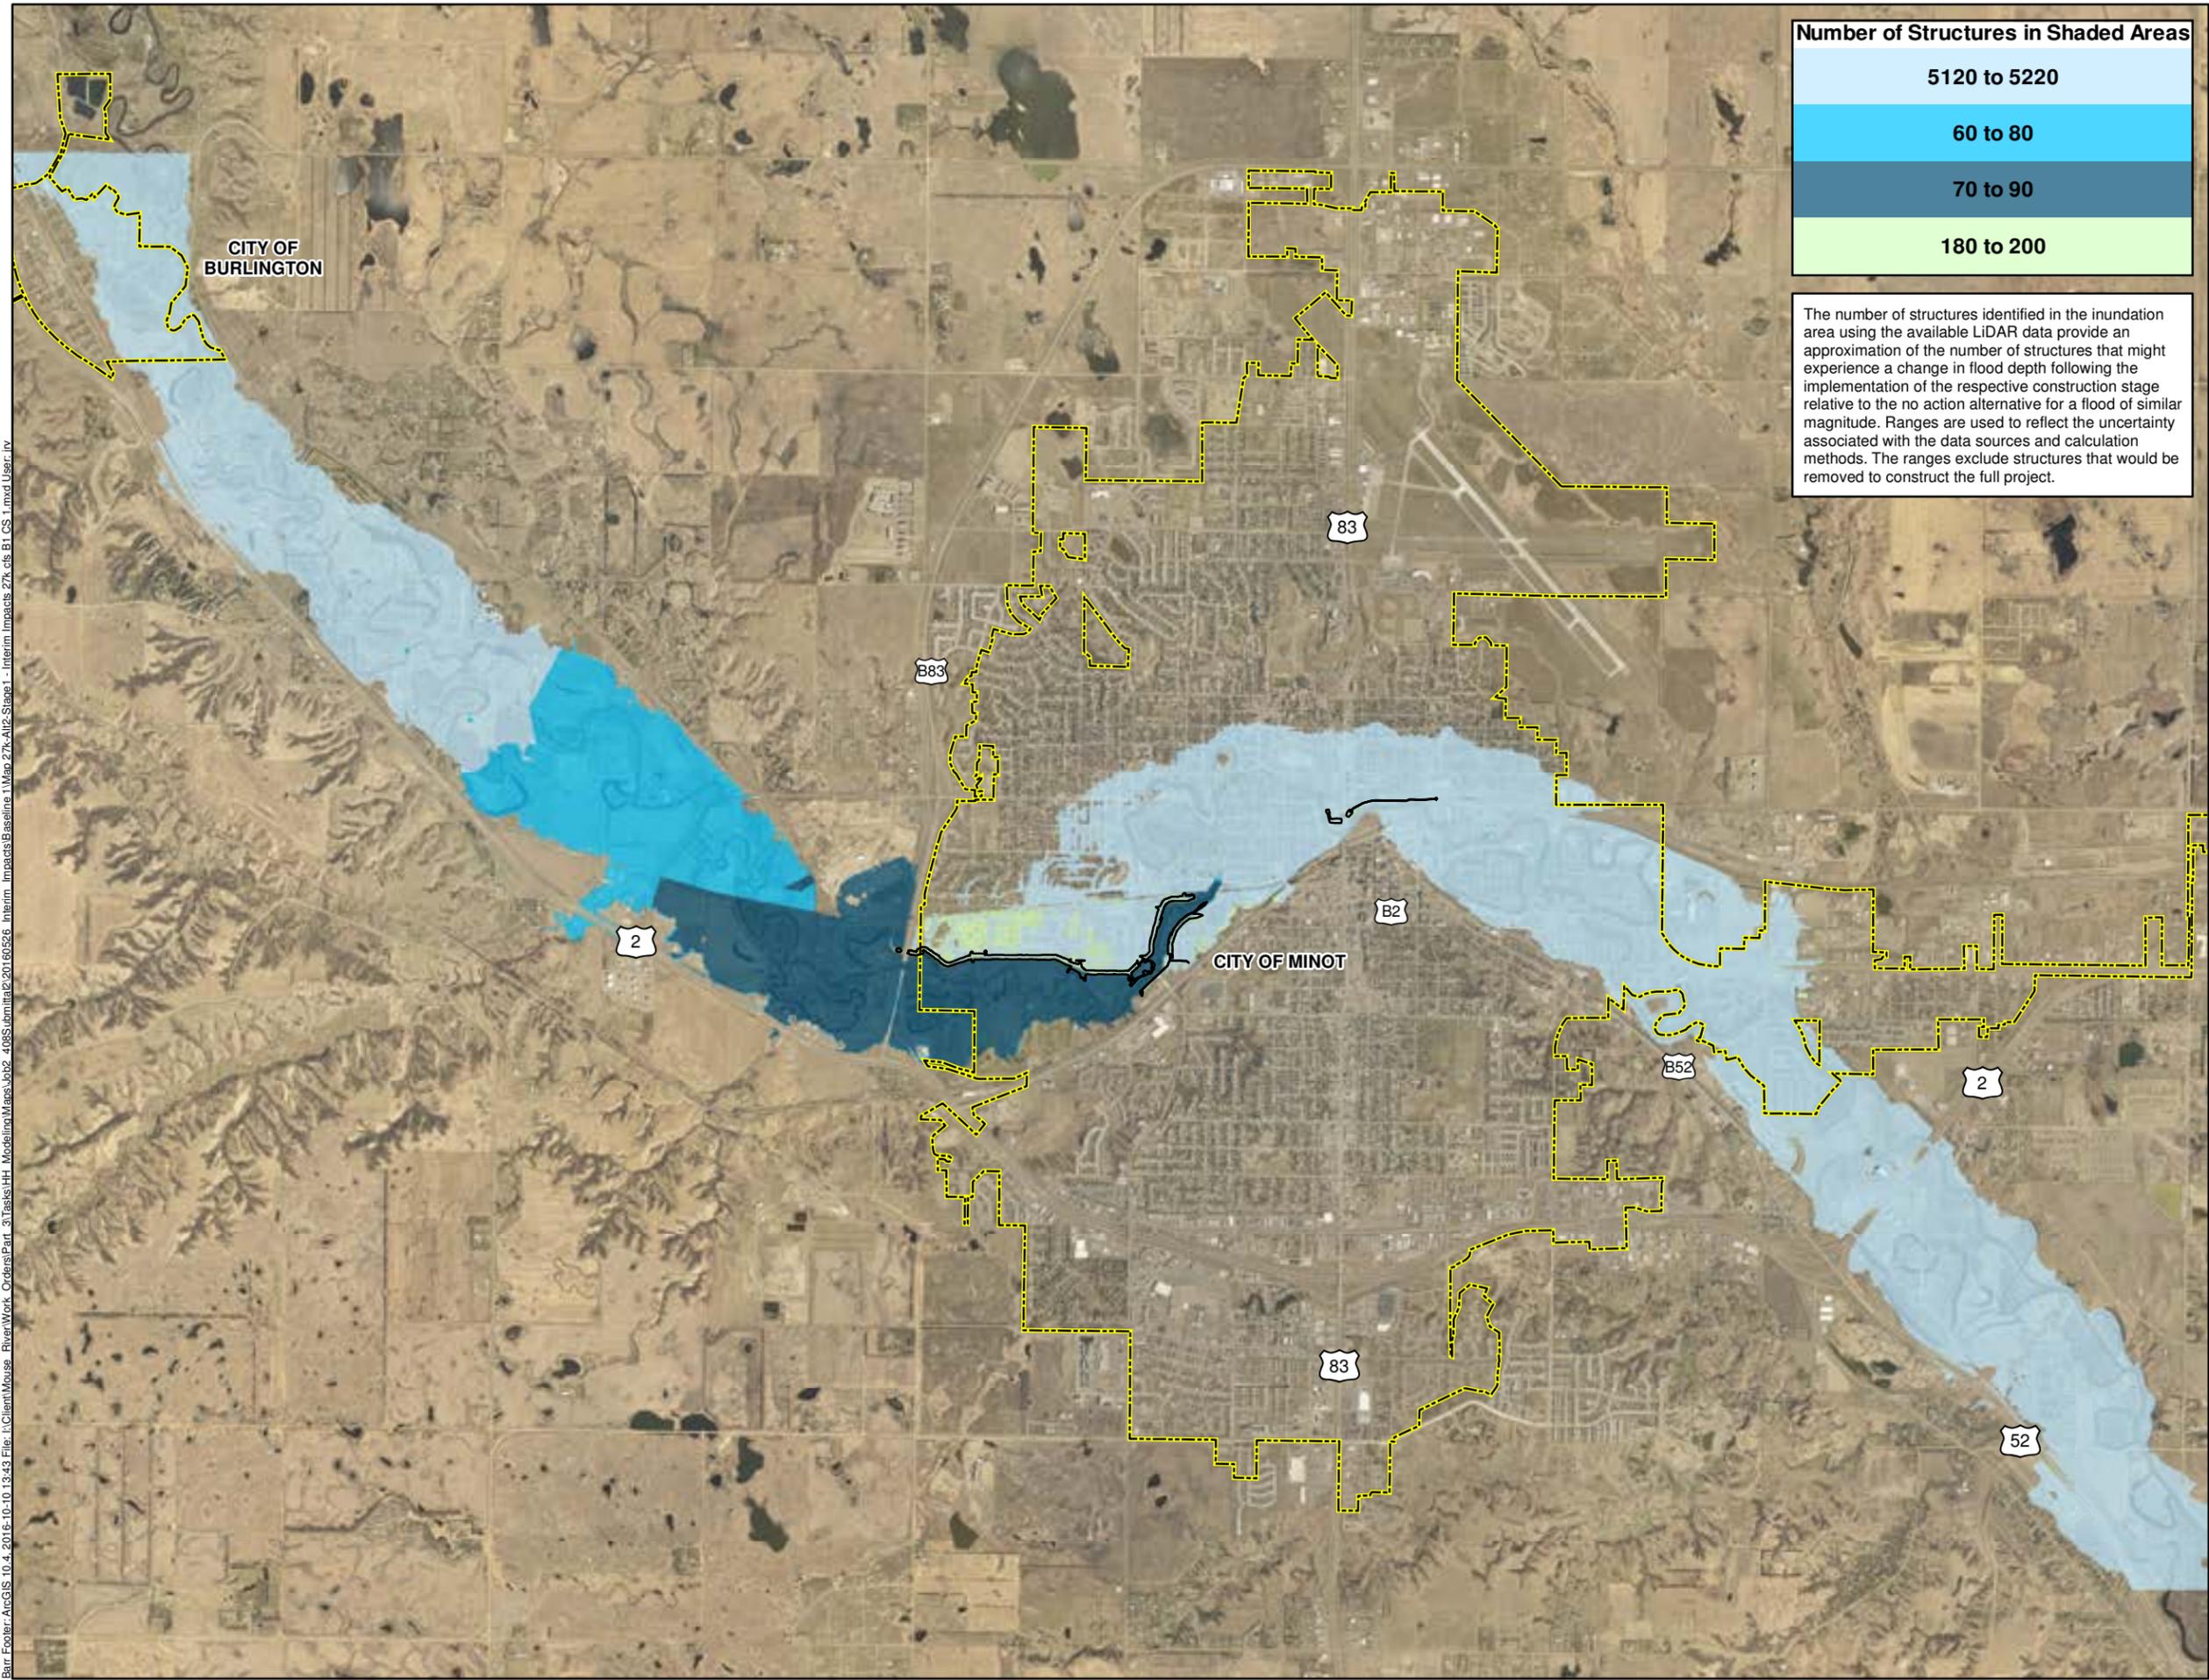
Number of Structures in Shaded Areas	
Light Blue	5120 to 5220
Medium Blue	60 to 80
Dark Blue	70 to 90
Green	180 to 200

The number of structures identified in the inundation area using the available LIDAR data provide an approximation of the number of structures that might experience a change in flood depth following the implementation of the respective construction stage relative to the no action alternative for a flood of similar magnitude. Ranges are used to reflect the uncertainty associated with the data sources and calculation methods. The ranges exclude structures that would be removed to construct the full project.

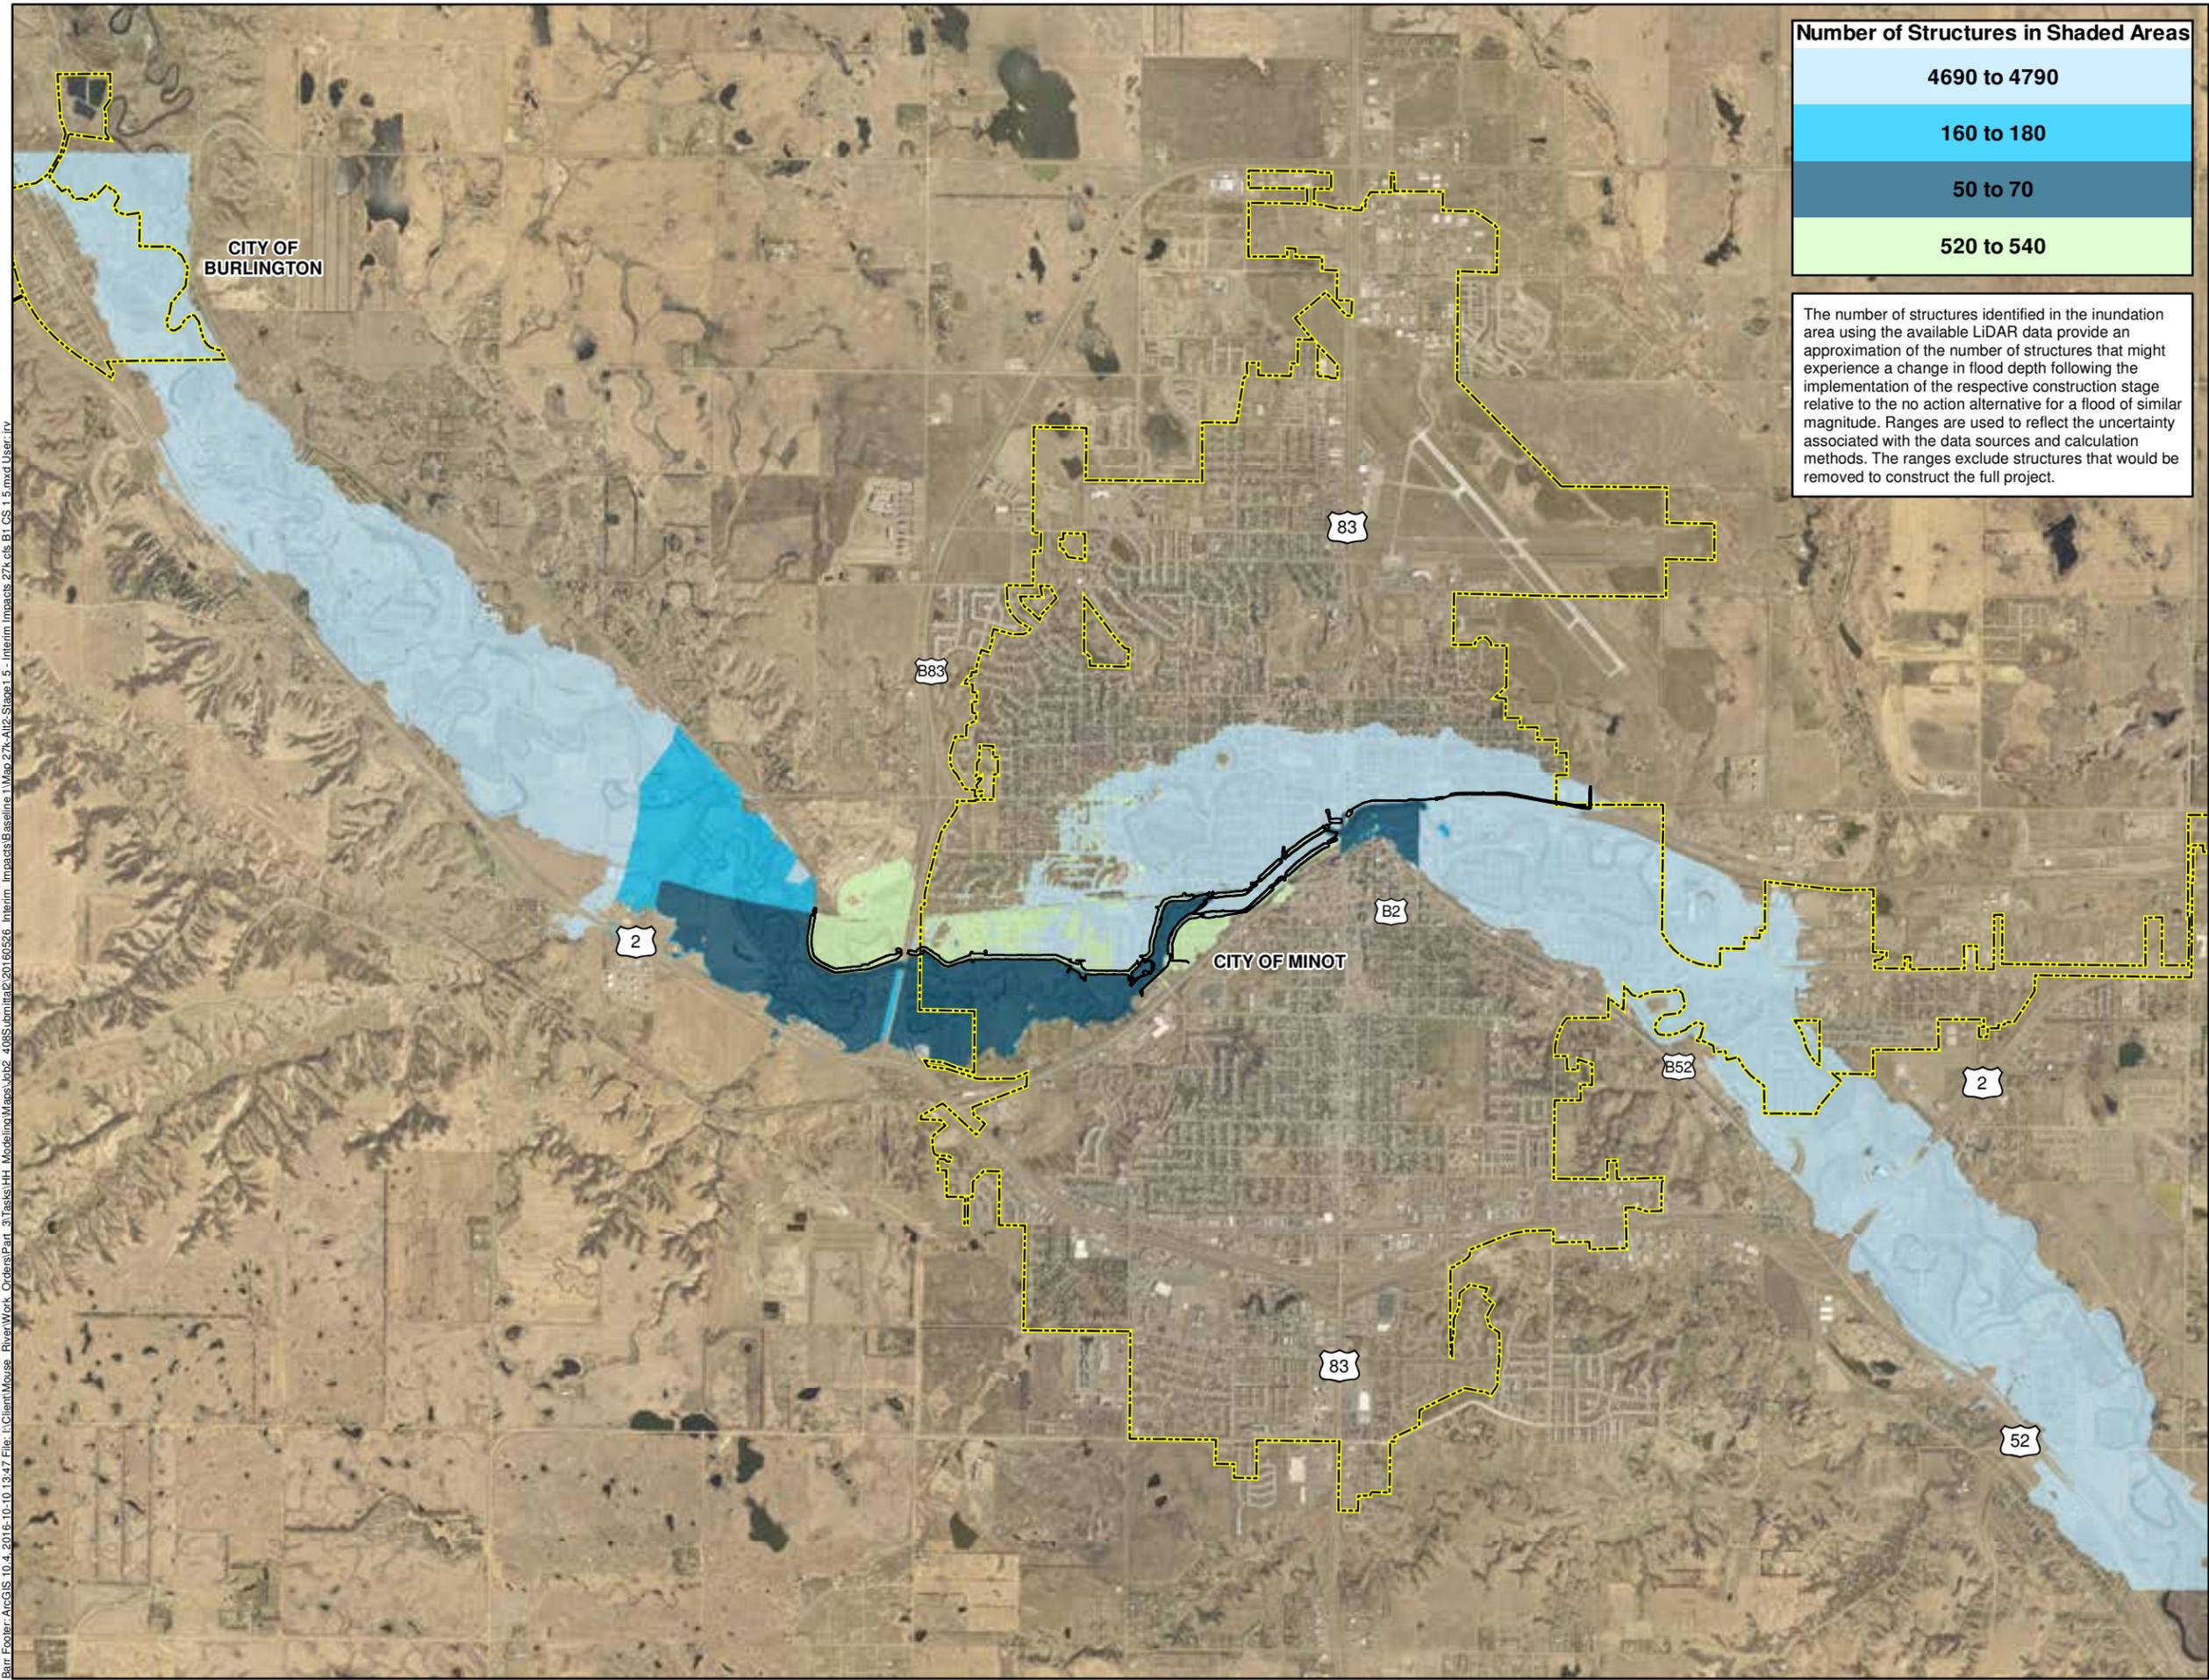
Number of Structures in Shaded Areas	
4690 to 4790	
160 to 180	
50 to 70	
520 to 540

The number of structures identified in the inundation area using the available LIDAR data provide an approximation of the number of structures that might experience a change in flood depth following the implementation of the respective construction stage relative to the no action alternative for a flood of similar magnitude. Ranges are used to reflect the uncertainty associated with the data sources and calculation methods. The ranges exclude structures that would be removed to construct the full project.

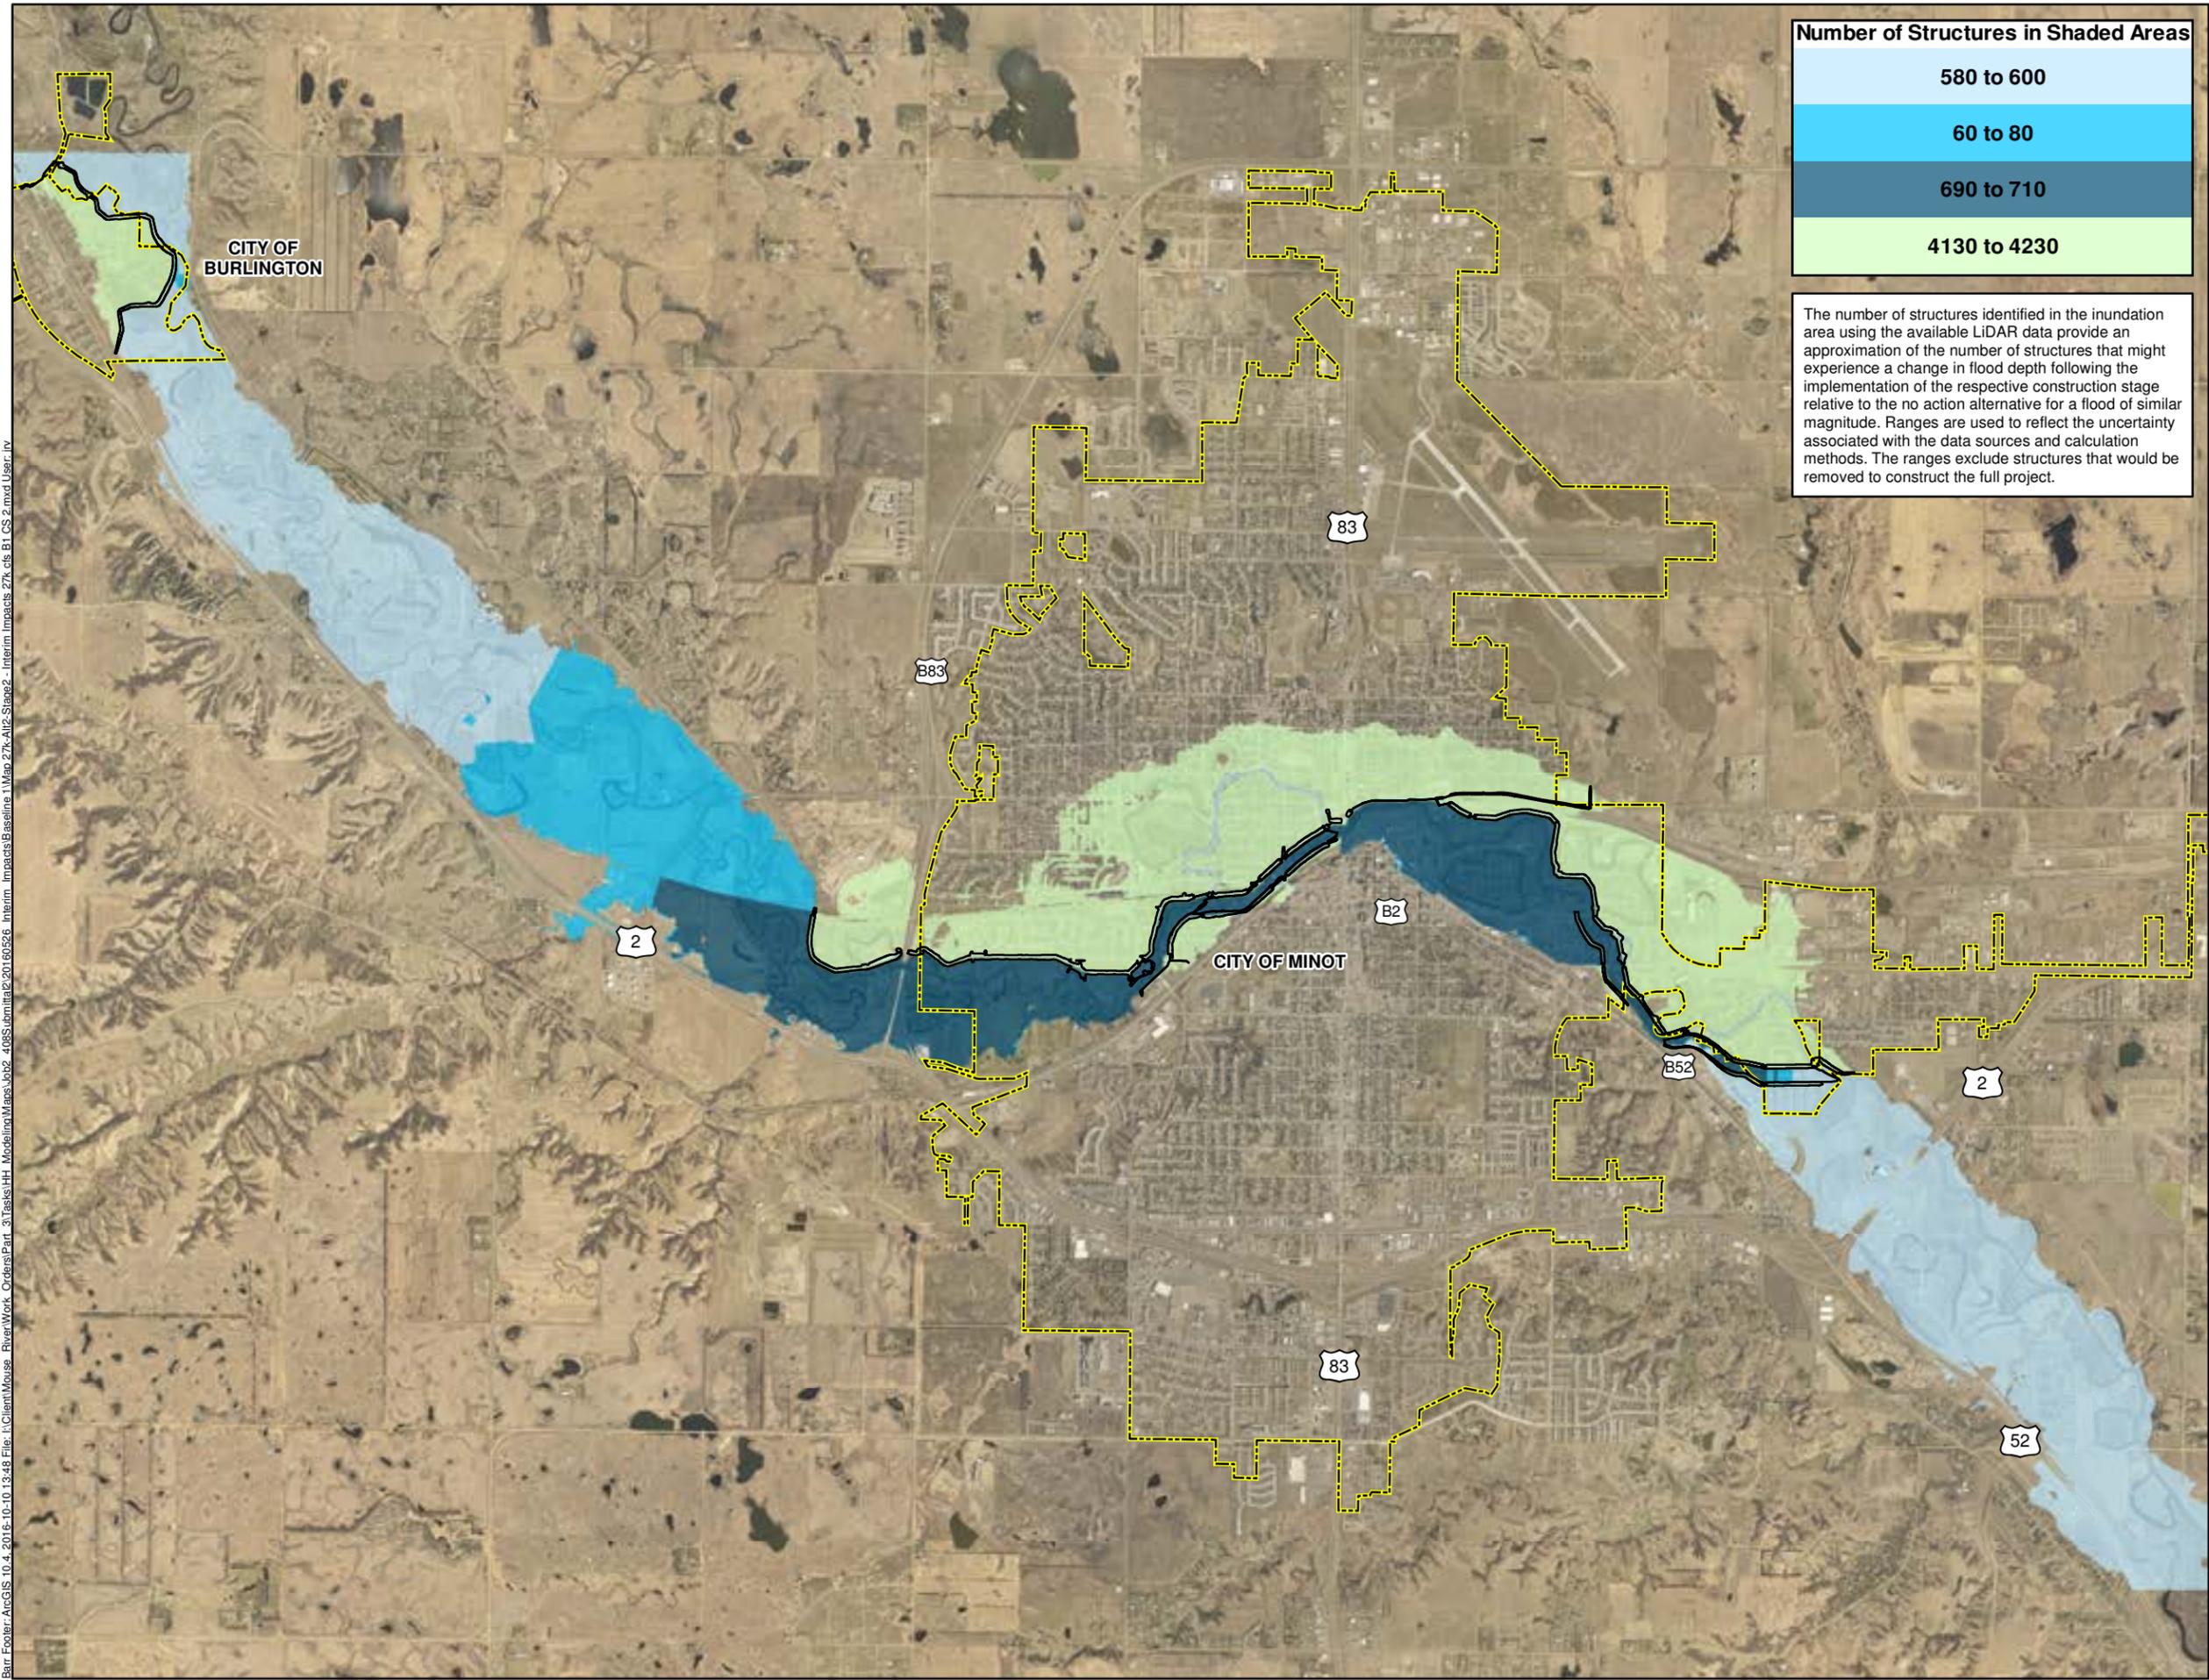
Number of Structures in Shaded Areas	
580 to 600	(Lightest Blue)
60 to 80	(Medium Blue)
690 to 710	(Darkest Blue)
4130 to 4230	(Light Green)

The number of structures identified in the inundation area using the available LIDAR data provide an approximation of the number of structures that might experience a change in flood depth following the implementation of the respective construction stage relative to the no action alternative for a flood of similar magnitude. Ranges are used to reflect the uncertainty associated with the data sources and calculation methods. The ranges exclude structures that would be removed to construct the full project.
