Scoping Document - Mouse River Enhanced Flood Protection Plan Environmental Impact Statement

MOUSE RIVER ENHANCED FLOOD PROTECTION PLAN ENVIRONMENTAL IMPACT STATEMENT

Version – February 29, 2016

WETLANDS, WATERS, and BIOLOGICAL INVENTORY REPORT

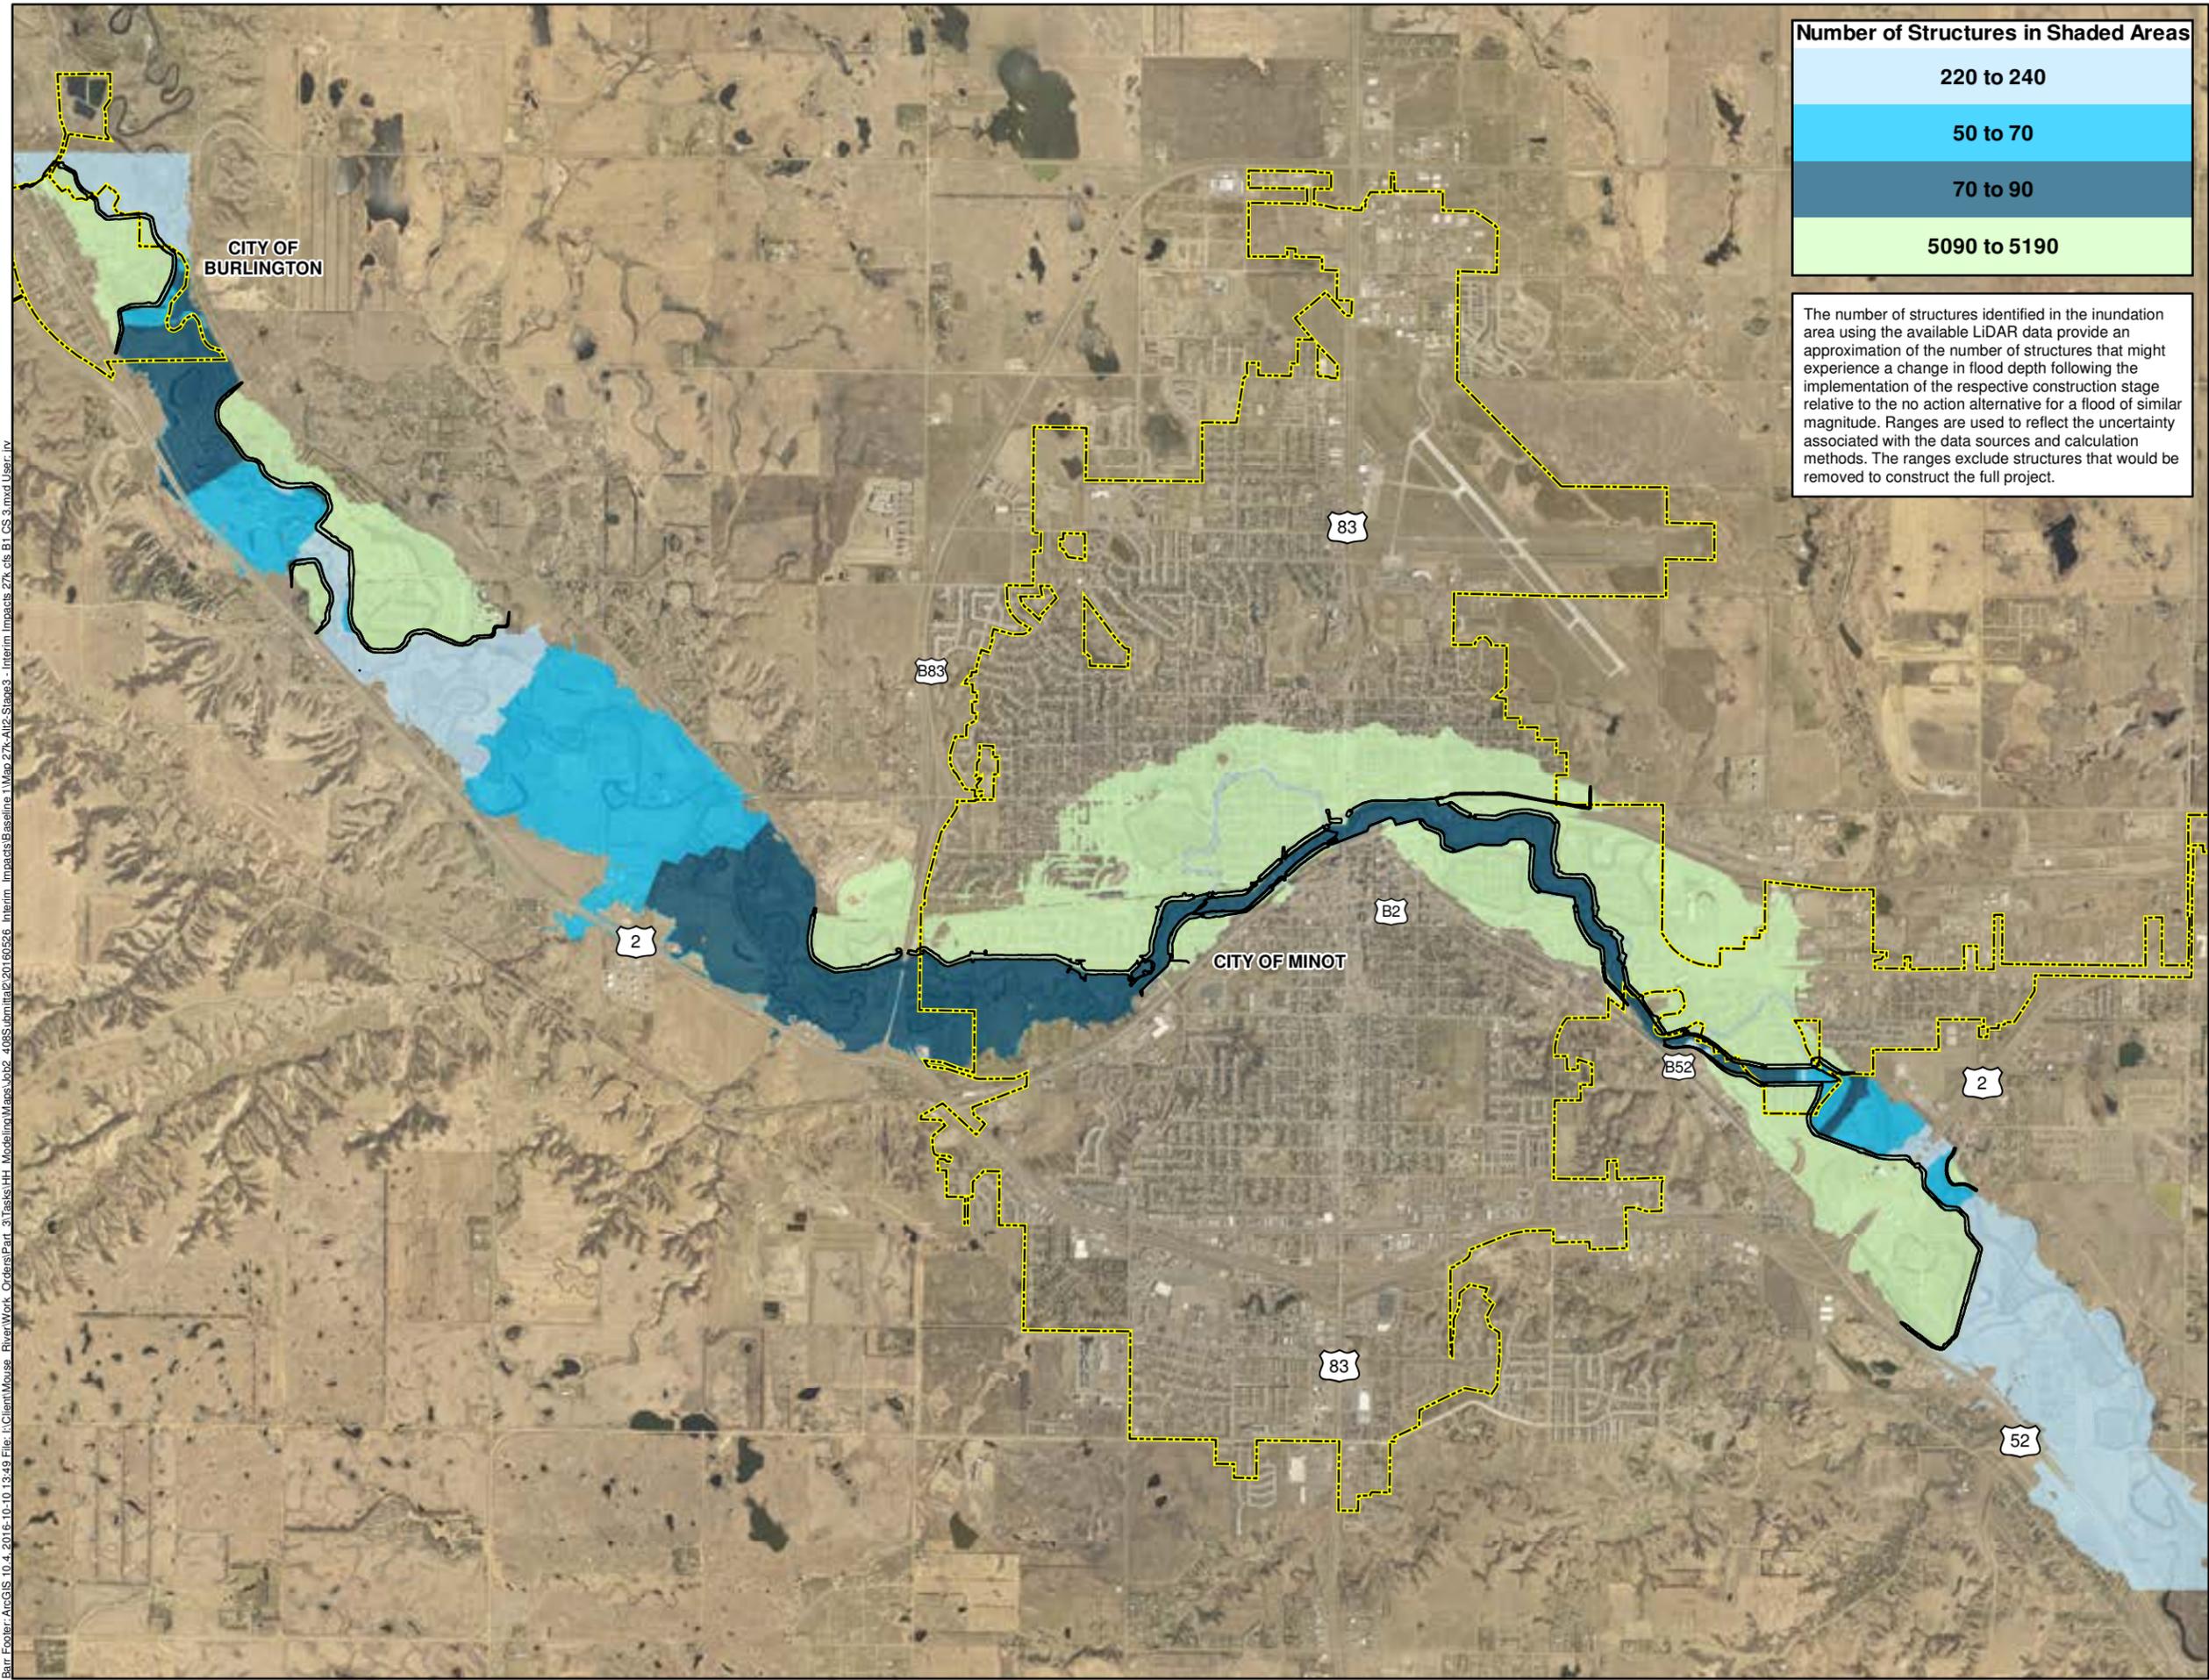
Number of Structures in Shaded Areas	
220 to 240	
50 to 70	
70 to 90	
5090 to 5190

The number of structures identified in the inundation area using the available LIDAR data provide an approximation of the number of structures that might experience a change in flood depth following the implementation of the respective construction stage relative to the no action alternative for a flood of similar magnitude. Ranges are used to reflect the uncertainty associated with the data sources and calculation methods. The ranges exclude structures that would be removed to construct the full project.

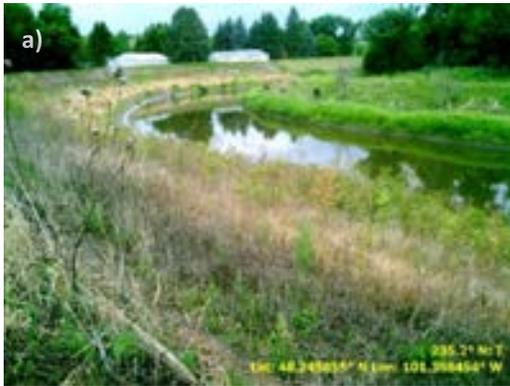
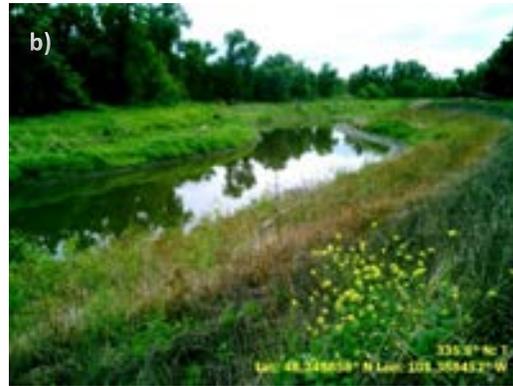
King's Court: The interior bank of the meander, near the houses, consists of a low levee sloping down to the river (Channel cut-off sites 1 and 2, **Attachment 2 Wetlands in Project Corridor**). The bank is composed of riprap and large rocks, channelized, with no natural habitat such as overbanks or mud (Figure 1). The vegetation is composed of predominantly non-native wetland plants and dryland plants growing among the rocks. Saplings of *Fraxinus pennsylvanica* (Green ash) that have germinated have been sprayed with herbicide. The opposite side of the river appears to have some natural habitat, including mud banks with some natural vegetation and mature trees, but the erosional banks have also been reinforced with riprap.

Site 1 – west side facing southwest

Site 1 – west side facing north

Figure 1: Photographs of the potential channel cut-off sites, a-d) King's Cross and e-f) 18th St SE.

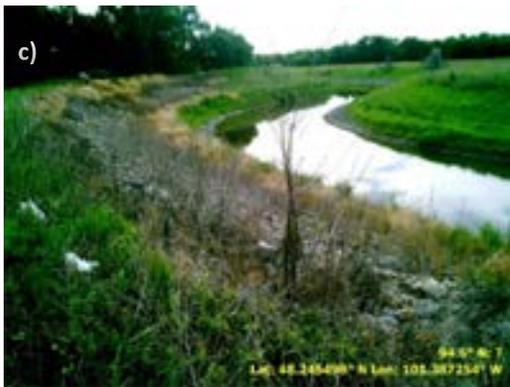
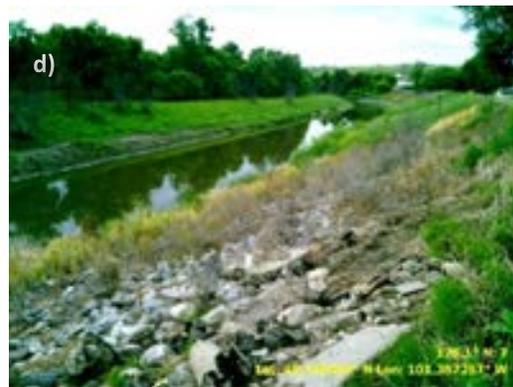
Site 2 – east side facing east

Site 2 – east side facing south

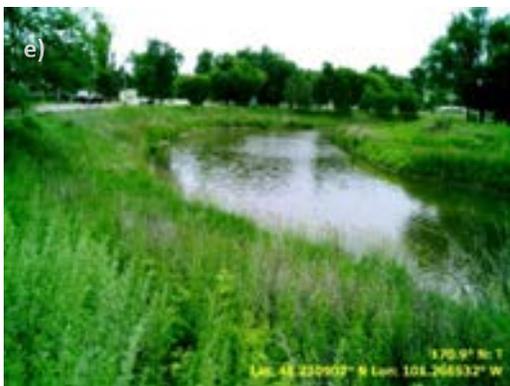
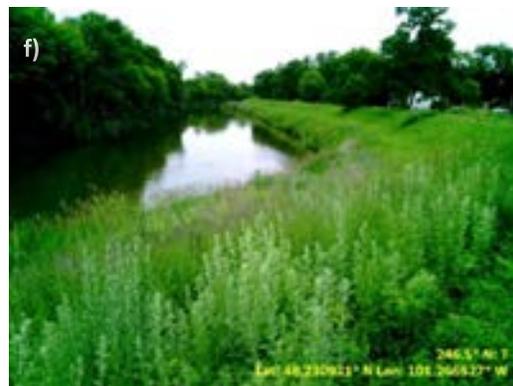
Meander near 18th St SE: Both sides of the river have been channelized with levees and riprap (Channel cut-off sites 3 and 4, **Attachment 2 Wetlands in Project Corridor**). The interior bank of the meander has developed a mud bank in the depositional area, and there is some natural habitat with both native and non-native vegetation including grasses and some large trees (Figure 1). The outer bank has more riprap exposed, and there is some natural vegetation with grasses, forbs, and trees in a range of sizes.

Site 3 – northeast side looking south

Site 4 – northeast side looking west

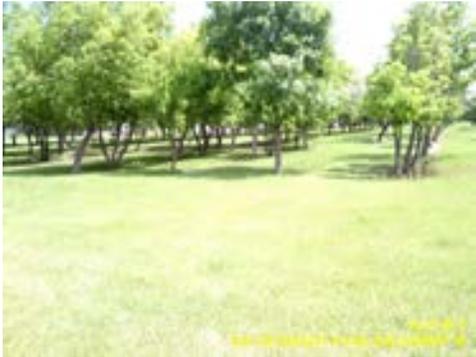
2nd Ave SW Tree area – area of proposed pond for water retention: This area is a small, triangular plot (5.4 acres, Tree site 1, **Attachment 2 Wetlands in Project Corridor**) containing planted trees of a large variety of species, including ornamental and fruit trees (Figure 2). Some of the species found here include *Acer ginnala* (Amur maple), *Acer negundo* (Box elder), *Elaeagnus angustifolia* (Russian olive), *Fraxinus pennsylvanica* (Green ash), *Malis pumila* (apple), Pine species (several), *Populus tremuloides* (Quaking aspen), *Prunus* species (plum), *Quercus macrocarpa* (Burr oak), *Salix* species (willows), and *Tilia americana* (American basswood). If this area is to be impacted by construction activities, we recommended that a more complete tree inventory be conducted.

Tree Site 1, 2nd Ave SW, potential ponding area

Figure 2: Photographs of tree sites and examples of impacts

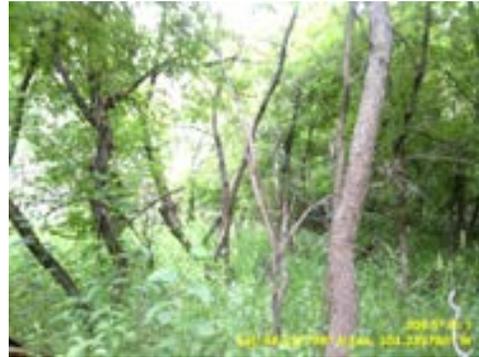
Naturally occurring stands of trees: Naturally occurring trees in North Dakota are limited typically to a small group of species. At the first natural sampling site (Tree site 2, **Attachment 2 Wetlands in Project Corridor**, Figure 2), the quadrat contained twelve *F. pennsylvanica* individuals and three *A. negundo*. Other species observed nearby were one *Q. macrocarpa* and many *Populus deltoides* (Cottonwood) saplings. The second site (Tree site 3) (75' radius) contained six *A. negundo* individuals, four *F. pennsylvanica*, one *Q. macrocarpa*, and one *Prunus virginiana* (Choke cherry). This results in a mean number of individuals per acre as follows: 97.5 *F. pennsylvanica*, 30.5 *A. negundo*, 1.25 *Q. macrocarpa*, and 1.25 *P. virginiana*. These estimates may be somewhat overestimated at locations of floodwalls, levees, and channel diversion areas because these construction activities are located in more built up areas and less frequently in natural stands of trees.

Tree Site 2, near OHW 7

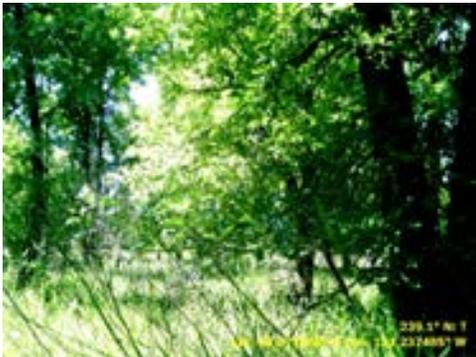
Tree Site 3, near OHW 14

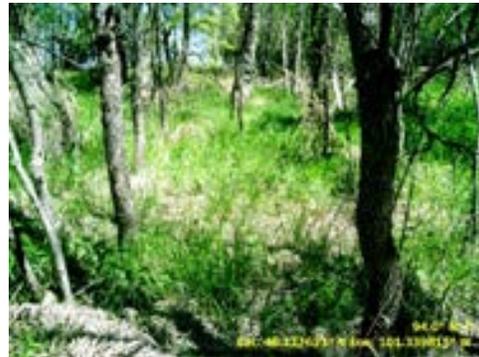
Trees near OHW 1

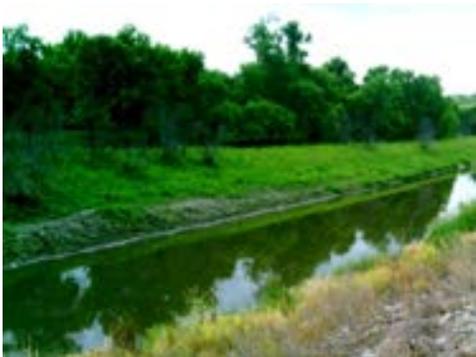
Trees potentially impacted by King's Cross levee

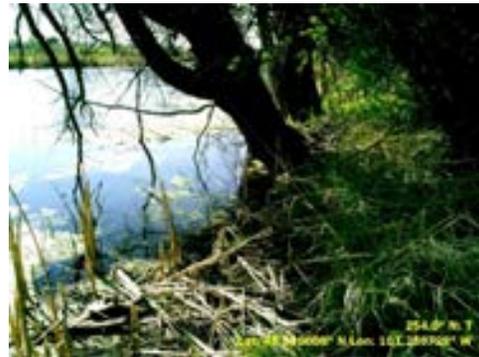
Trees in potential ponding areas (Site 25w)

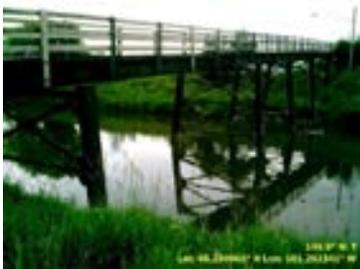
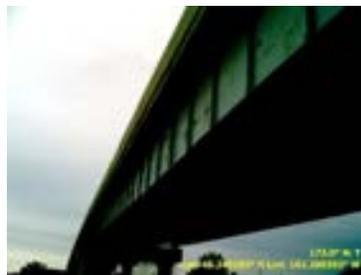
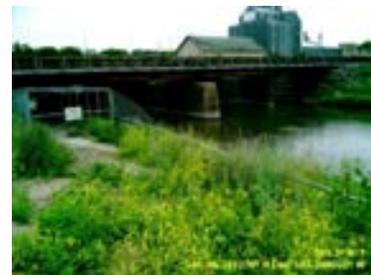
Figure 1: bridges within construction Phase 1 – 4th Ave NE

Three bridges crossing the main river channel are located within this area (Table 1). Only one, the 3rd St SE bridge, showed evidence of the presence of birds (Figure 1). Rock pigeons were identified, but nests were not visible or not present. Cliff swallows were seen flying and nesting, with a total nest count estimated at 170.

Bridge site number	Location/description (over main river channel unless otherwise specified)	Bird species present	Nest count estimate
19	Old wooden footbridge	none	none
20	Concrete vehicle bridge, 3 rd St SE	cliff swallows rock pigeons	170 unknown
21	Railway bridge	none	none

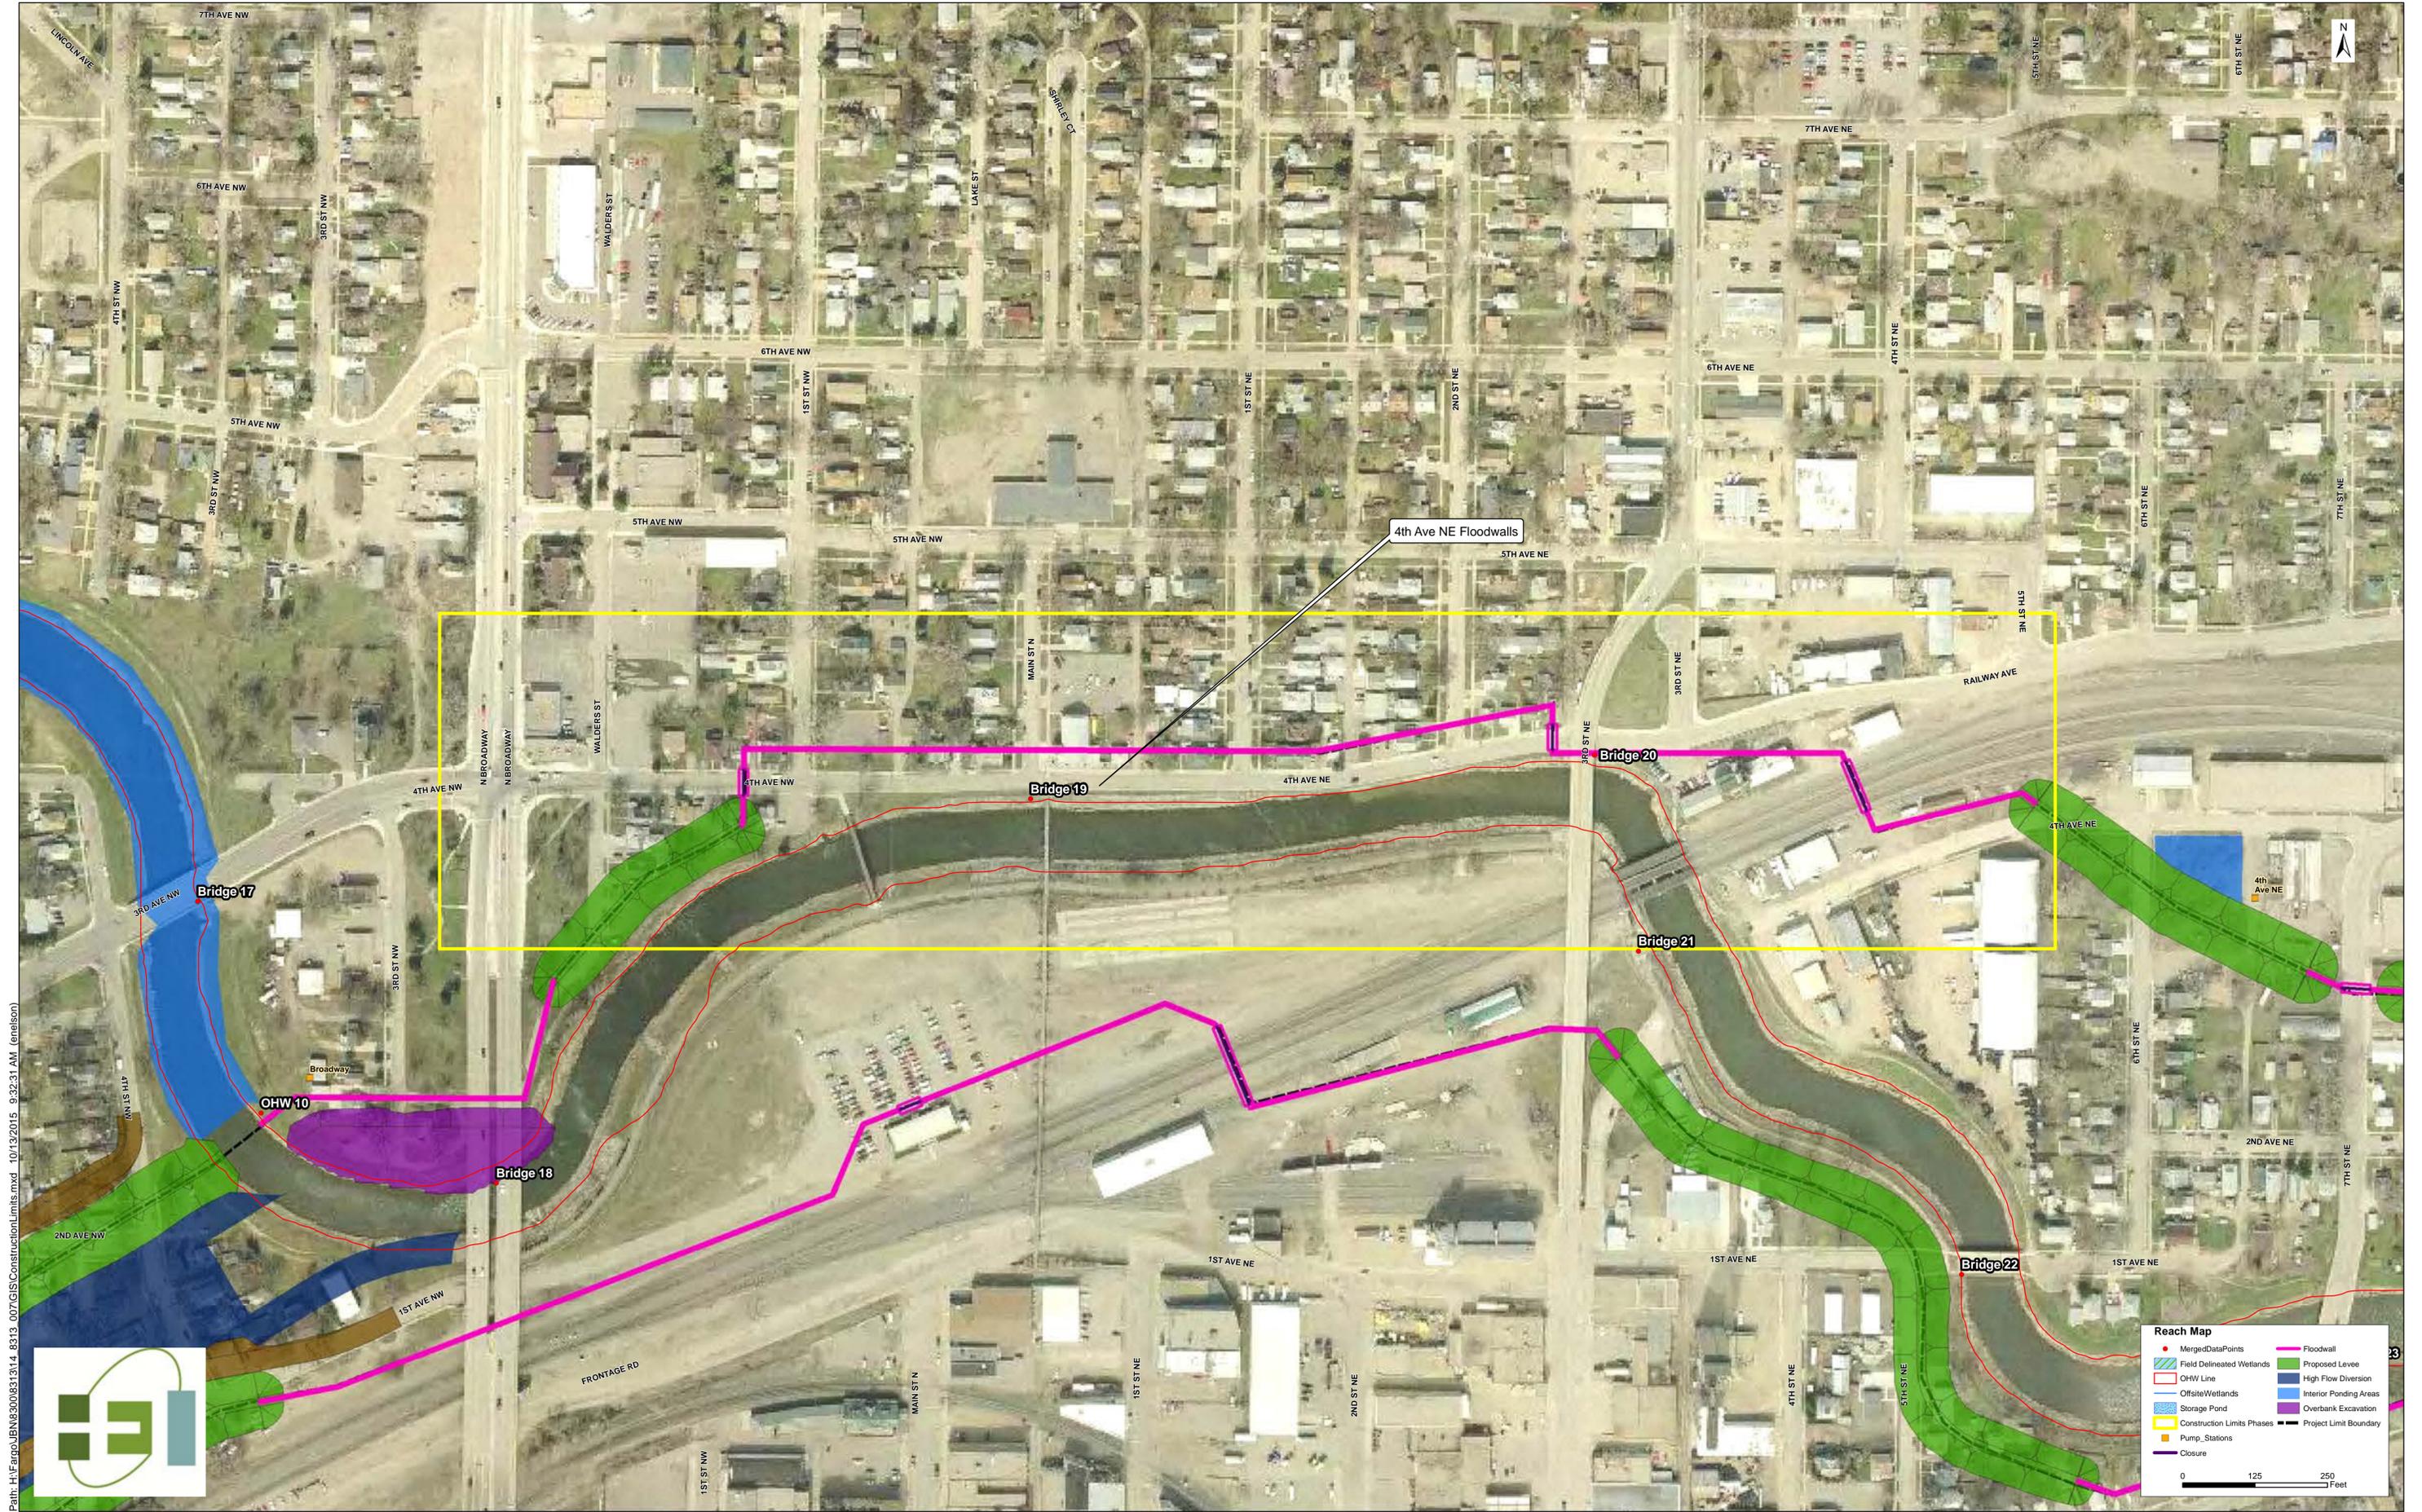
A small area of trees may be impacted by construction of a levee.

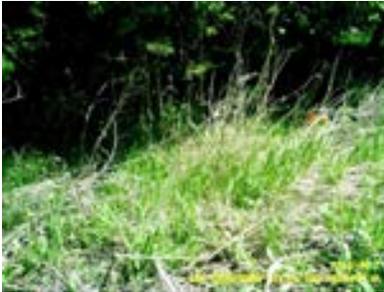
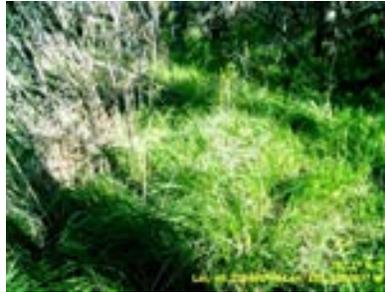
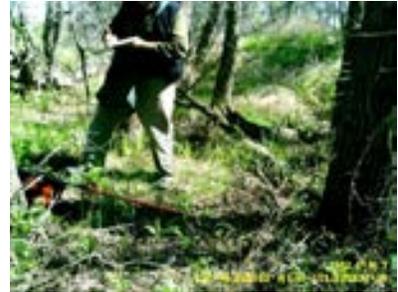
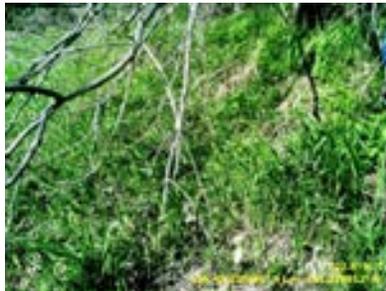
Figure 1: Examples of natural wetlands identified within or adjacent to the Napa Valley Construction Phase

There are seven wetlands located within or bordering on this construction phase (Table 1, Figure 1). The artificial wetland within this area is the constructed holding pond at the Perkett Ditch pump station (not delineated in this report because it is clearly constructed), listed by NWI as PABFx. Some of the wetlands extend beyond the boundaries of the construction area.

Site number	NWI listed	Cowardin classification	Total wetland area (acres)
9	no	PEMC	0.021
10	yes	PEMC	0.34
12	no	PFO/EMA	1.46
16	yes	PFO/EMA	0.16
17	no	PEMC	0.1
18	no	PEMA	0.19
19	no	PEMF	0.32
Total acres			2.591

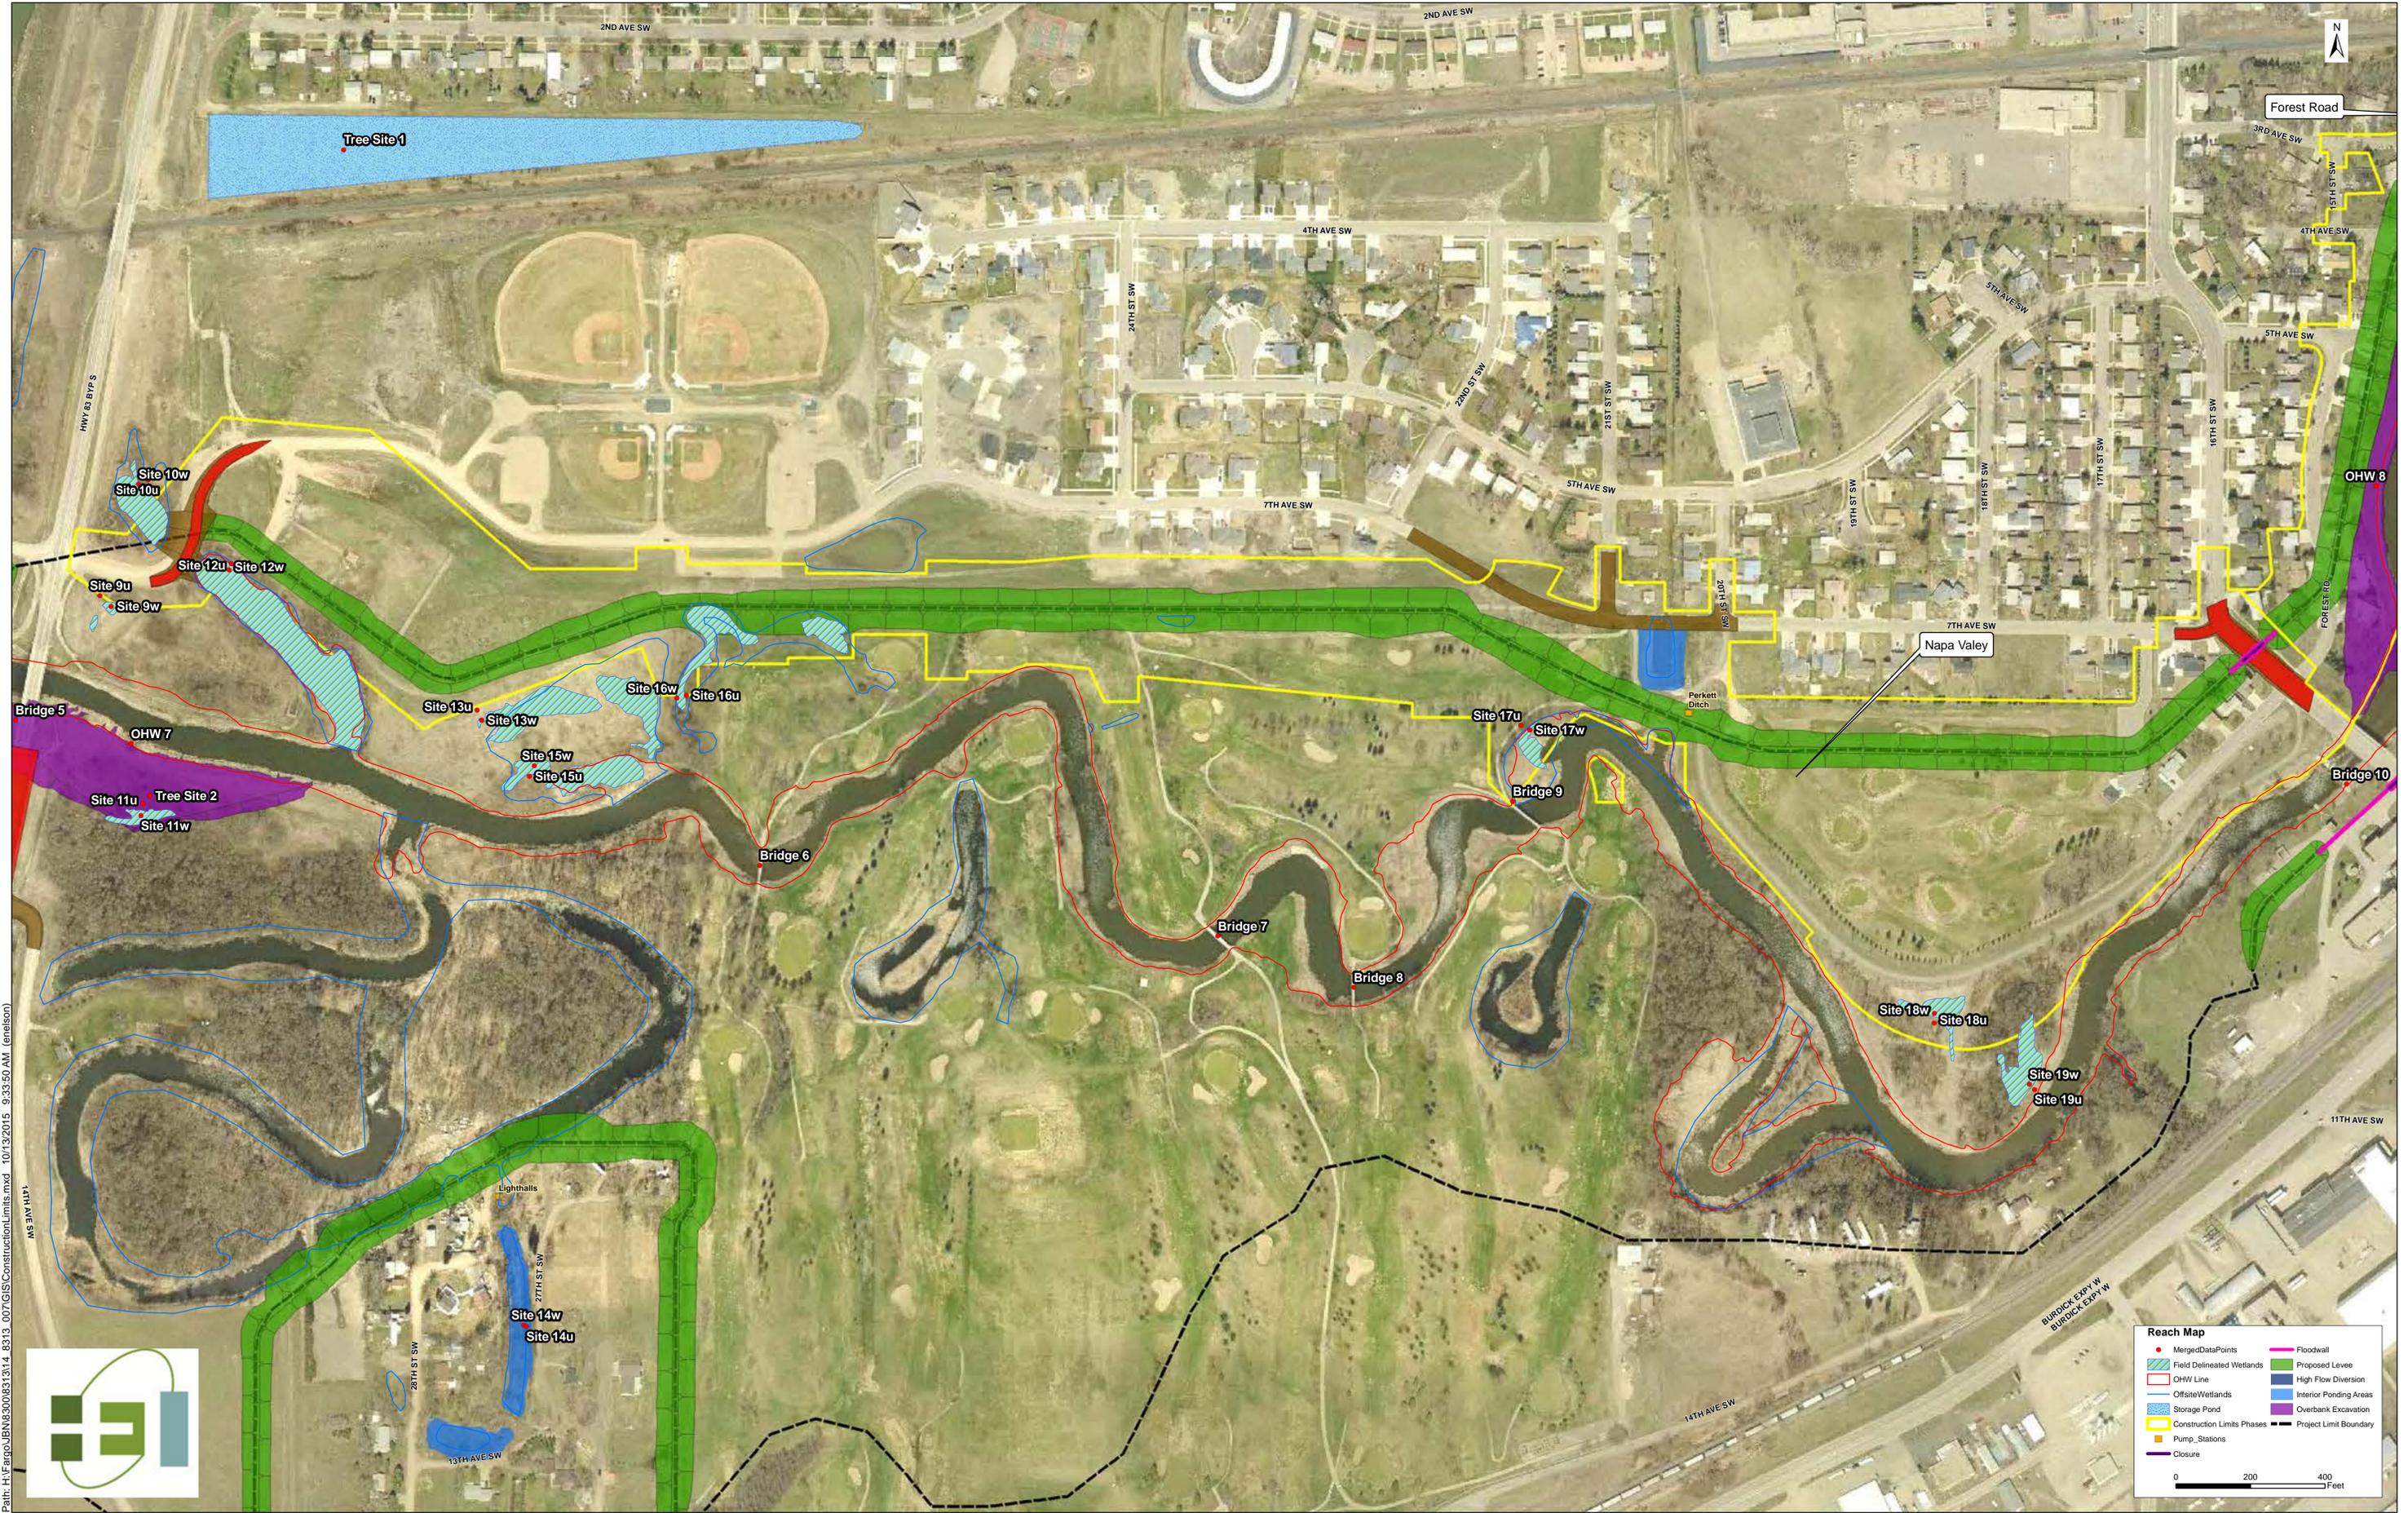
Trees will be impacted by the construction of the levee within this construction phase.

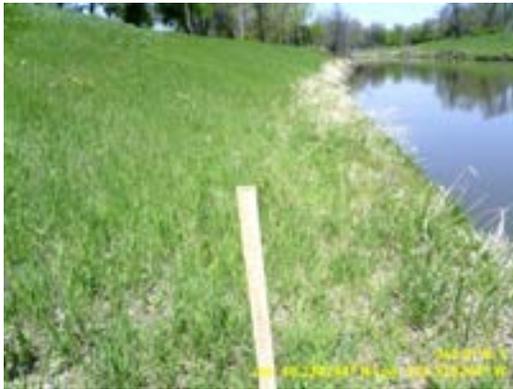
OHW Site 8

Within the Forest Road Construction Phase, the entire stretch of the river banks are sites of potential overbank excavation. The elevation of the wetland boundary (ordinary high water mark) was determined at two sites (OHW sites 8 and 9) where these banks were predominantly grasses (Figure 1). The following species were present in the plant community above the ordinary high water mark(OHW) include *Phalaris arundinacea*, *Artemisia vulgaris*, *Medicago sativa*, *Cirsium arvense*, *Taraxacum officinale*, *Elymus repens*, *Euphorbia esula*, *Acer negundo*, *Poa pratensis*, while below the OHW there are *P. arundinacea*, and *Carex species* (**Attachment 9 – OHW data forms**).

Figure 1: Overbank excavation sites within construction Phase 2 – Forest Road

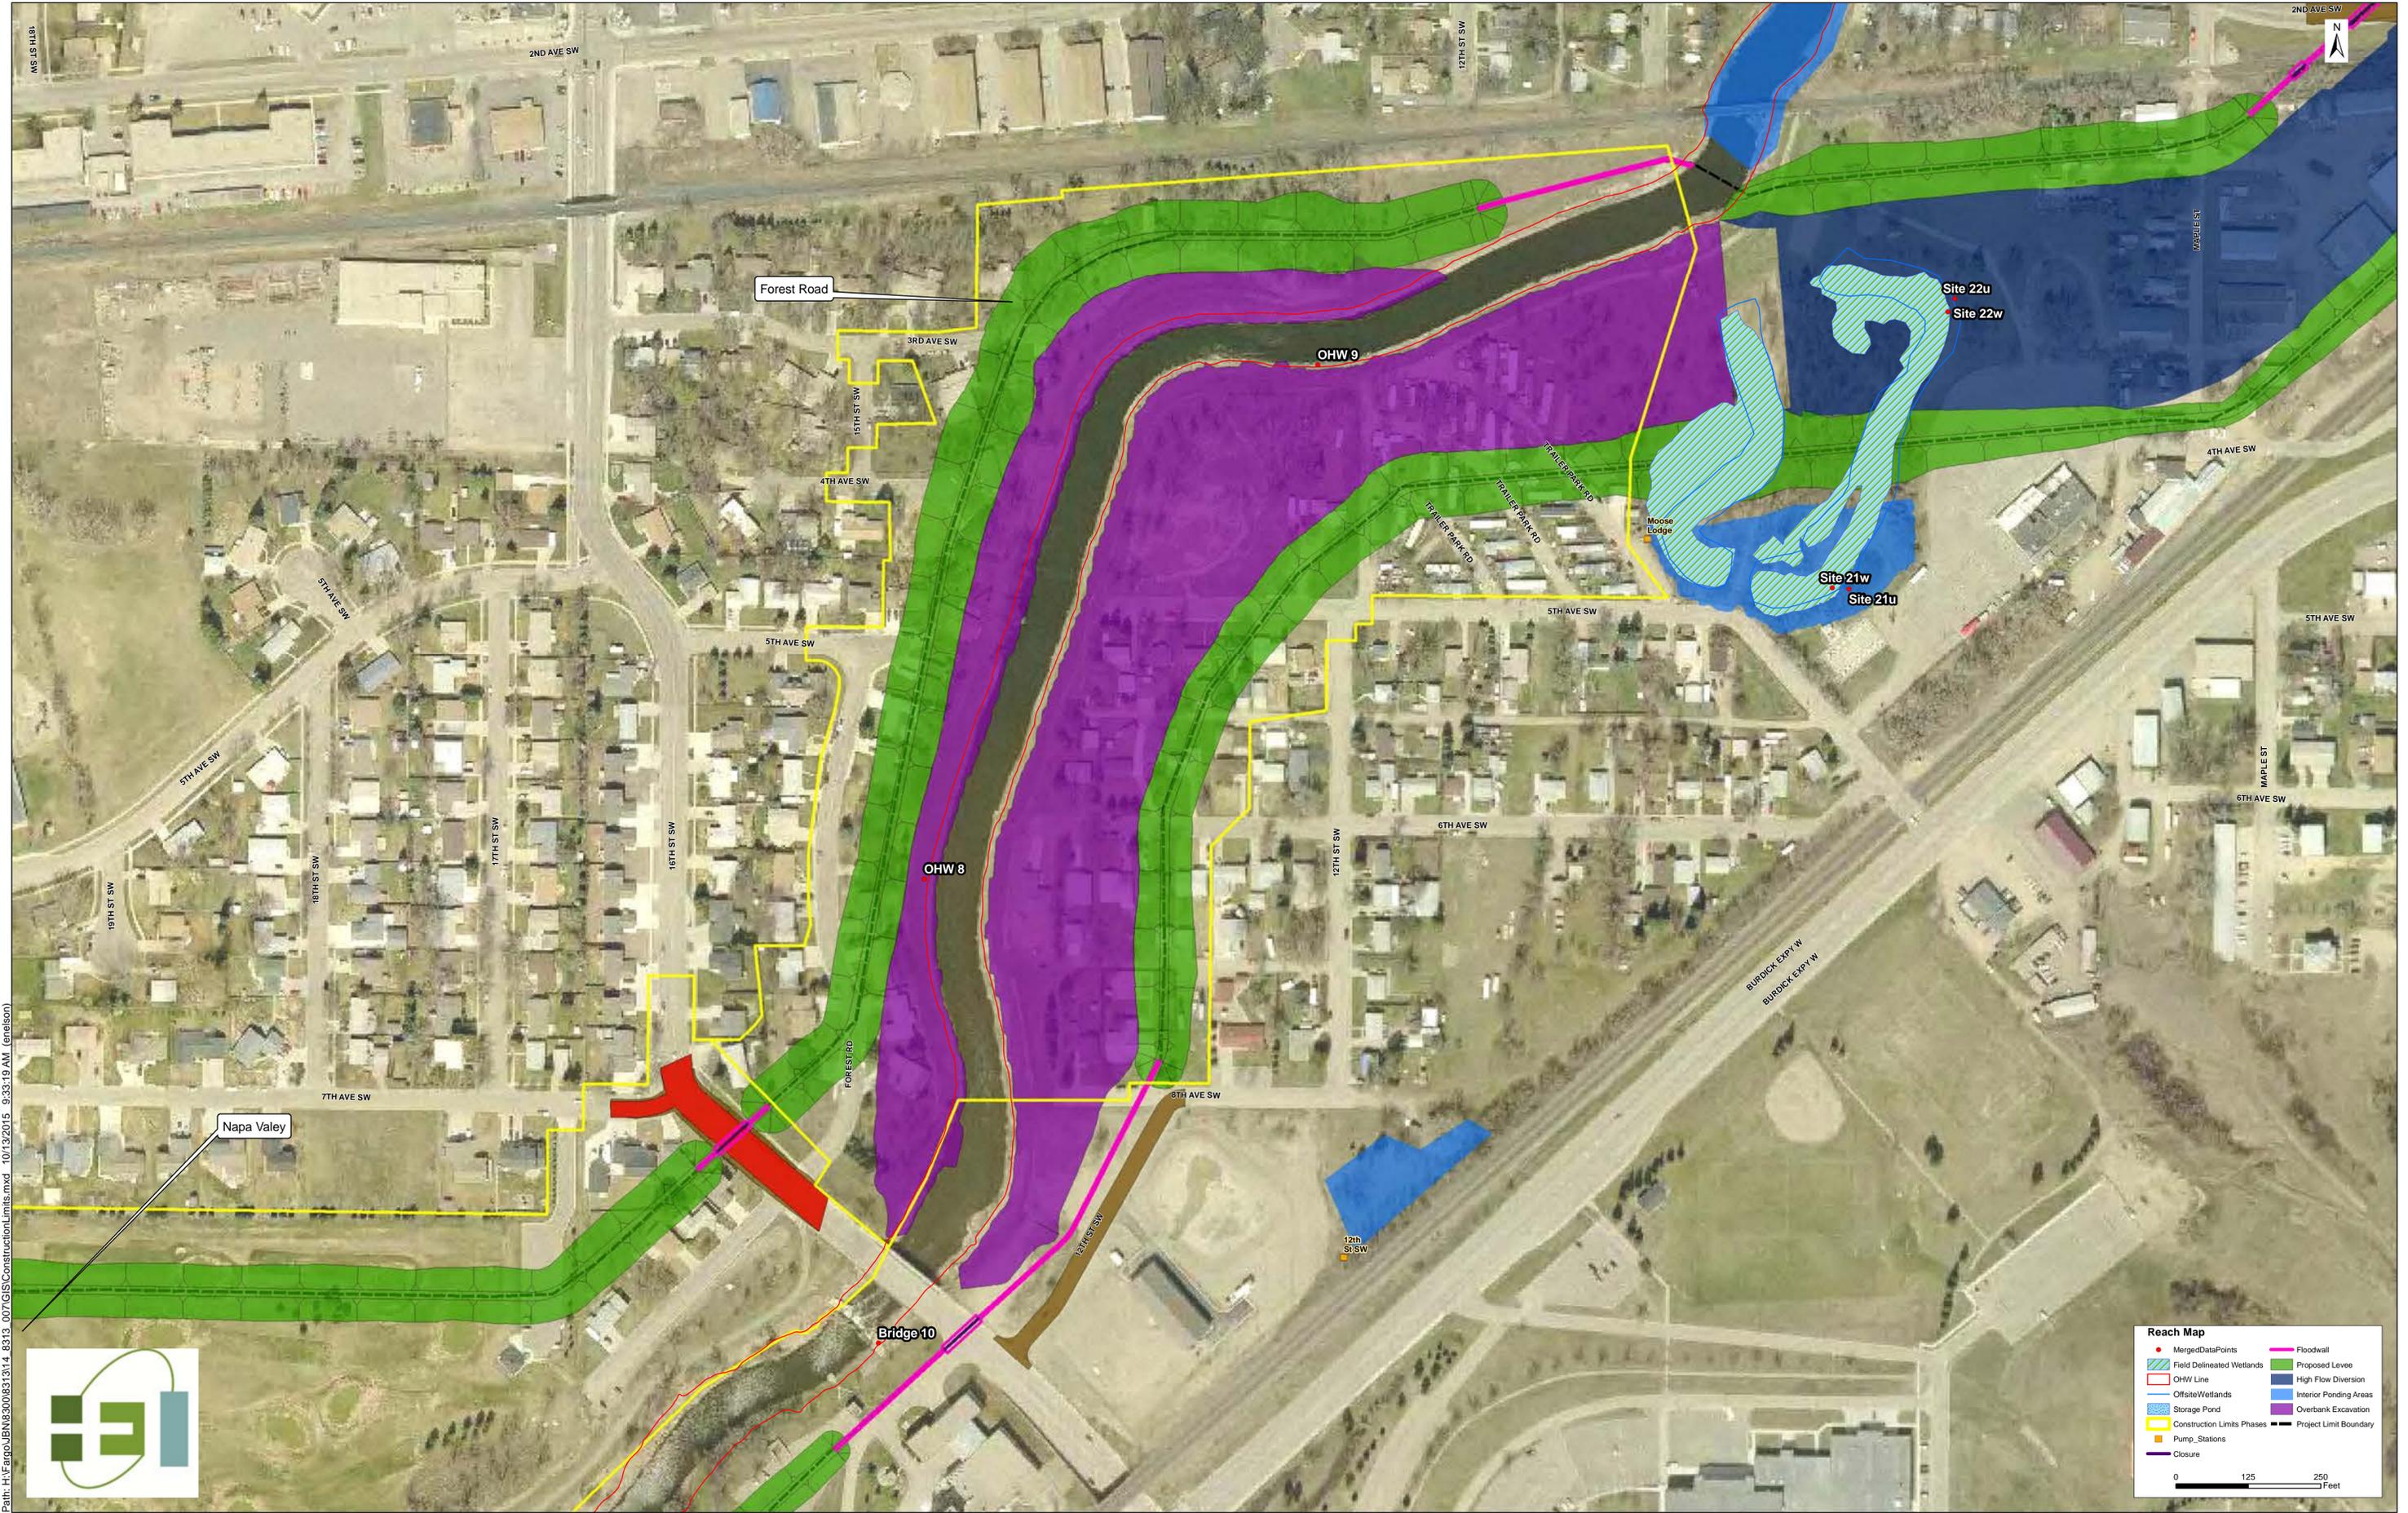
Trees will be impacted by the construction of the levee and the overbank excavation within this construction phase.
