## **Appendix A**

### **USACOE Wetland Determination Data Forms**

Project/Site: SR 87 Connector PD&E City/County: Santa Rosa Sampling Date: Sep 13, 2011  
 Applicant/Owner: FDOT State: Florida Sampling Point: CP1-A  
 Investigator(s): Todd Campbell Section, Township, Range: \_\_\_\_\_  
 Landform (hillslope, terrace, etc.) \_\_\_\_\_ Local relief (concave, convex, none): none Slope (%): \_\_\_\_\_  
 Subregion (LRR or MLRA): LRR P Lat: 30°39'4.7" N Long: 86°58'51.1" W Datum: NAD 83  
 Soil Map Unit Name: Bibb/Kriston Association NWI Classification: \_\_\_\_\_  
 Are climatic / hydrologic conditions on the site typical for this time of year? Yes X No \_\_\_\_\_ (If no, explain in Remarks.)  
 Are Vegetation \_\_\_\_\_, Soil \_\_\_\_\_, or Hydrology \_\_\_\_\_ significantly disturbed? Are "Normal Circumstances" present? Yes X No \_\_\_\_\_  
 Are Vegetation \_\_\_\_\_, Soil \_\_\_\_\_, or Hydrology \_\_\_\_\_ naturally problematic? (If needed, explain any answers in Remarks.)

### **Alignment Revisions and Minimization**

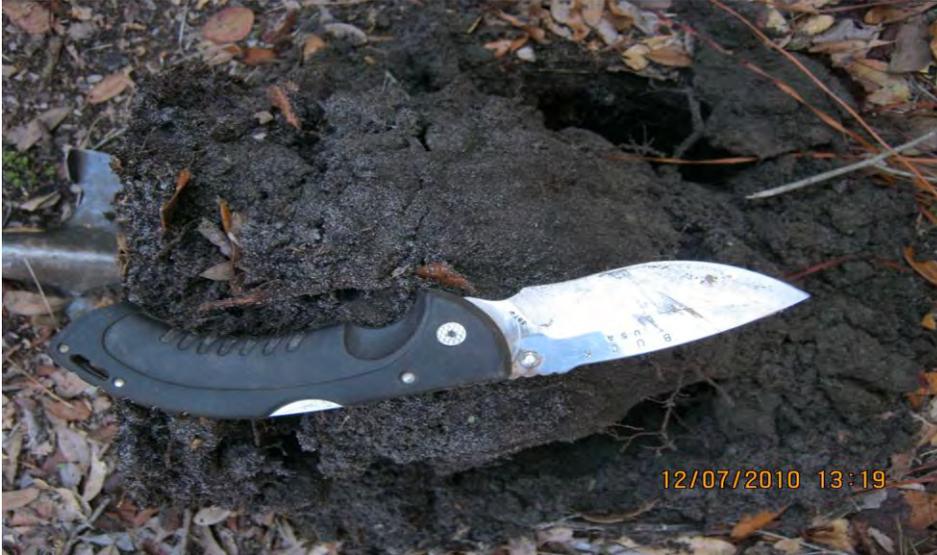
#### A. 1 - Albany Loamy Sand; 0-5% Slopes

0-3"	A	10YR 3/2 Sand
3"-8"	E1	10YR 3/1 Loamy Sand
8"-12"+	E2	10YR 4/4 Loamy Sand

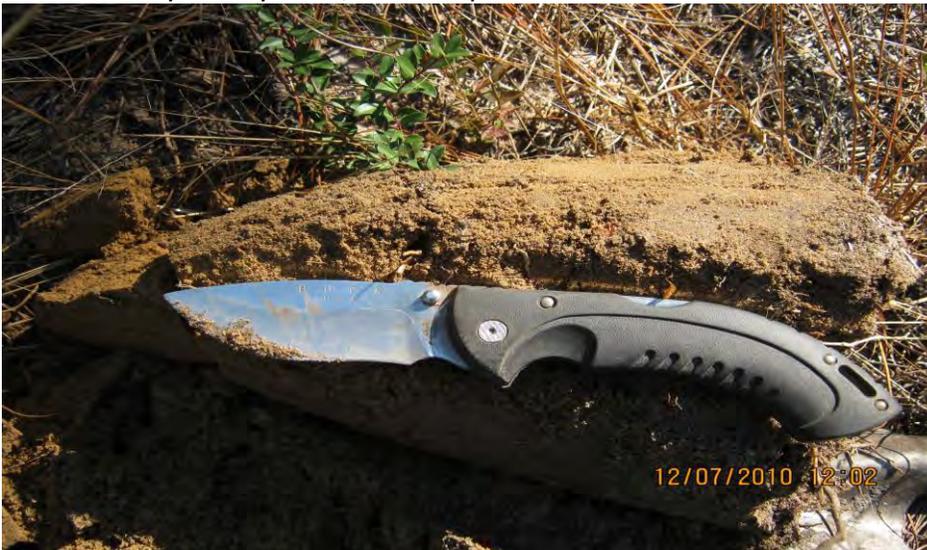
#### B. 5 - Bonifay Loamy Sand; 0-5% Slopes

0-12"+	A	10YR 5/4 Loamy Sand
--------	---	---------------------

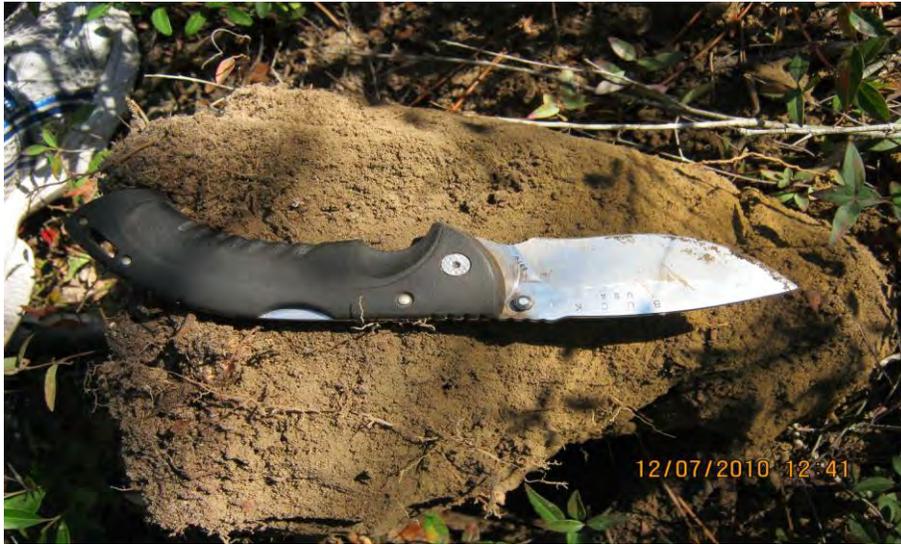
C. 9 - Dothan Fine Sandy Loam; 2-5% Slopes

0-1"	A	10YR 5/2 Sandy Loam
1"-6"	E1	10YR 4/3 Sandy Loam
6"-12"+	E2	10YR 5/6 Sandy Loam

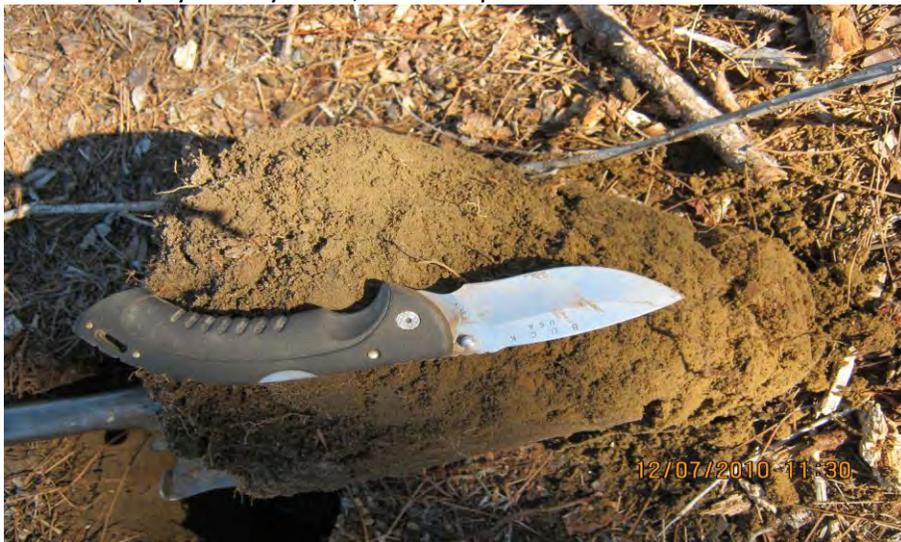
D. 14 - Fuquay Loamy Sand; 0-5% Slopes

0-0.25"	Oi	10YR 2.5/1 Pine Duff
0.25"-6"	A	10YR 3/3 Loamy Sand
6"-12"+	E	10YR 4/4 Loamy Sand

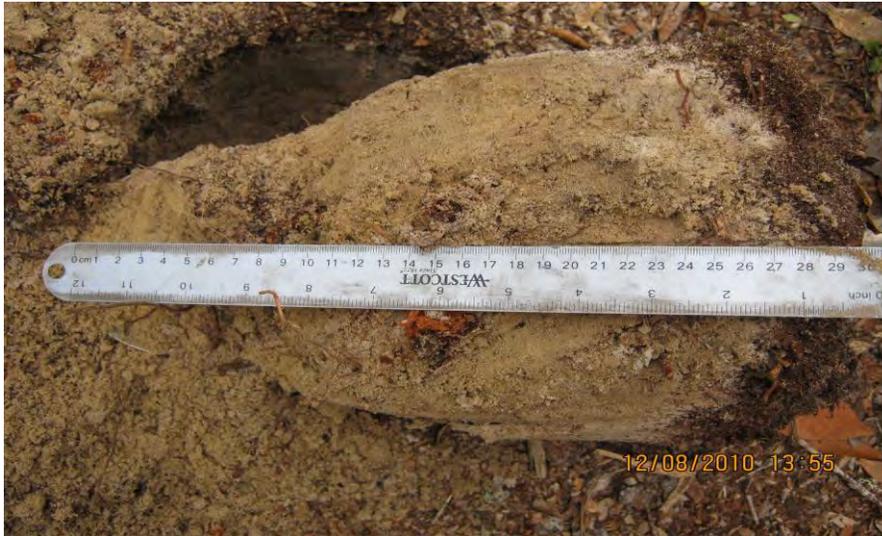
E. 19 - Kalmia Loamy Fine Sand; 2-5% Slopes

0-1"	Oi	10R 2.5/1 Pine Duff
1"-4"	AE1	10YR 7/1 Loamy Fine Sand w/ 10YR 6/2 Loamy Fine Sand
4"-8"	AE2	10YR 5/4 Loamy Fine Sand w/ 10YR 6/4 Loamy Fine Sand
8"-12"+	E	10YR 6/4 Loamy Fine Sand

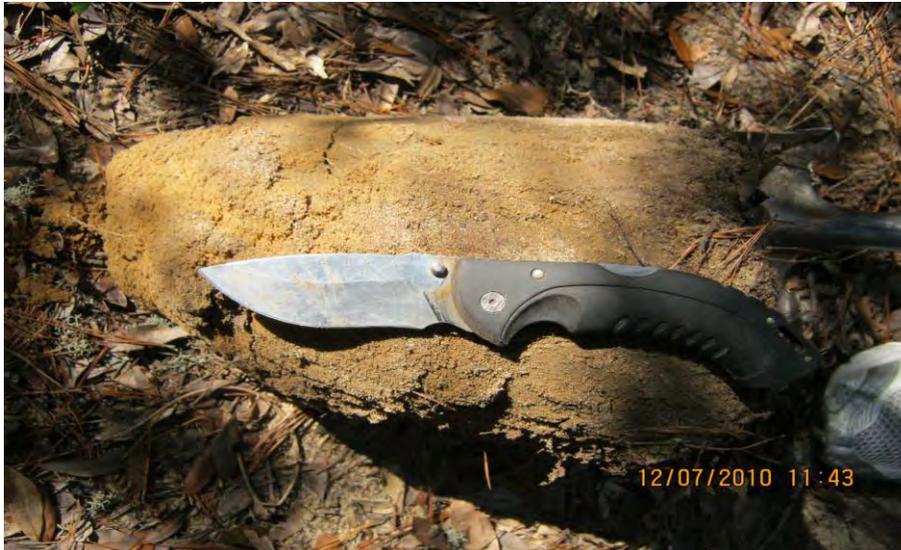
F. 21 - Lakeland Sand; 0-5% Slopes

0-0.25"	Oi	10R 2.5/1 Pine Duff
0.25"-1.5"	A	10YR 6/4 Loamy Sand
1.5"-5"	AE	10YR 5/4 Loamy Sand
5"-12"+	E	10YR 5/6 Loamy Sand

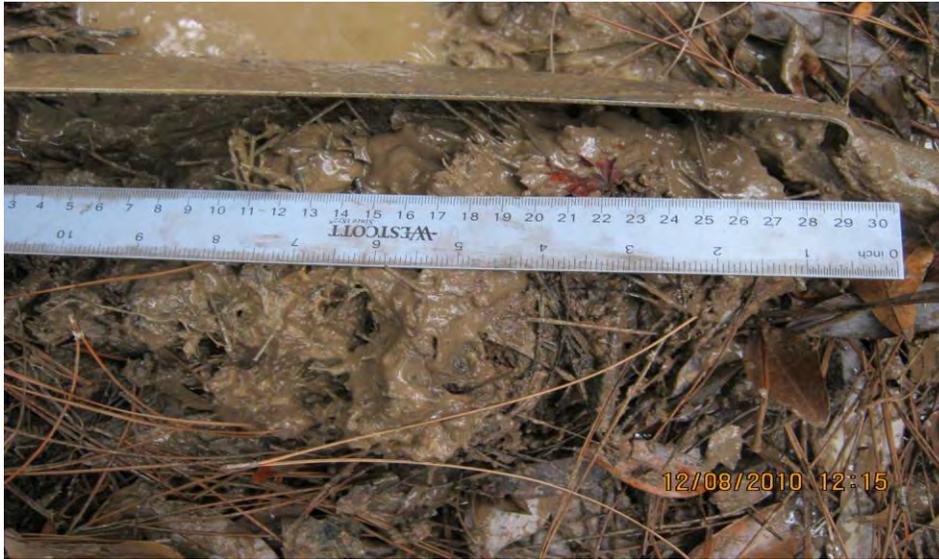
G. 22 - Lakeland Sand; 5-12% Slopes

0-2"	Oi	10YR 5/3 Leaf Litter Layer
2"-12"+	A	10YR 5/3 Sand

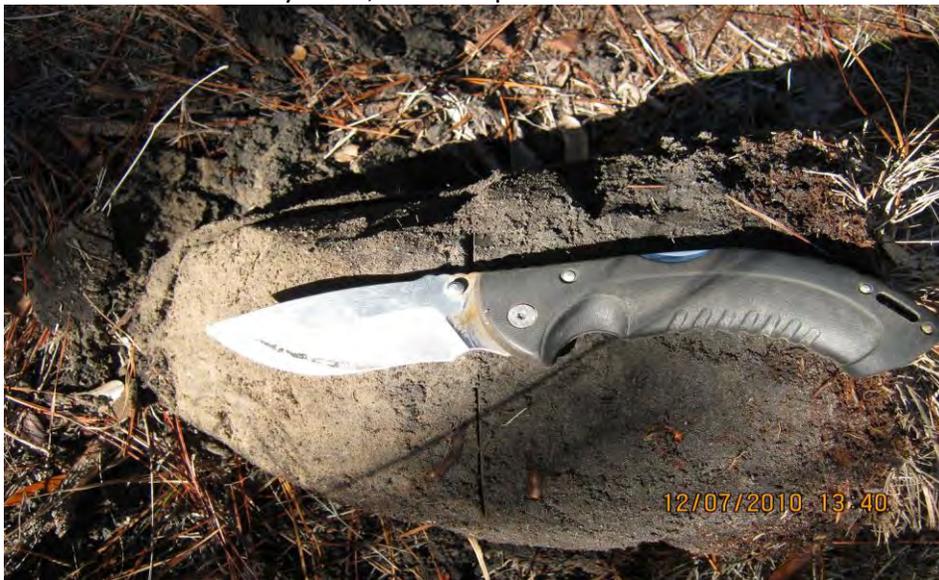
H. 34 - Pactolus Loamy Sand; 0-5% Slopes

0-1"	Oi	10R 2.5/1 Pine Duff
1"-5"	A	10YR 2/1 Loamy Sand
5"-12"+	E	10YR 4/2 Loamy Sand

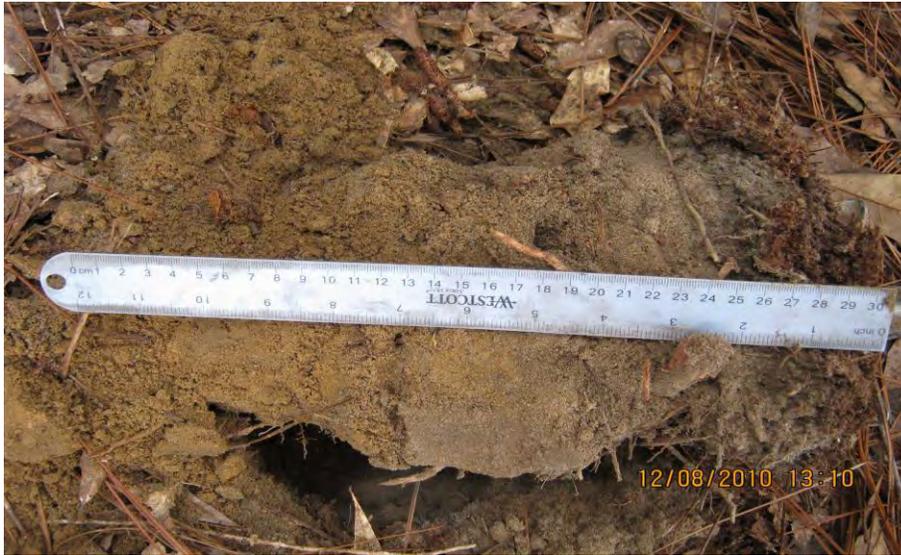
I. 44 - Troup Loamy Sand; 0-5% Slopes

0-0.5"	Oi	10R 2.5/1 Pine Duff
0.5"-4"	A	10YR 4/3 Loamy Sand
4"-12"+	E	10YR 5/6 Loamy Sand

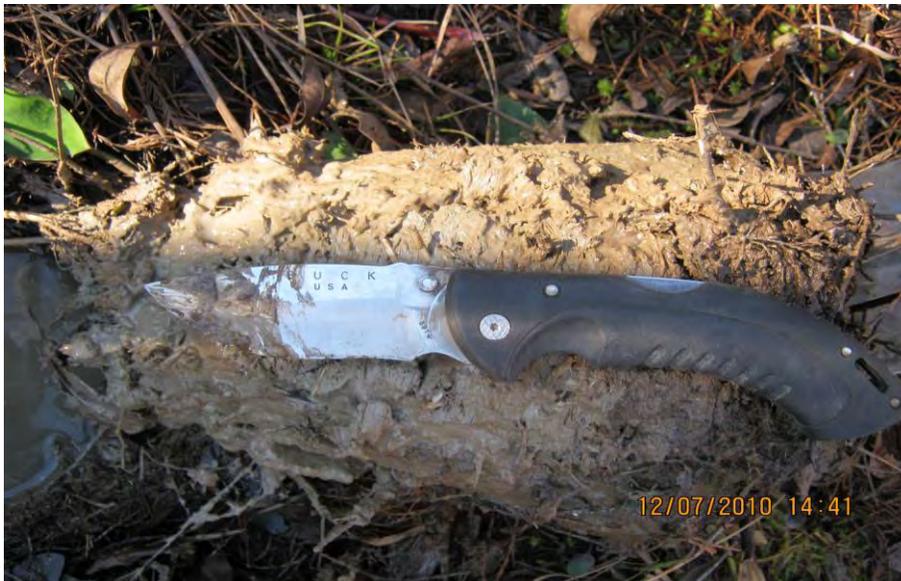
A. 3- Bibb-Kinston Association

0-1.5"	A	5G 5/1 Leaf Litter Layer
1.5"-12"+	C	5G 5/1 Clay

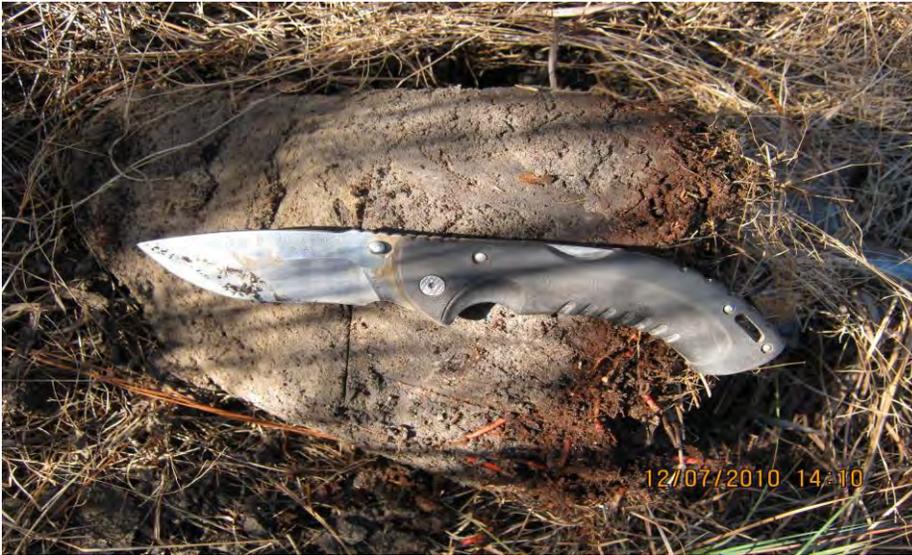
**B. 37 - Rains Fine Sandy Loam**

0-1.5"	Oi	10R 2.5-1 Pine Duff
1.5"-6"	A	10YR 4/1 Sandy Loam
6"-12"+	E	10YR 5/1 Sandy Loam w/ 10YR 5/6 Redox

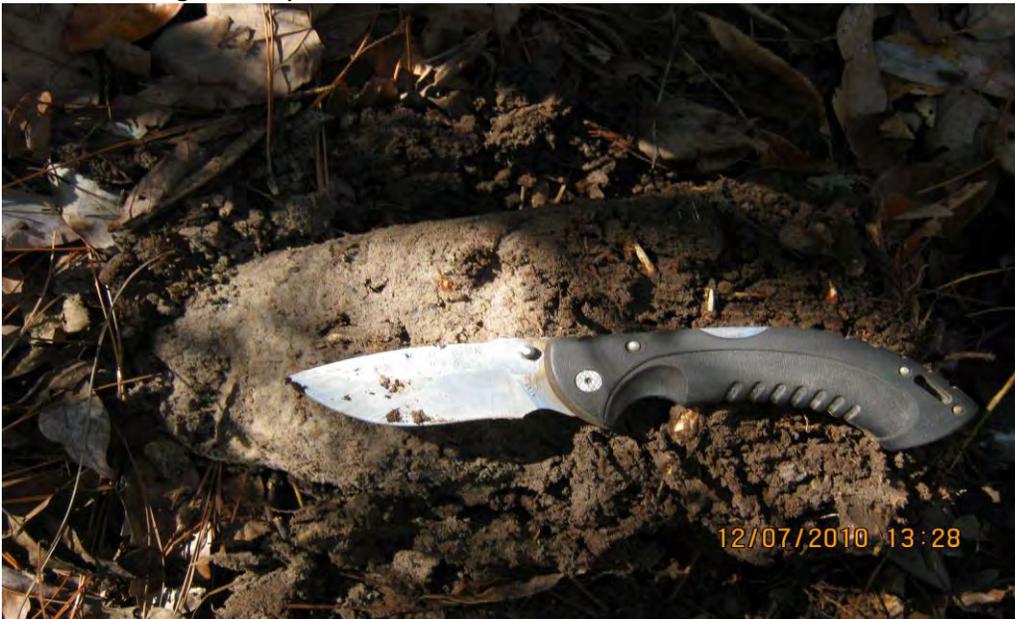
**C. 40 - Rutledge Loamy Sand**

0-5"	A	10YR 3/2 Muck
5"-12"+	E	10YR 5/1 Loamy Sand w/ 10YR 6/5 Redox
