TRANSPORTATION PROJECT REPORT

DRAFT DESIGN REPORT / DRAFT ENVIRONMENTAL IMPACT STATEMENT / DRAFT 4(f) EVALUATION

Appendix C1: Traffic Information – Part I Appendix C2: Traffic Information – Part II

PIN 5470.22
NYS Route 198 (Scajaquada Expressway) Corridor
Grant Street Interchange to Parkside Avenue Intersection
City of Buffalo
Erie County

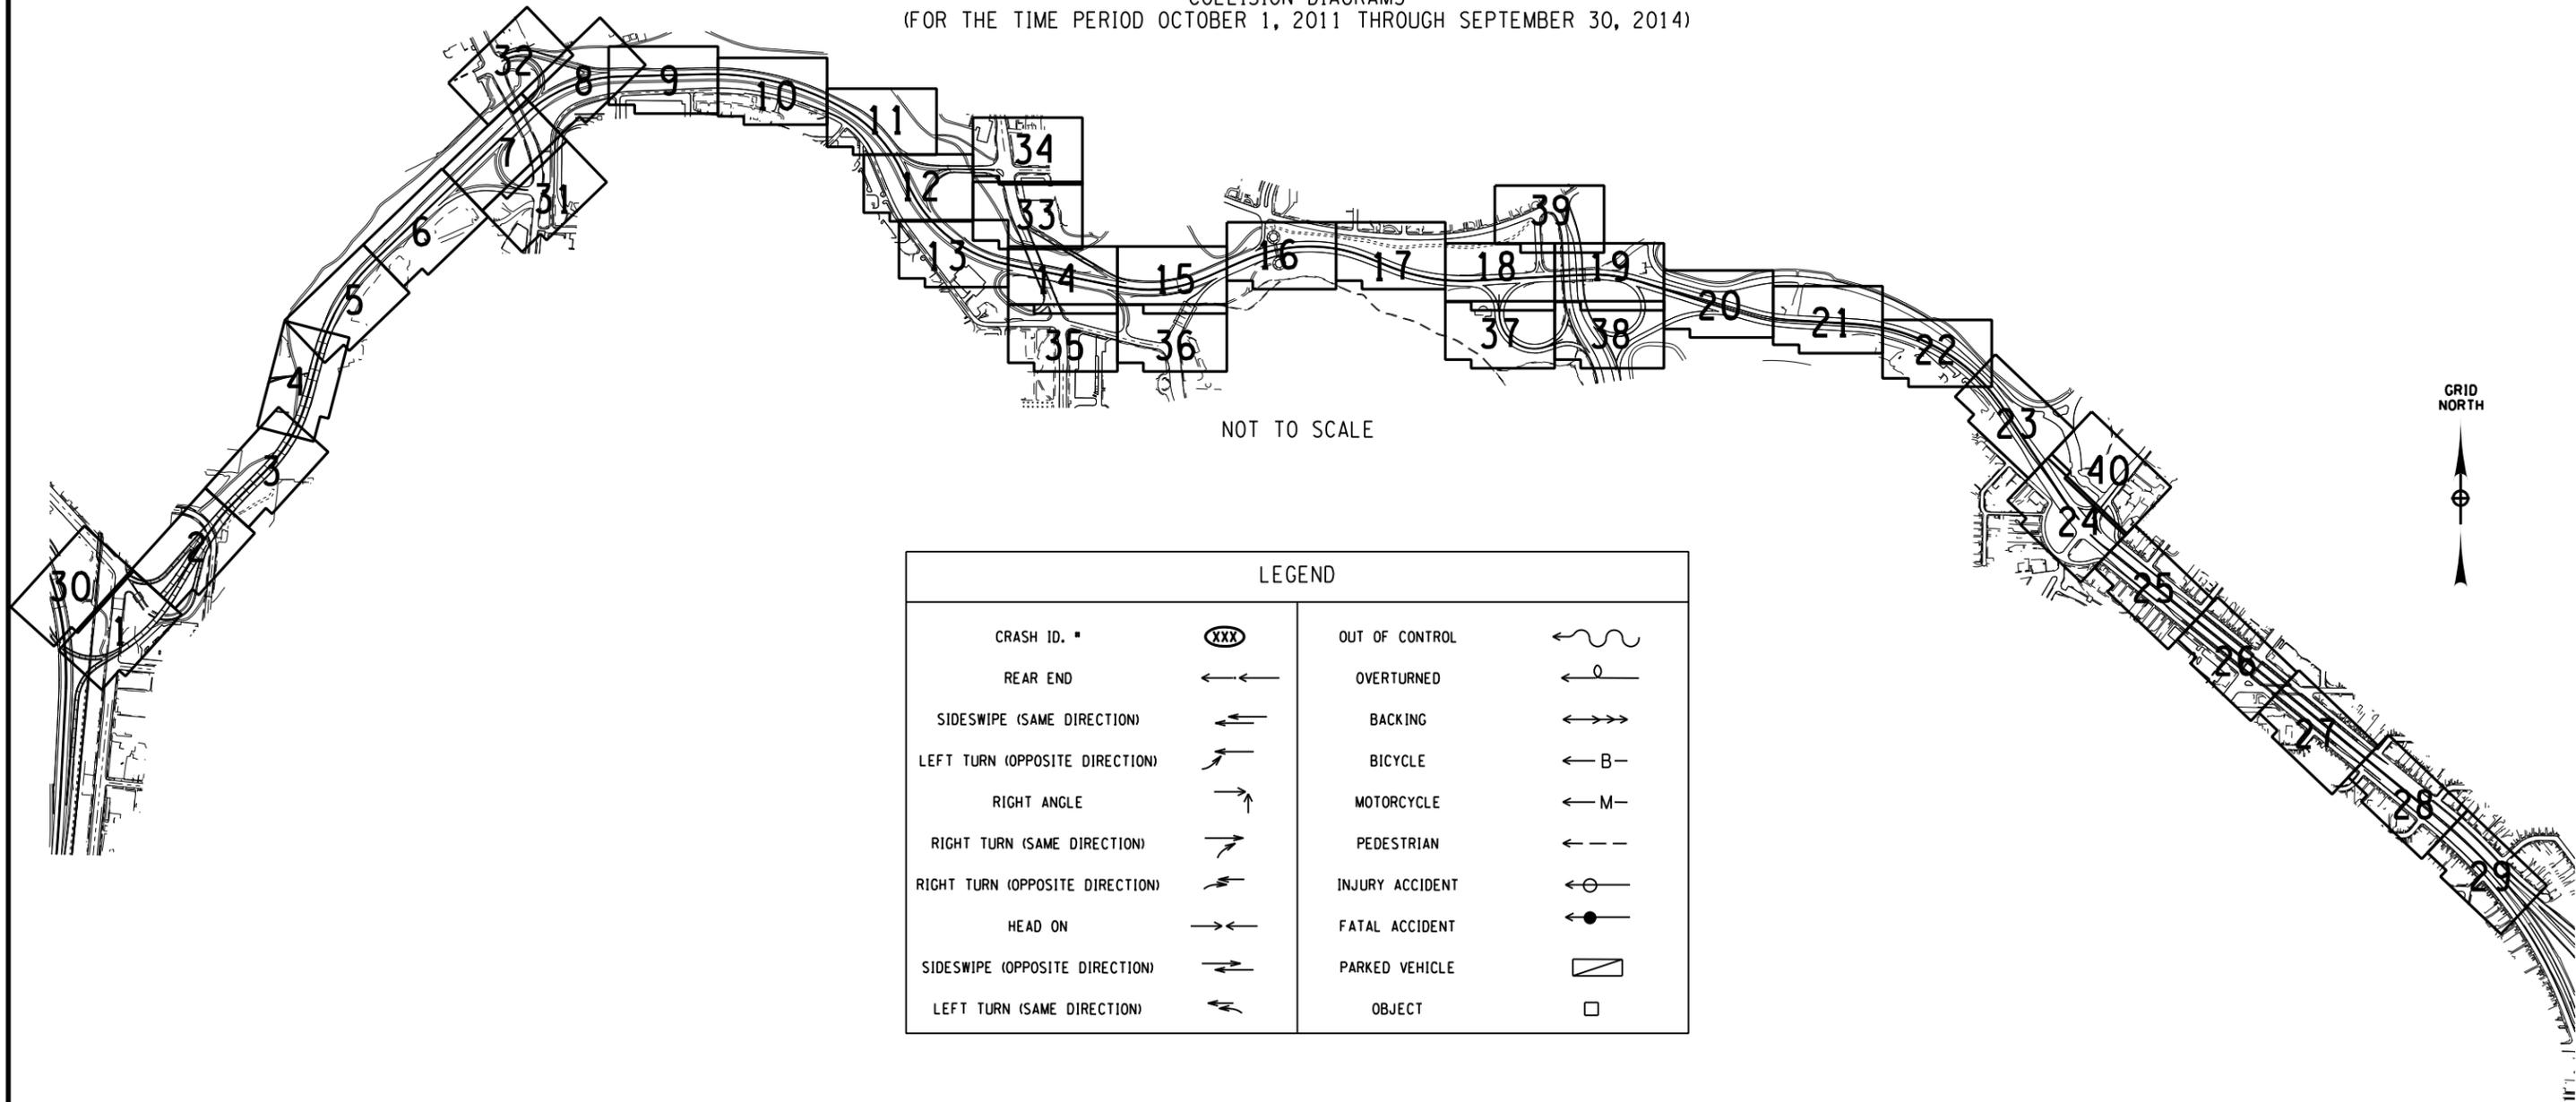
COLLISION DIAGRAM
 (FOR THE TIME PERIOD OCTOBER 1, 2011 THROUGH SEPTEMBER 30, 2014)

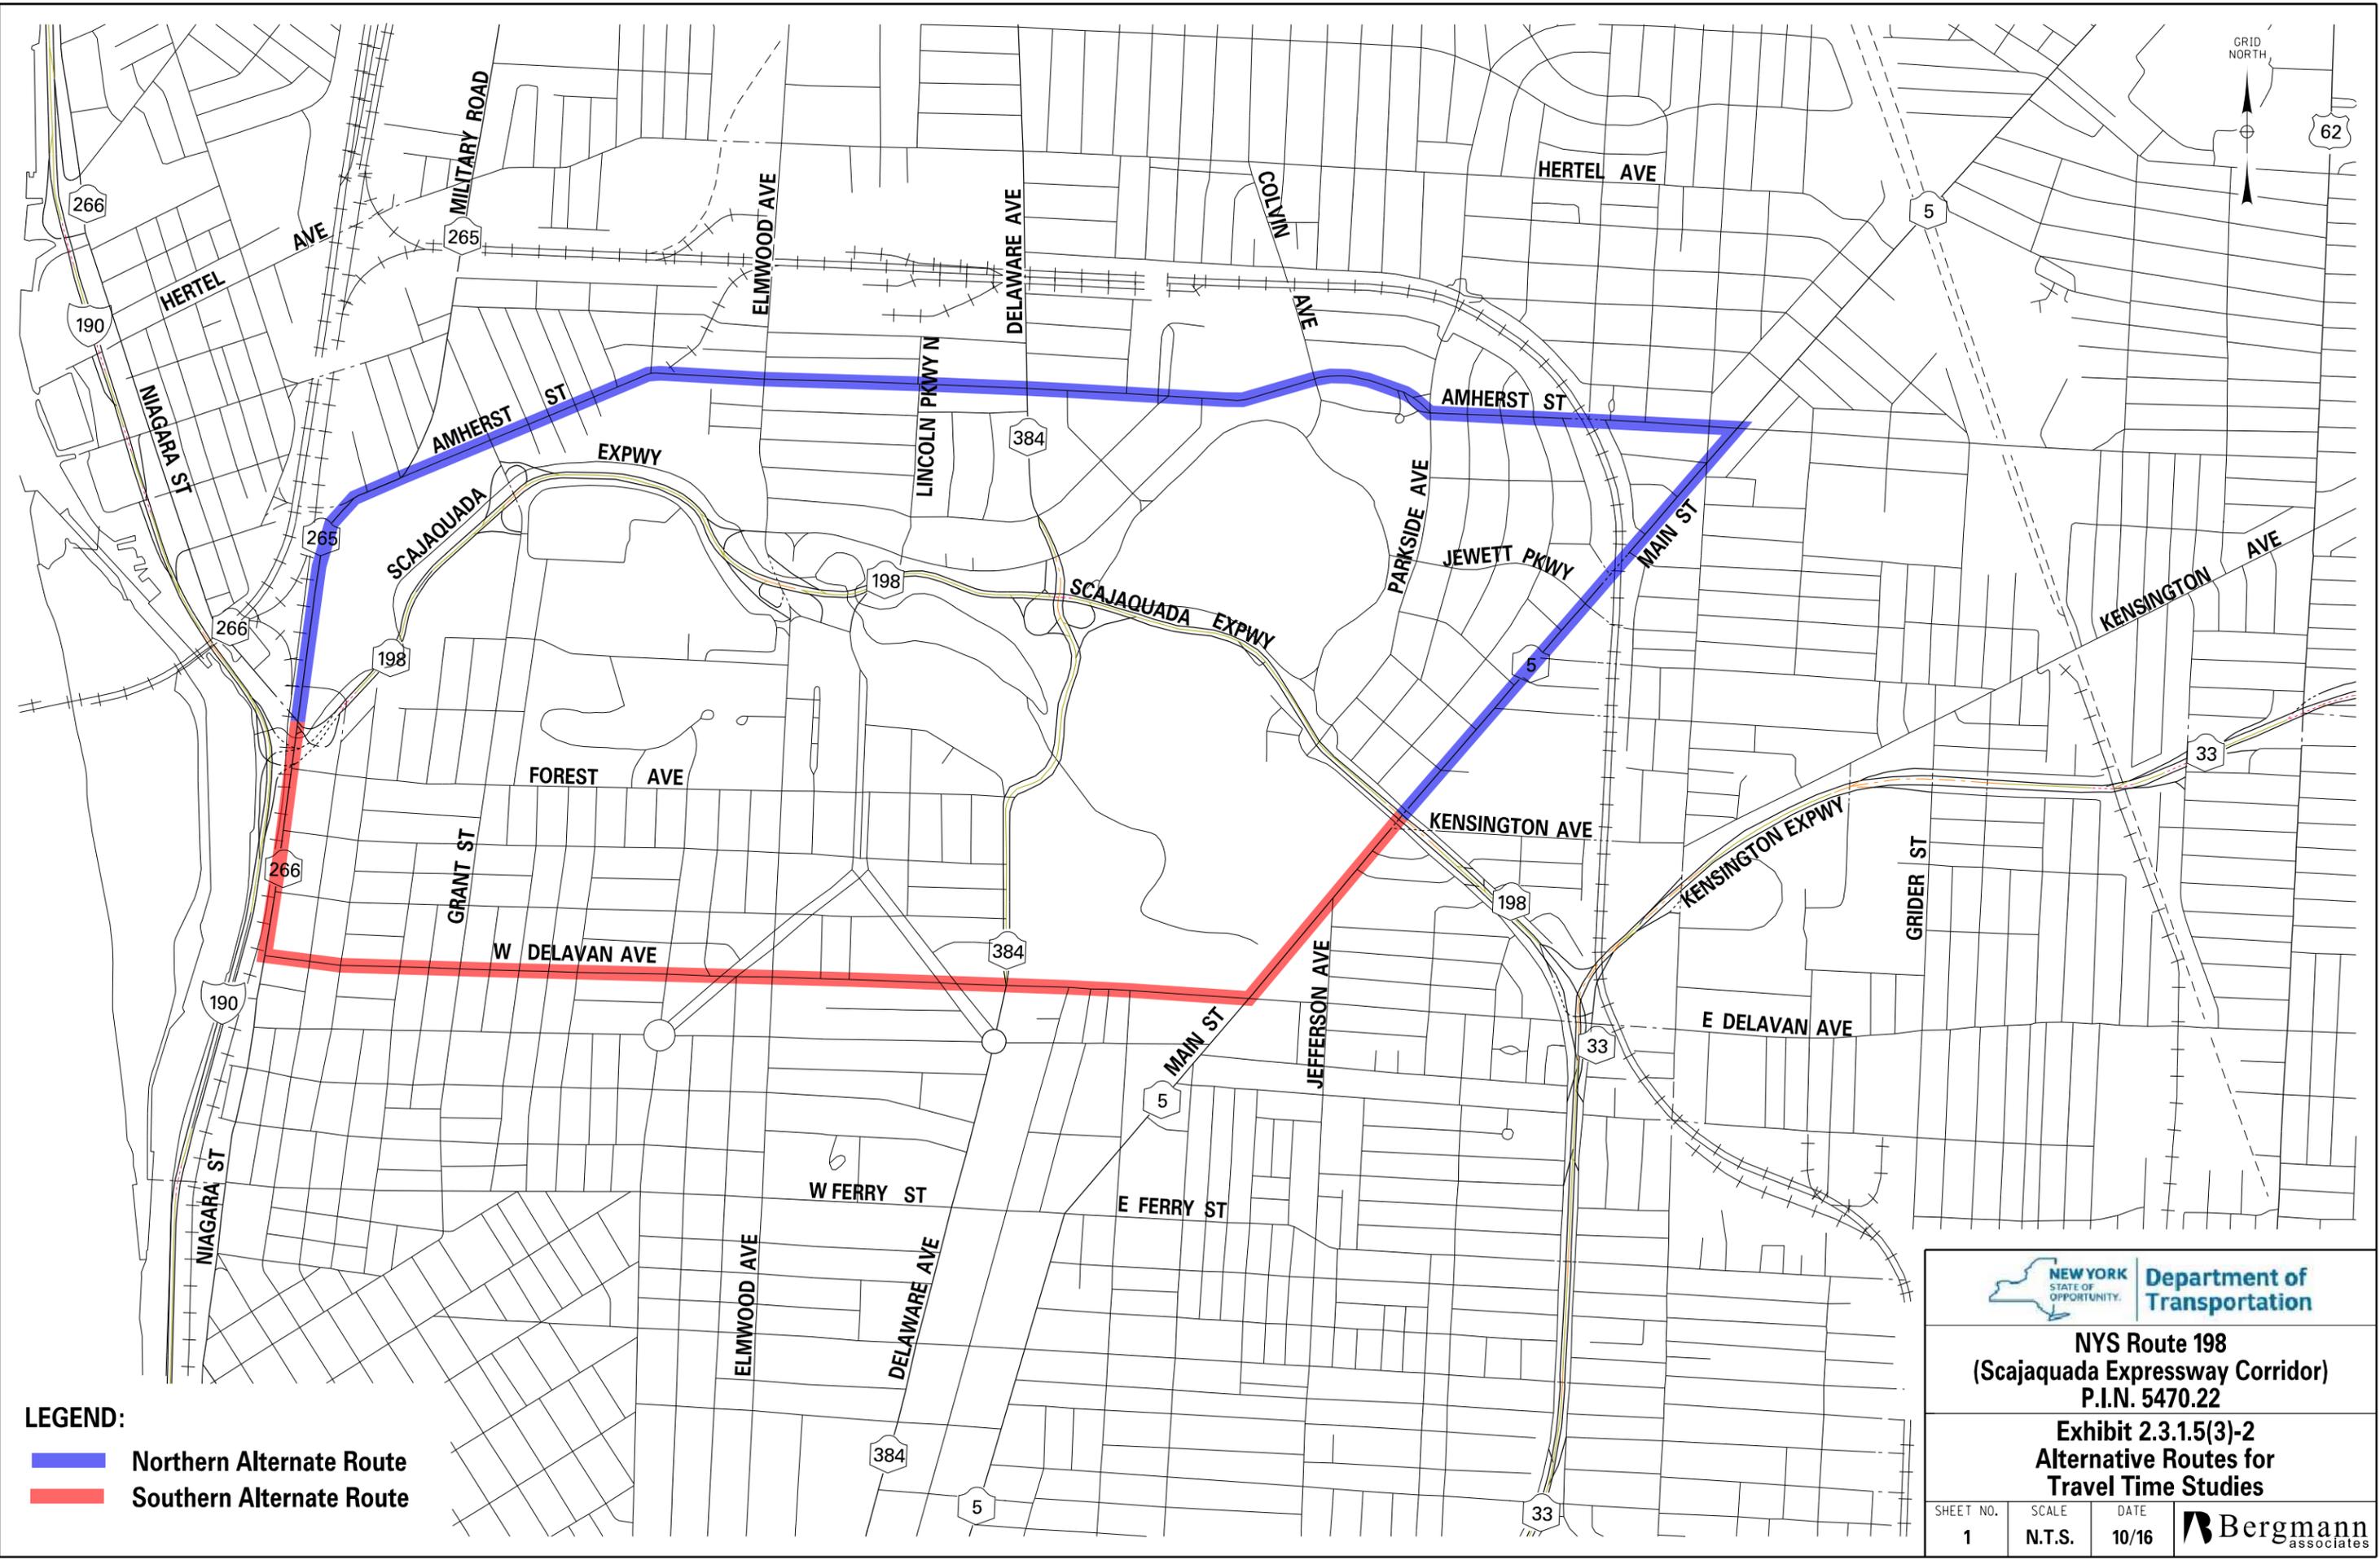
LEGEND:
█ Northern Alternate Route
█ Southern Alternate Route

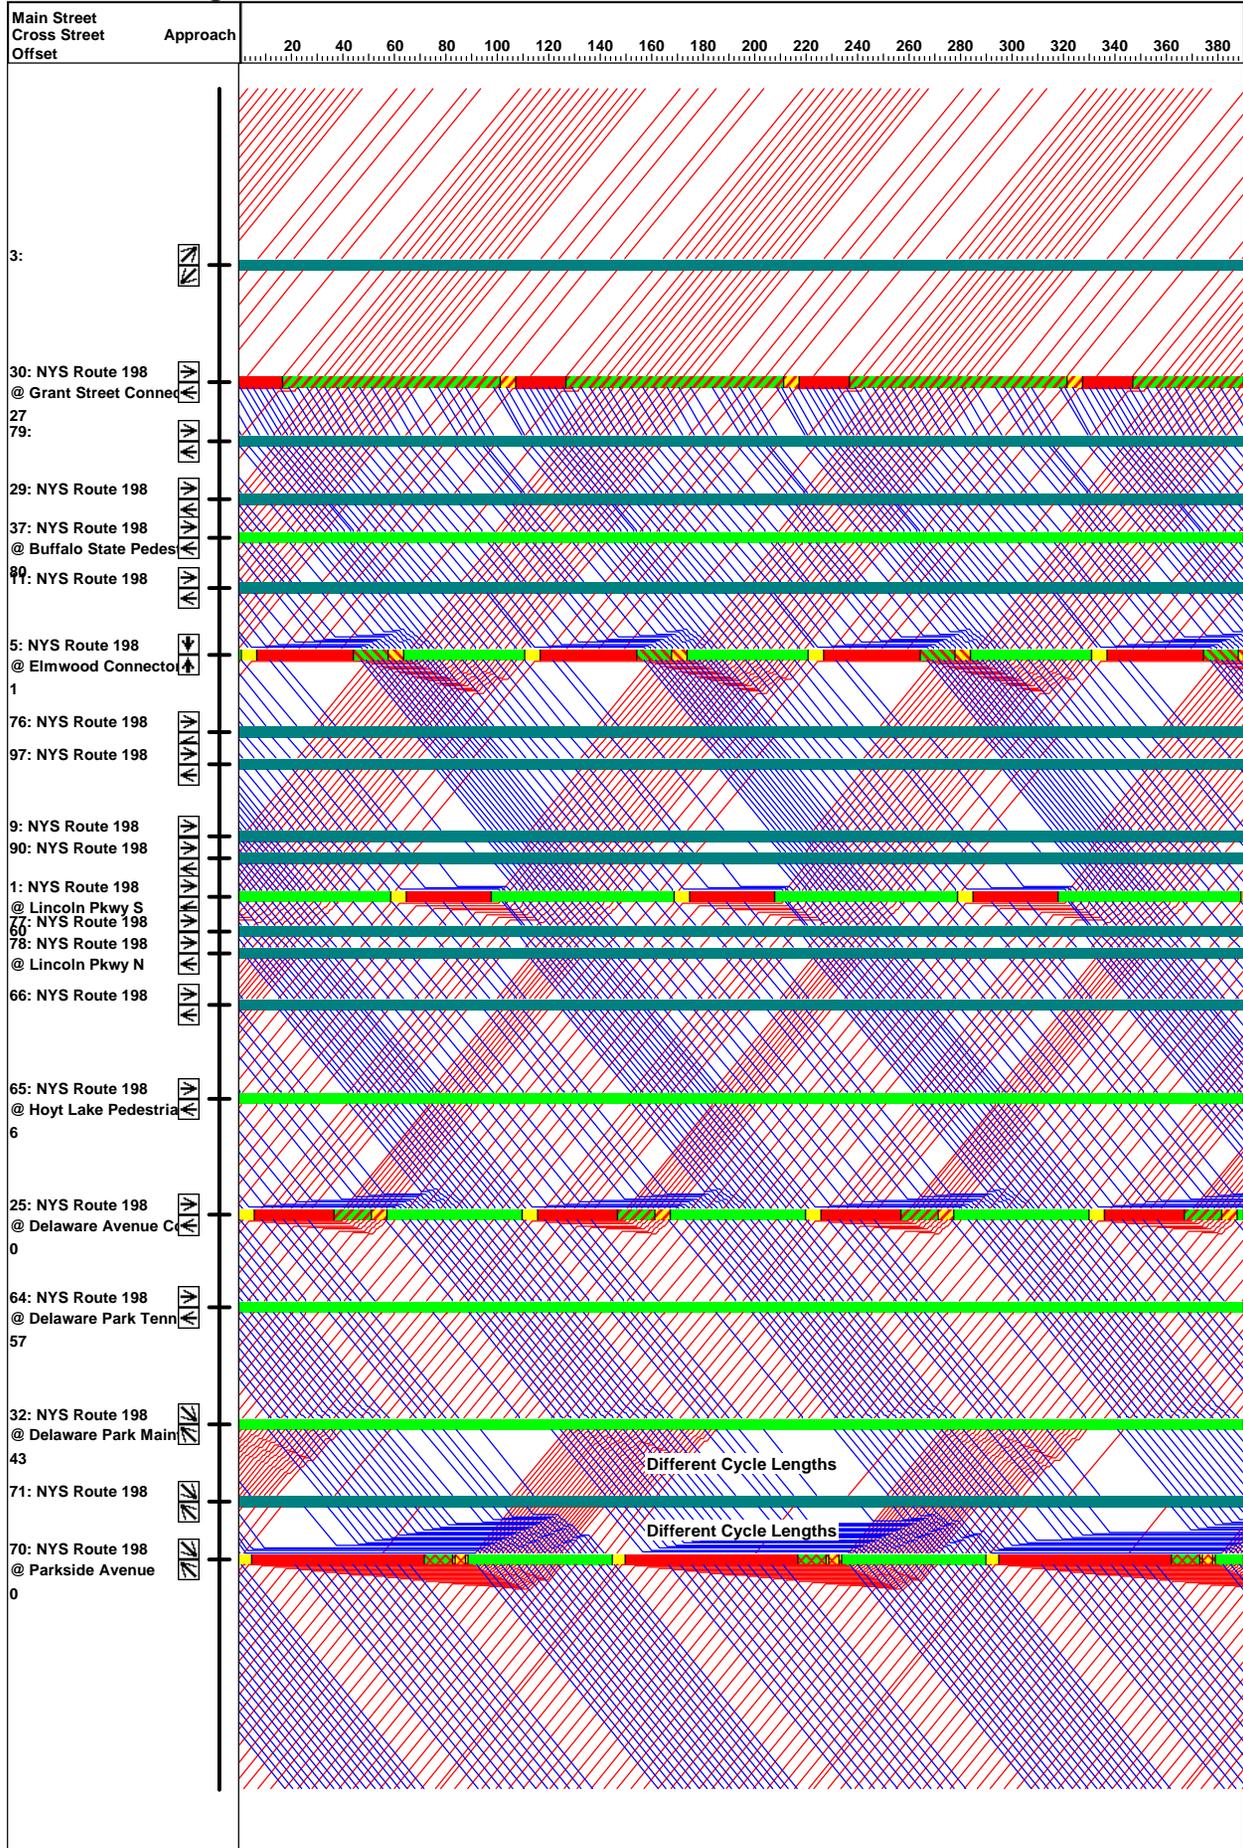
Time-Space Diagram - NYS Route 198
Traffic Flow Diagram, 50th Percentile Flow and Green Times

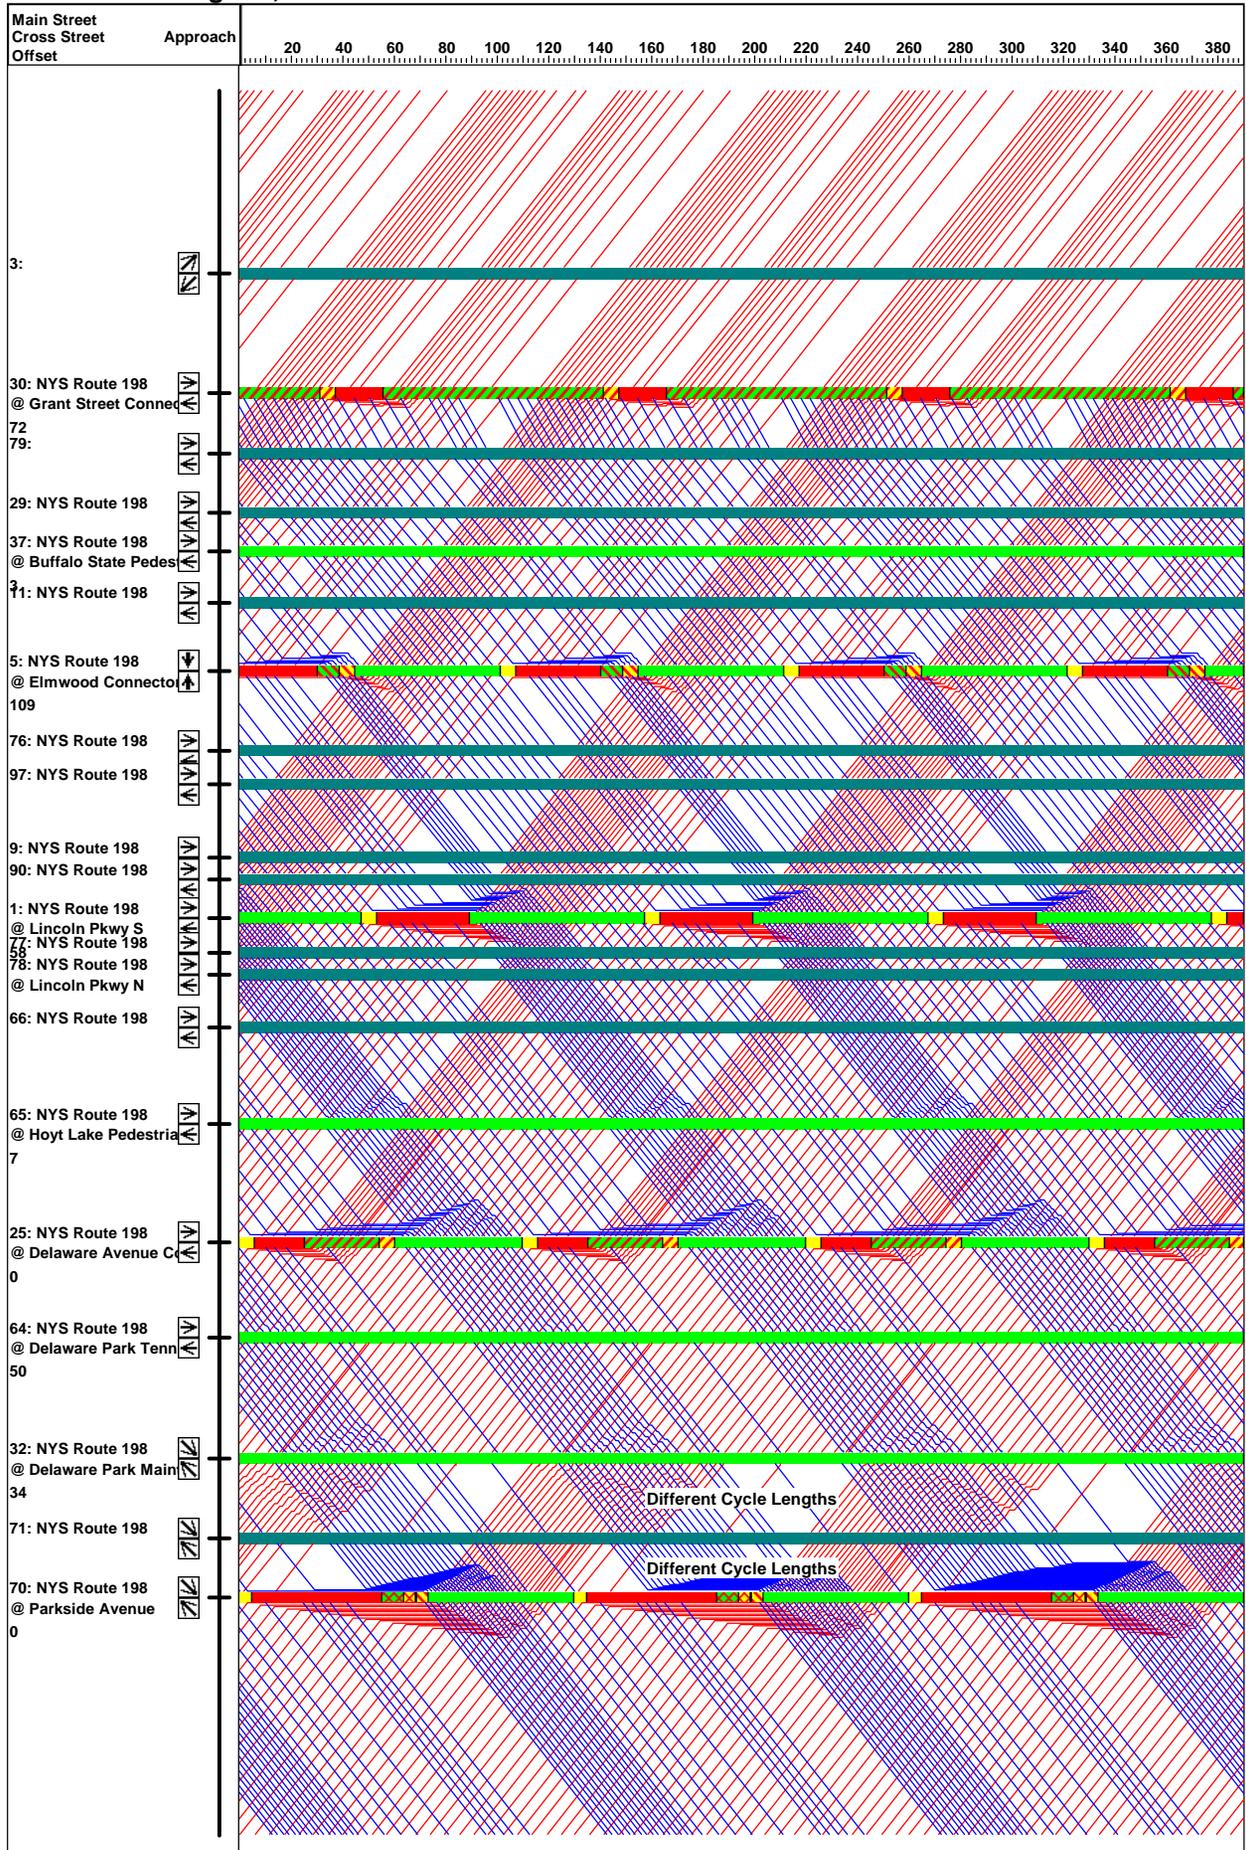
Time-Space Diagram - NYS Route 198
Traffic Flow Diagram, 50th Percentile Flow and Green Times

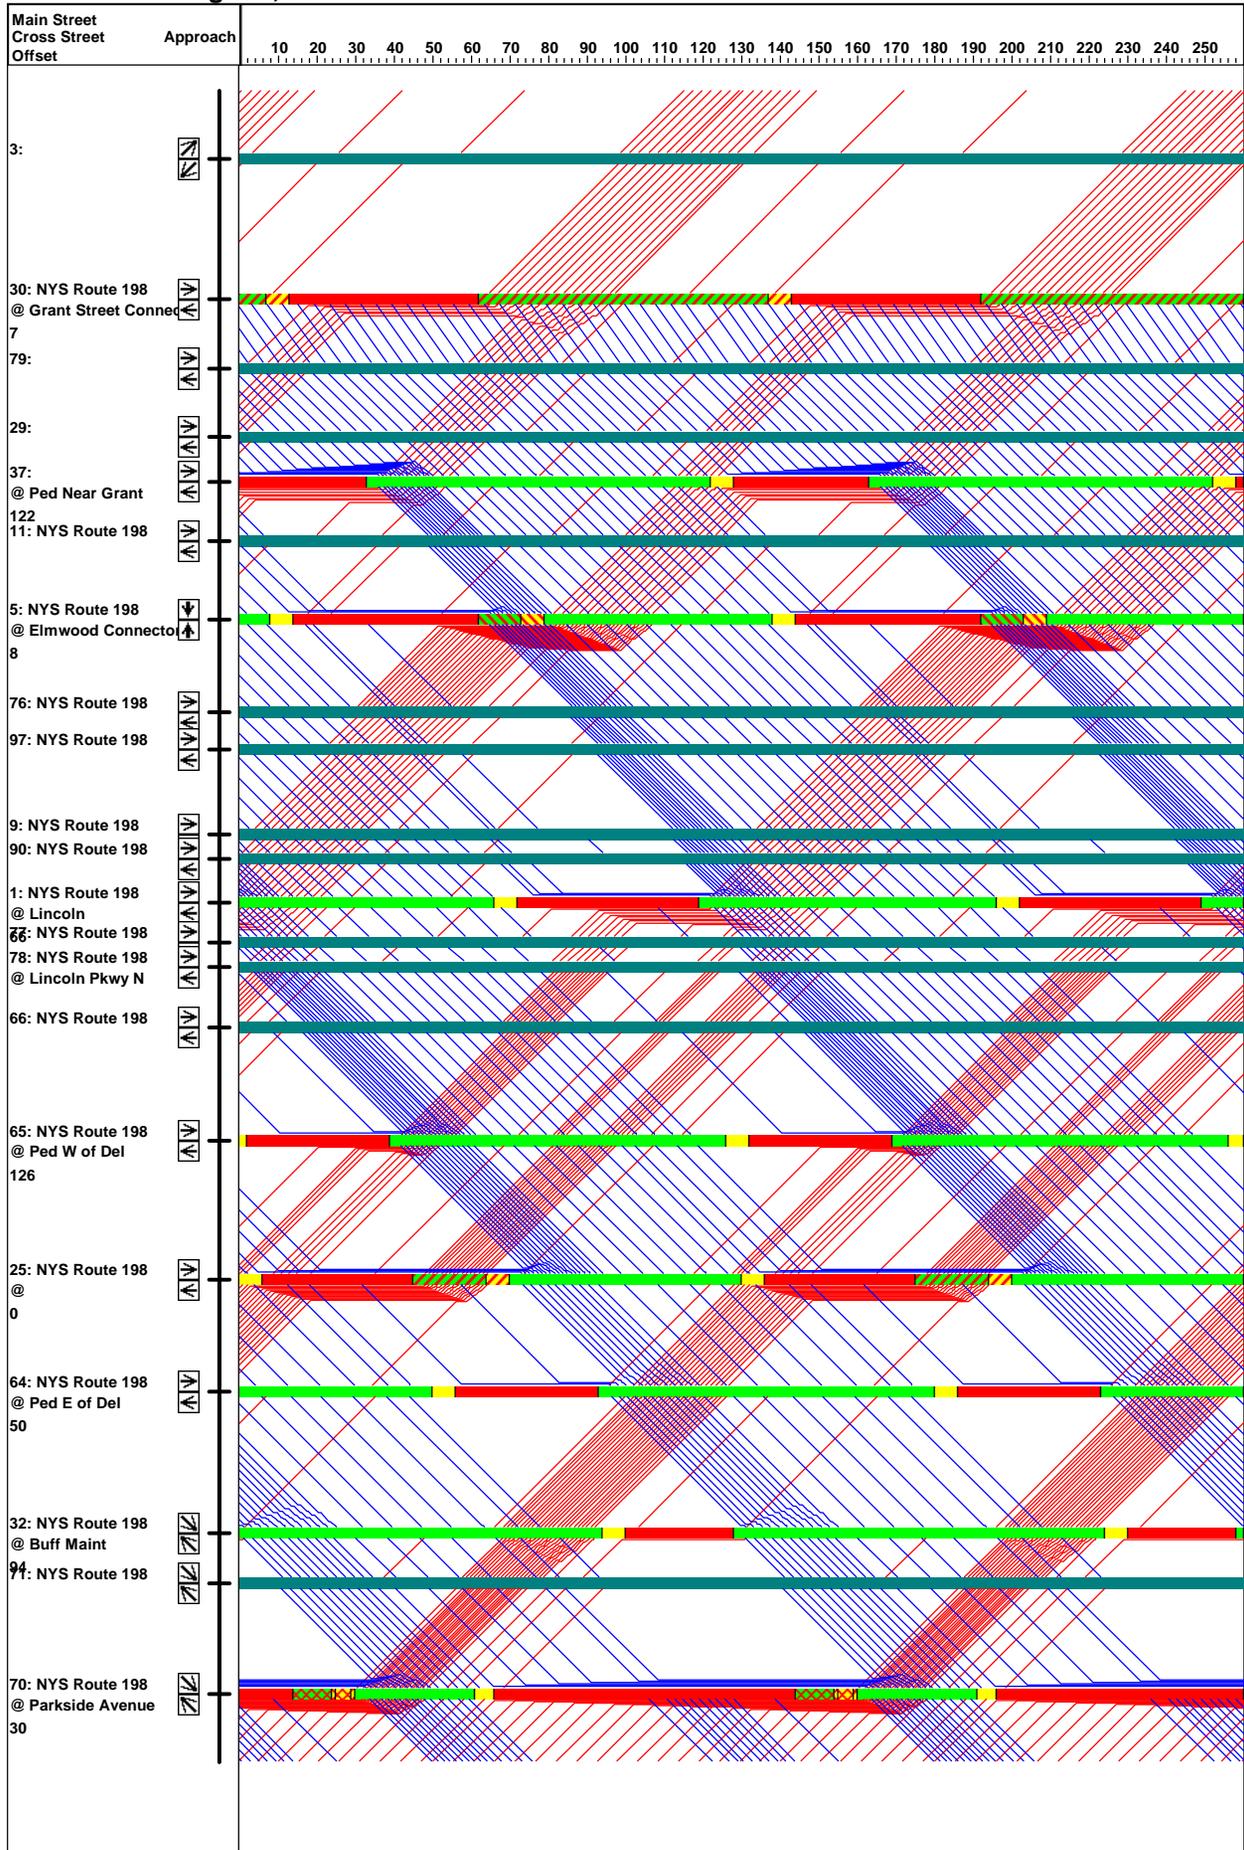
Time-Space Diagram - NYS Route 198
Traffic Flow Diagram, 50th Percentile Flow and Green Times

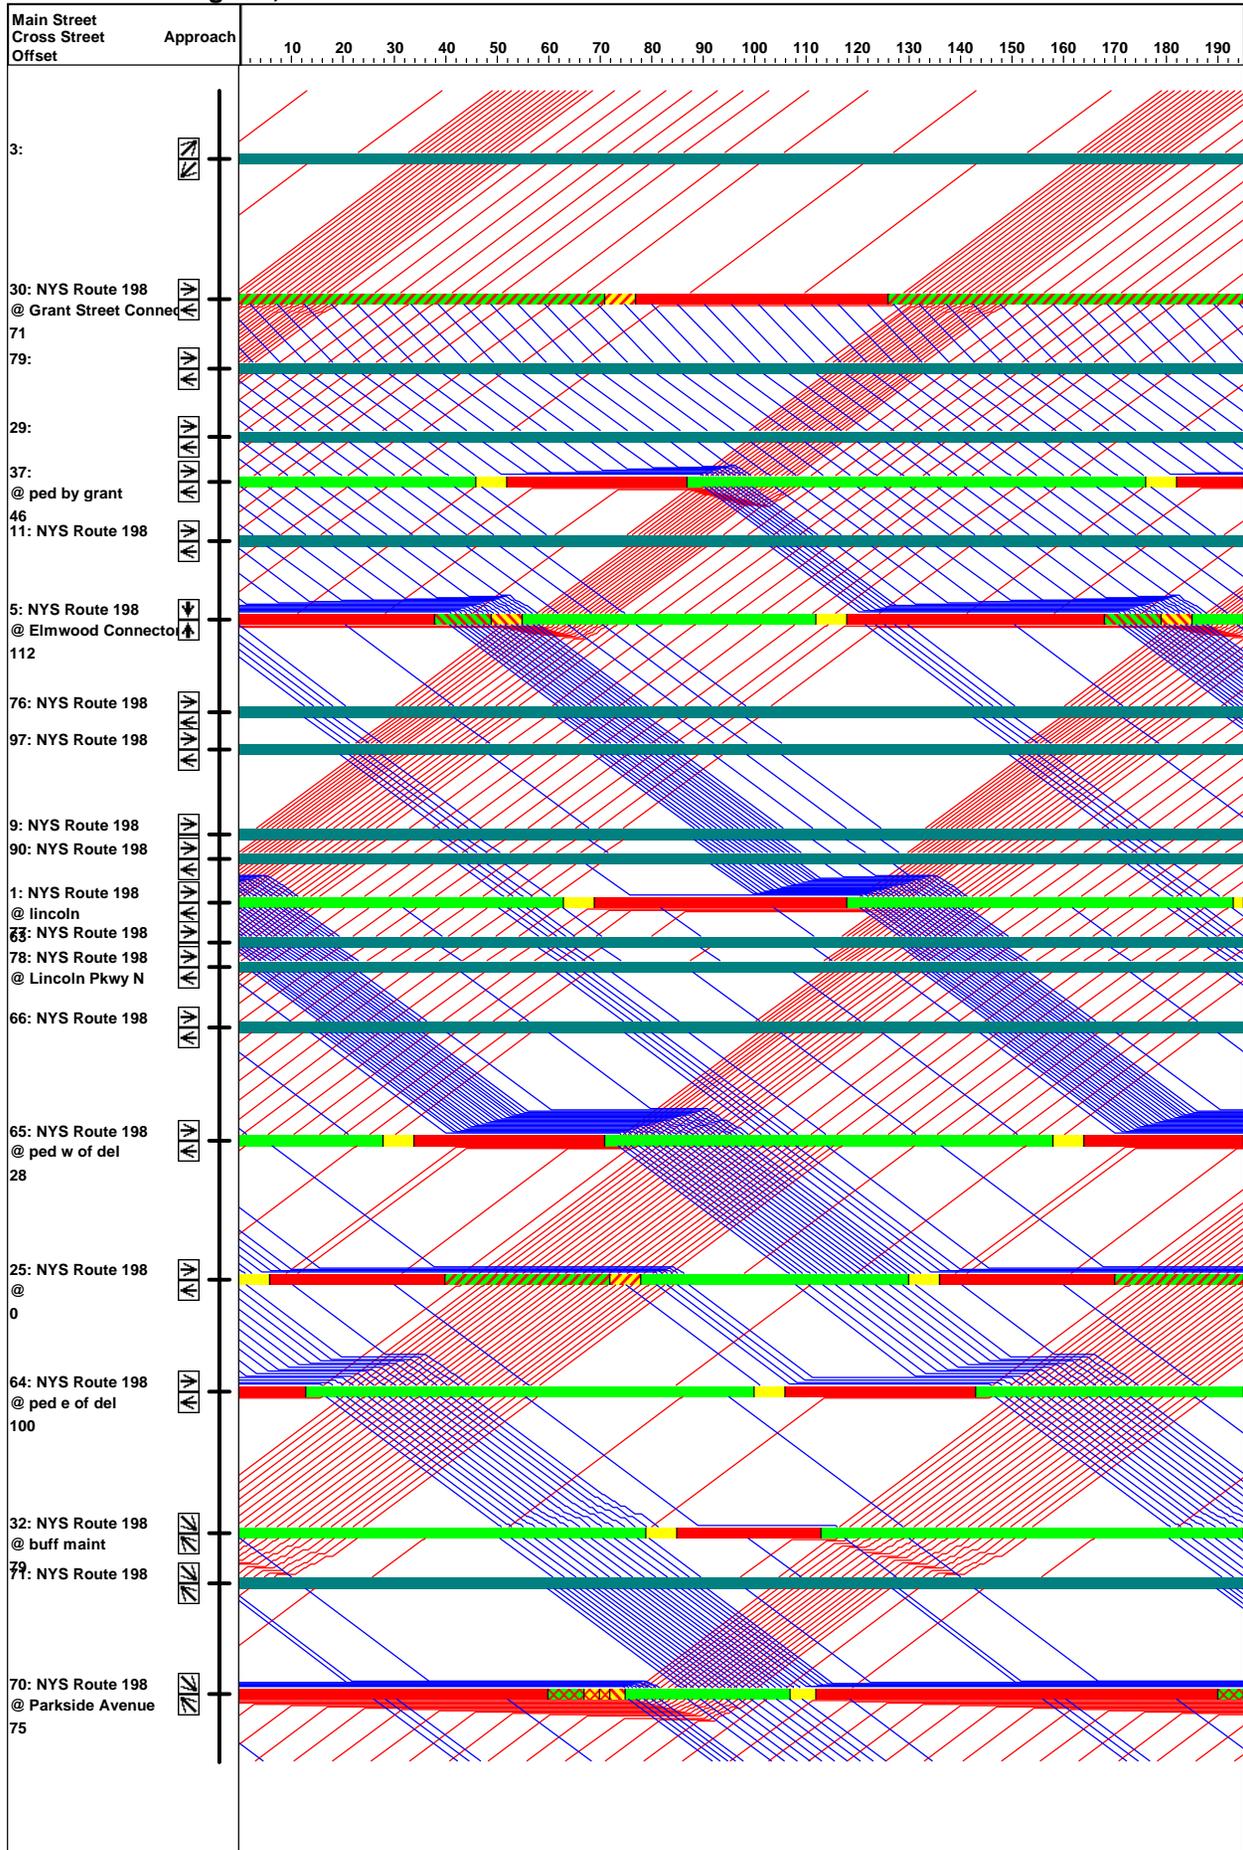
2040 Off-Peak Pre-Timed for WB
