APPENDIX A

Inlet-Related Shoreline Changes: Rich Inlet, North Carolina

Update Through 2007

William J. Cleary

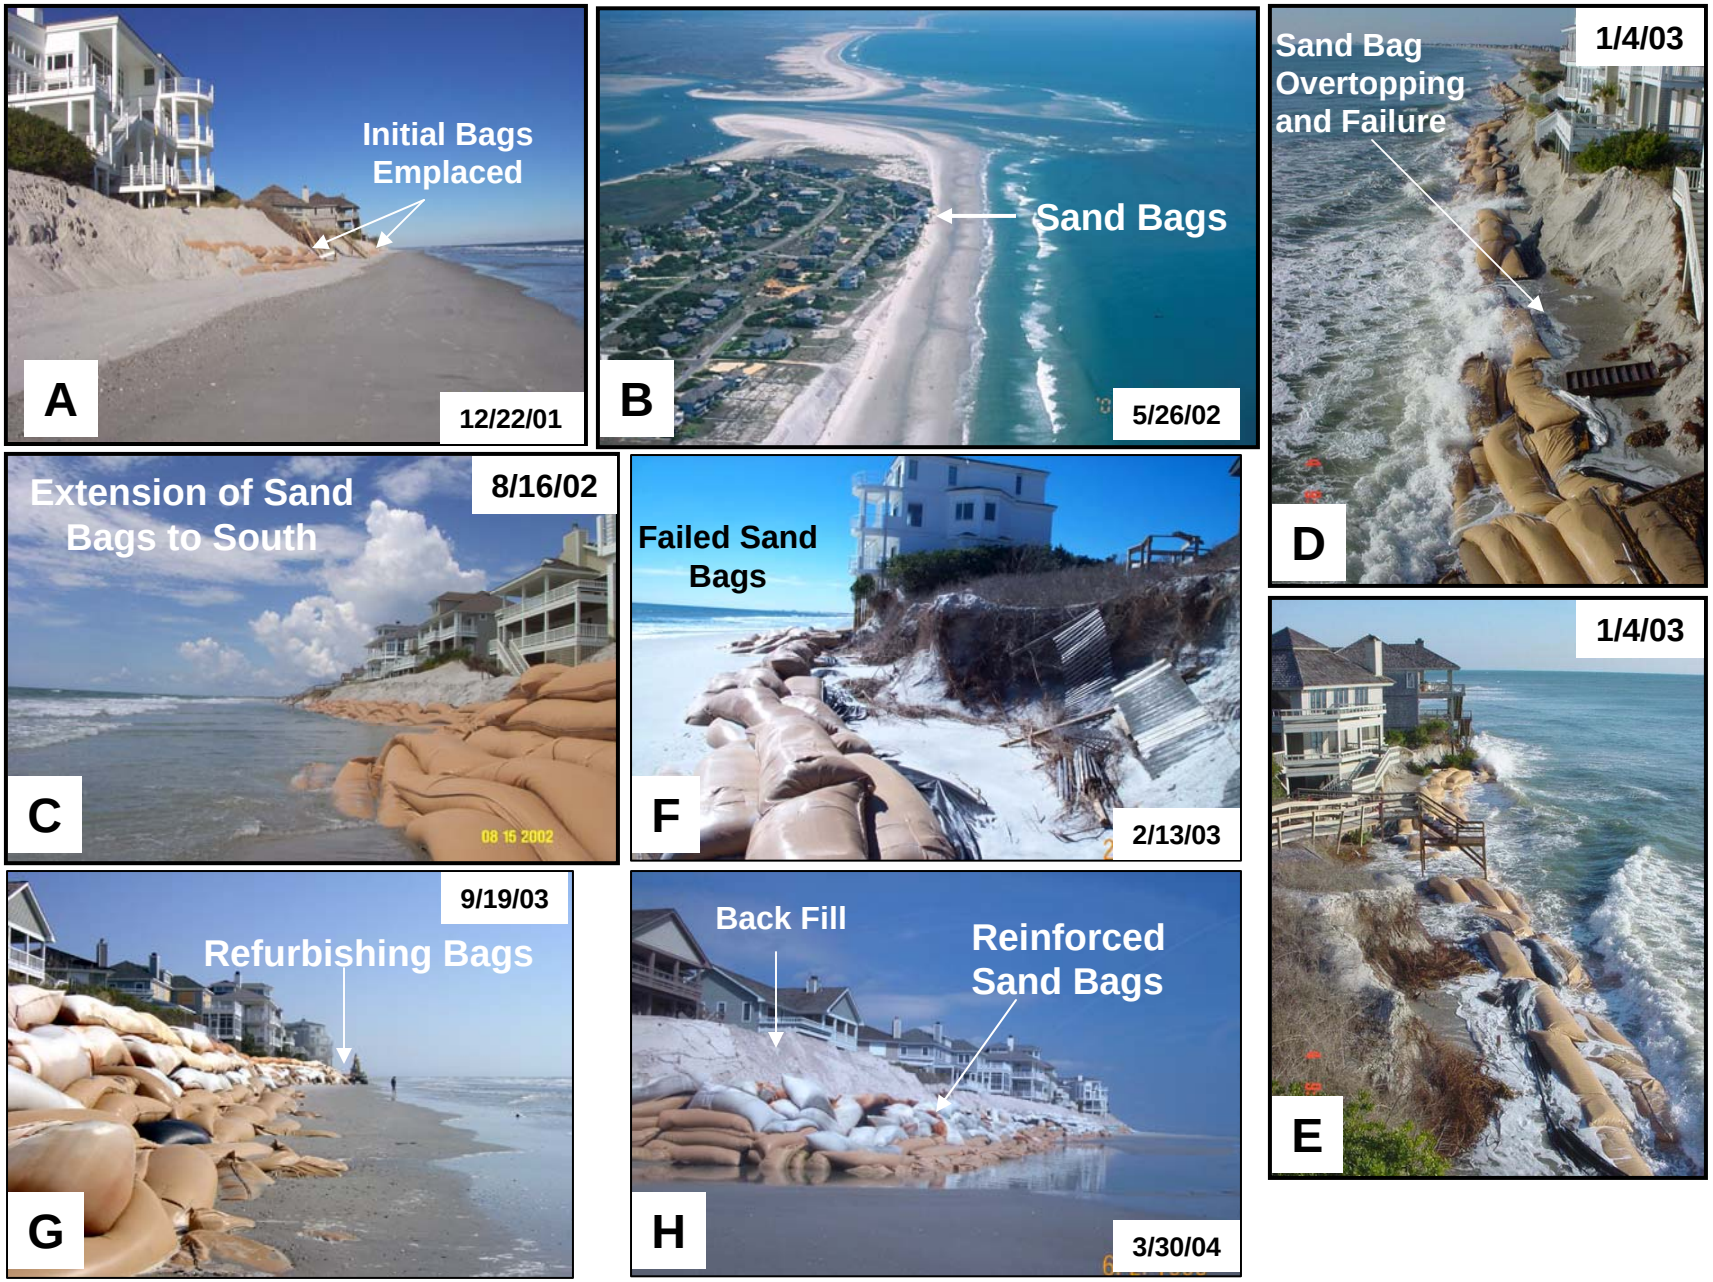
Figure 1. Appendix. Views of shoreline armored with sand bags. **A. – H.** shows initial bag emplacement and subsequent continuation to south, overtopping and failure and heightened sand bag wall. Variance was granted in August 2003 to increase height of existing bags (**G**. and **H**.).

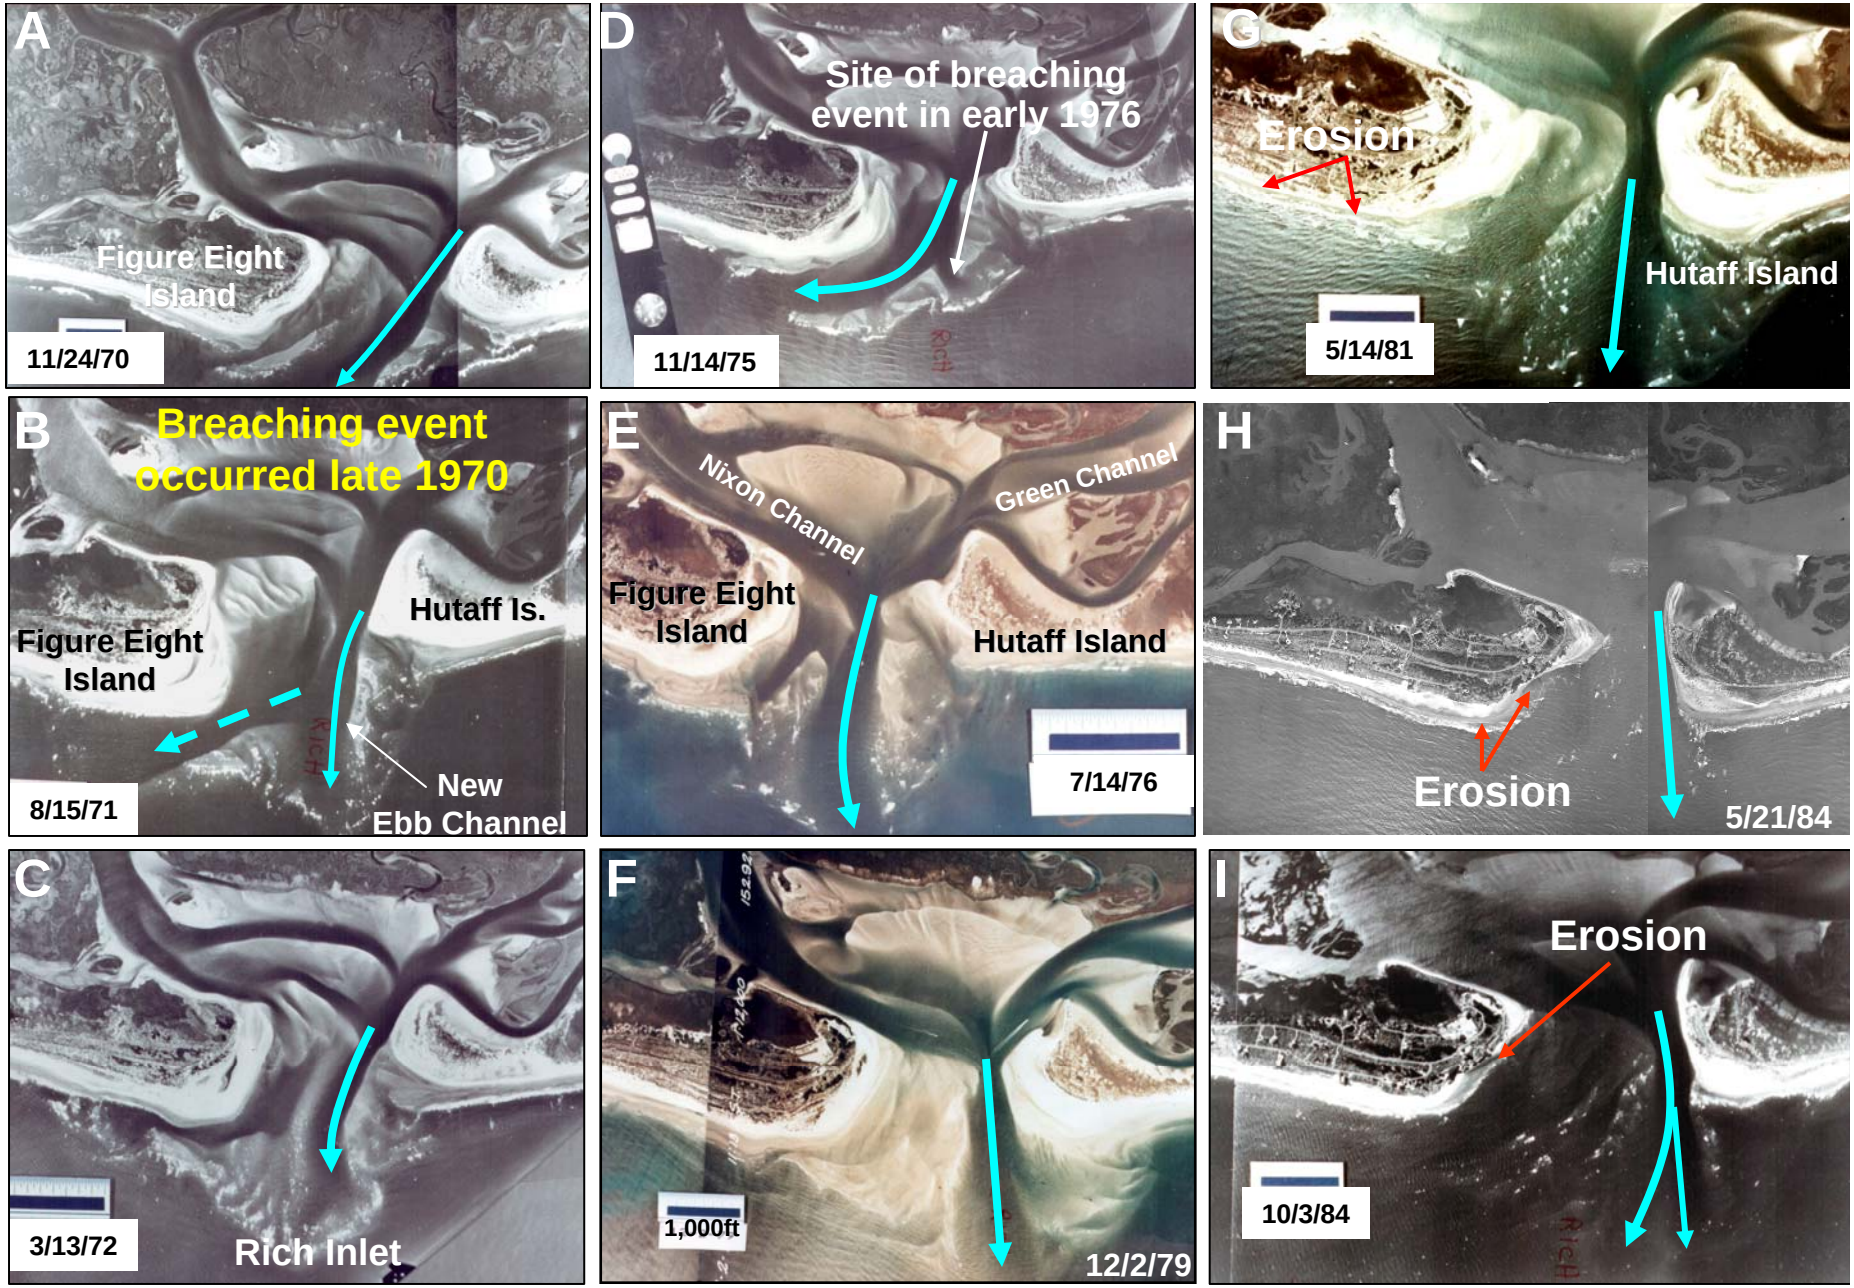
Figure 10 Appendix. Aerial photographs (1970-1984) depicting ebb and flood channel changes and the mid 1971 ebb delta breaching episode (**D**) and future breaching site (**D**) in late 1975/early 1976. Note spit development associated with ebb and flood channel changes and inlet shoreline erosion depicted in **"H-I"** (5/84 to10/84). Also note the oceanfront erosion imaged in "**G-H**".

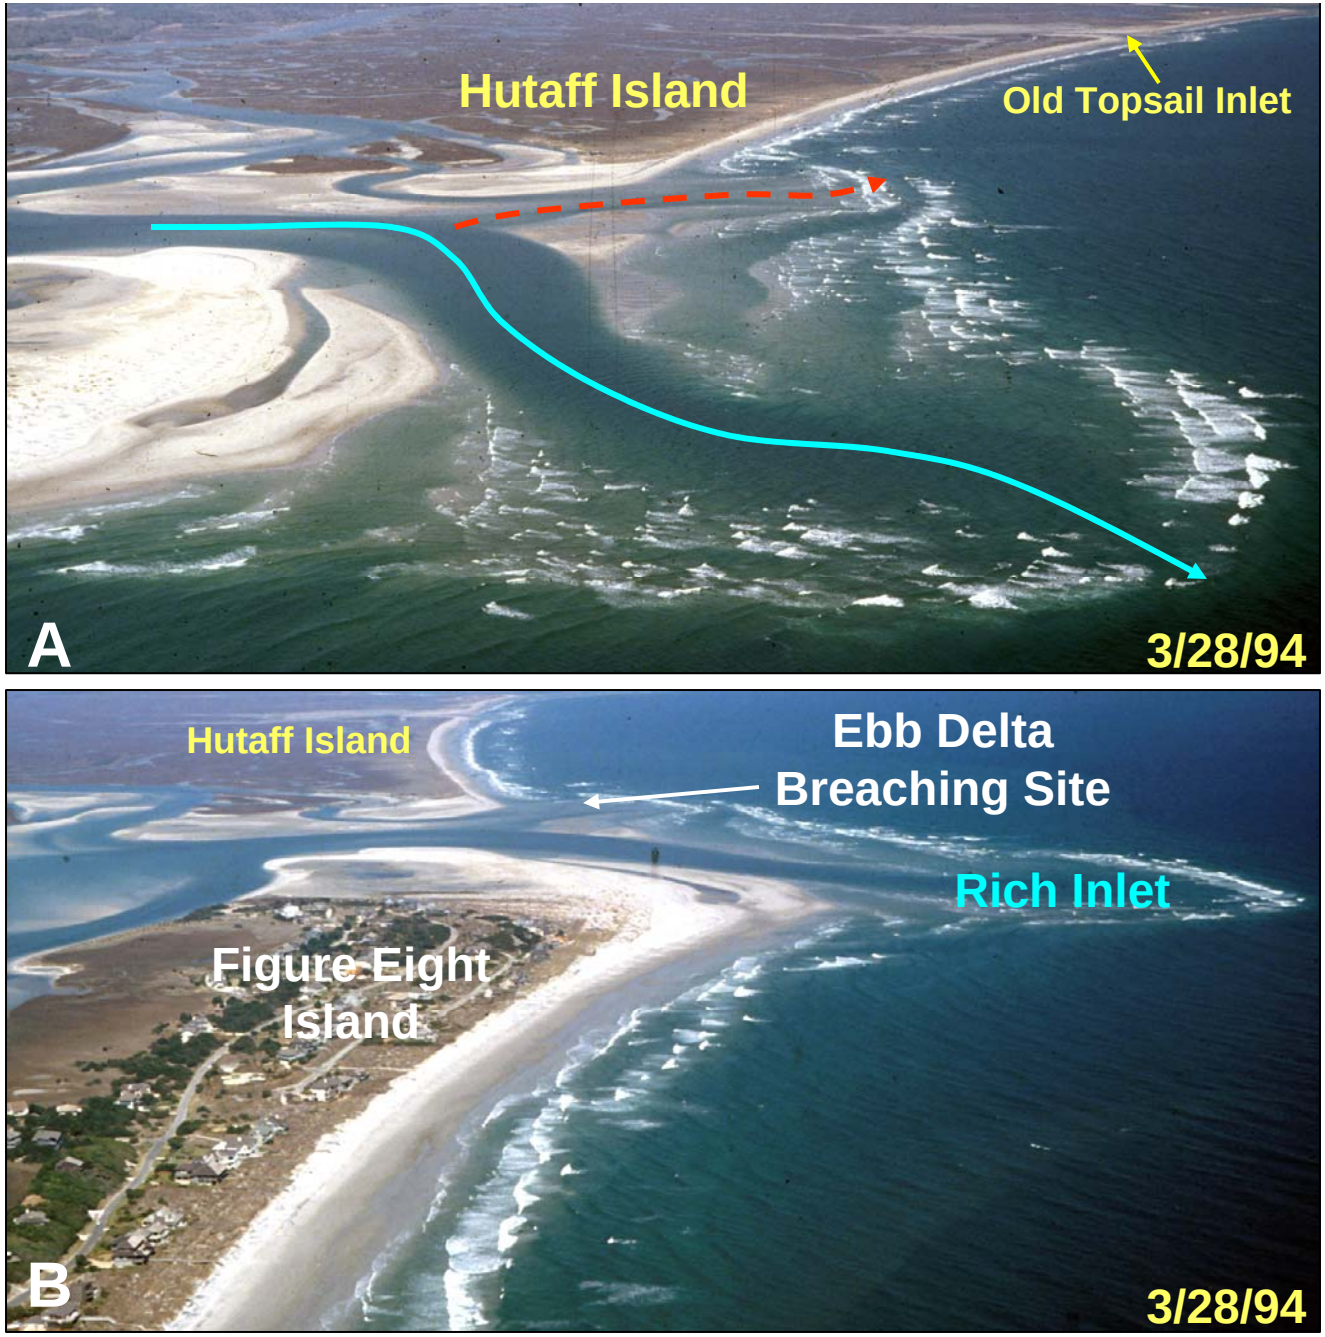
Figure 11 Appendix. Oblique aerial photographs depicting large bar attachment along F8I margin of Rich Inlet. A. View (3/28/94) depicting future breach site across swash platform. **B.** Expanded view of "A". Note growth of F8I spit extending into throat.

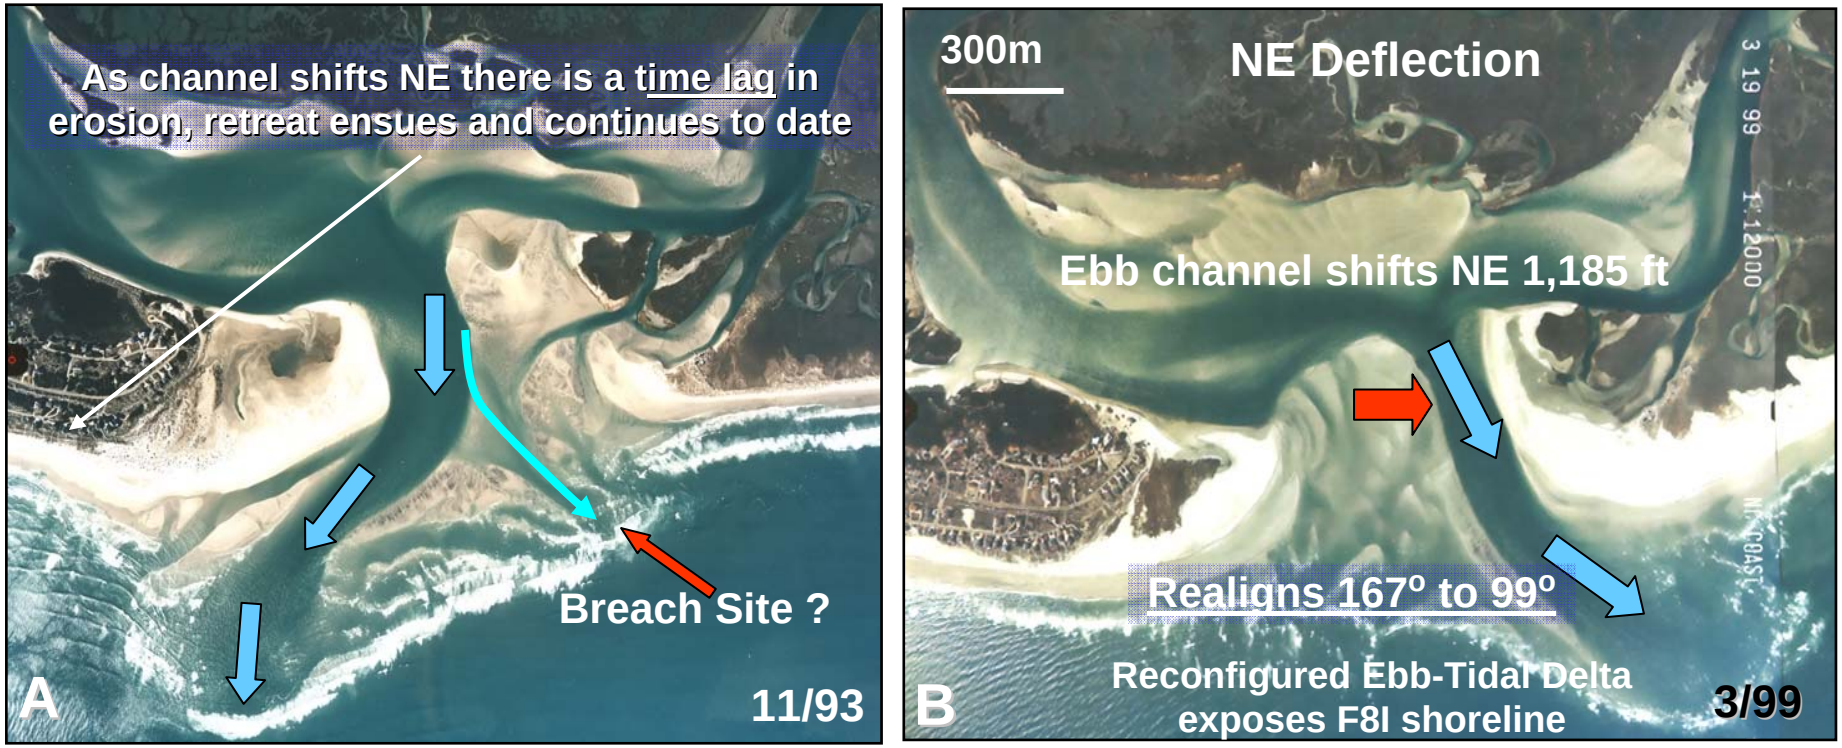
Figure 13 Appendix. Aerial photographs depicting the mechanism that has promoted chronic erosion along F8I oceanfront shoreline since 2000. **A**. Aerial photograph (11/93) of Rich Inlet and the highly skewed ebb channel. Note the likely site within the swash platform where ebb delta breaching occurred. **B**. Aerial photograph (3/99) showing the northward migration of the ebb channel and the realigned outer segment of the ebb channel. Compare the potential wave sheltering effect along the F8I oceanfront in “A” and “B”. Also note the lack of swash bars attachment along F8I in “B”.

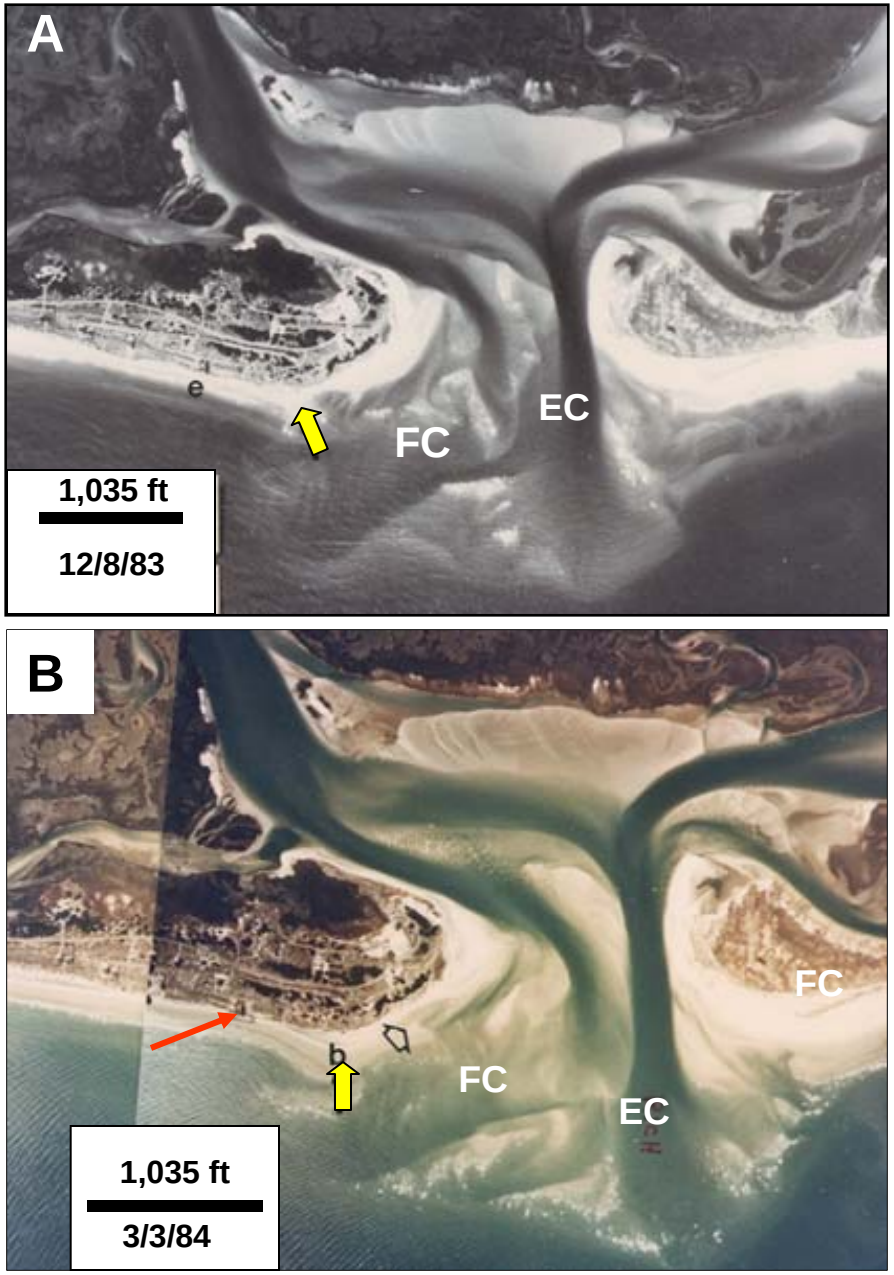
Figure 16. Appendix. Historic Aerial photographs of north end erosion **A**. View (12/8/83) of erosion of beach fill and attaching swash bar. **B.** View (3/3/84) depicting onset of inlet shoreline and increased oceanfront erosion related to attachment of swash bars (**b**) and erosion in lee of bar (yellow arrow).

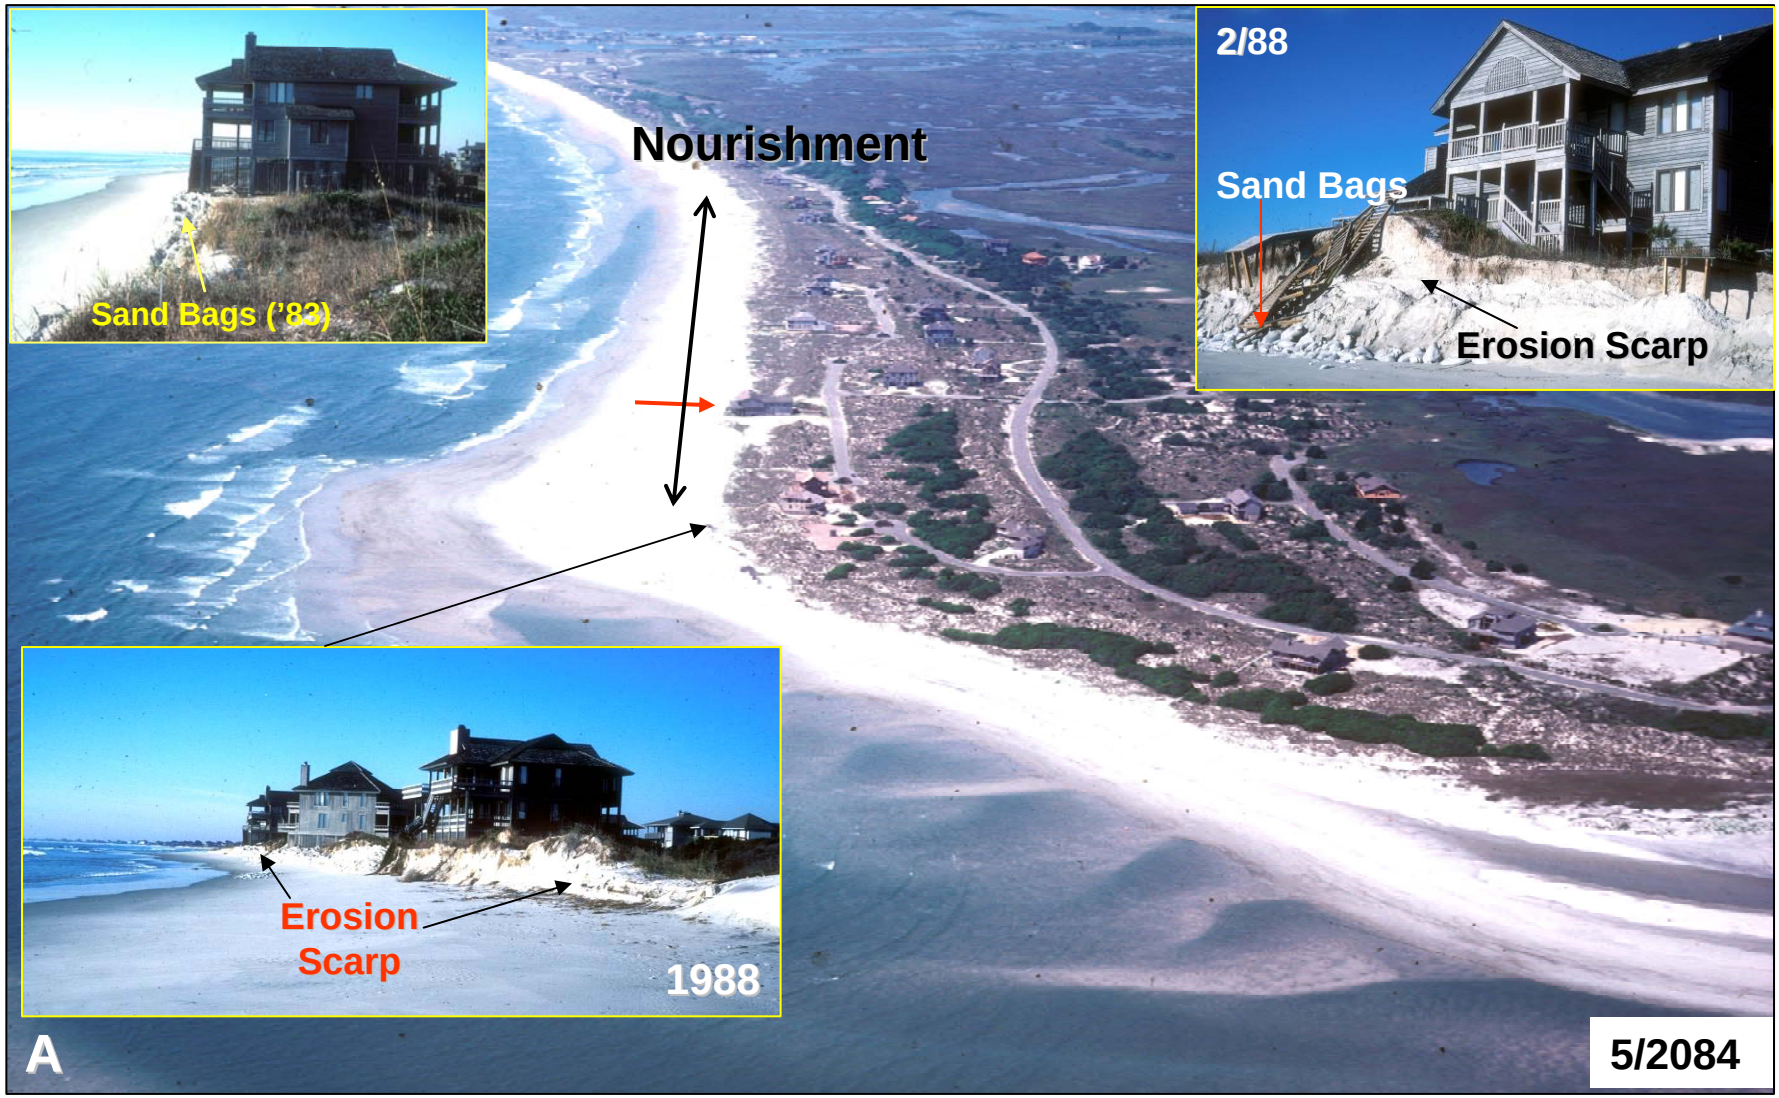
Figure 17 Appendix. Oblique Aerial photograph (5/20/84) depicting a south view of the historic accretion zone and the sand bags placed along the shoreline in 1983 prior to the small nourishment project along the northern end of F8I. Inserts show homes fronted by sand bags in 2/88.

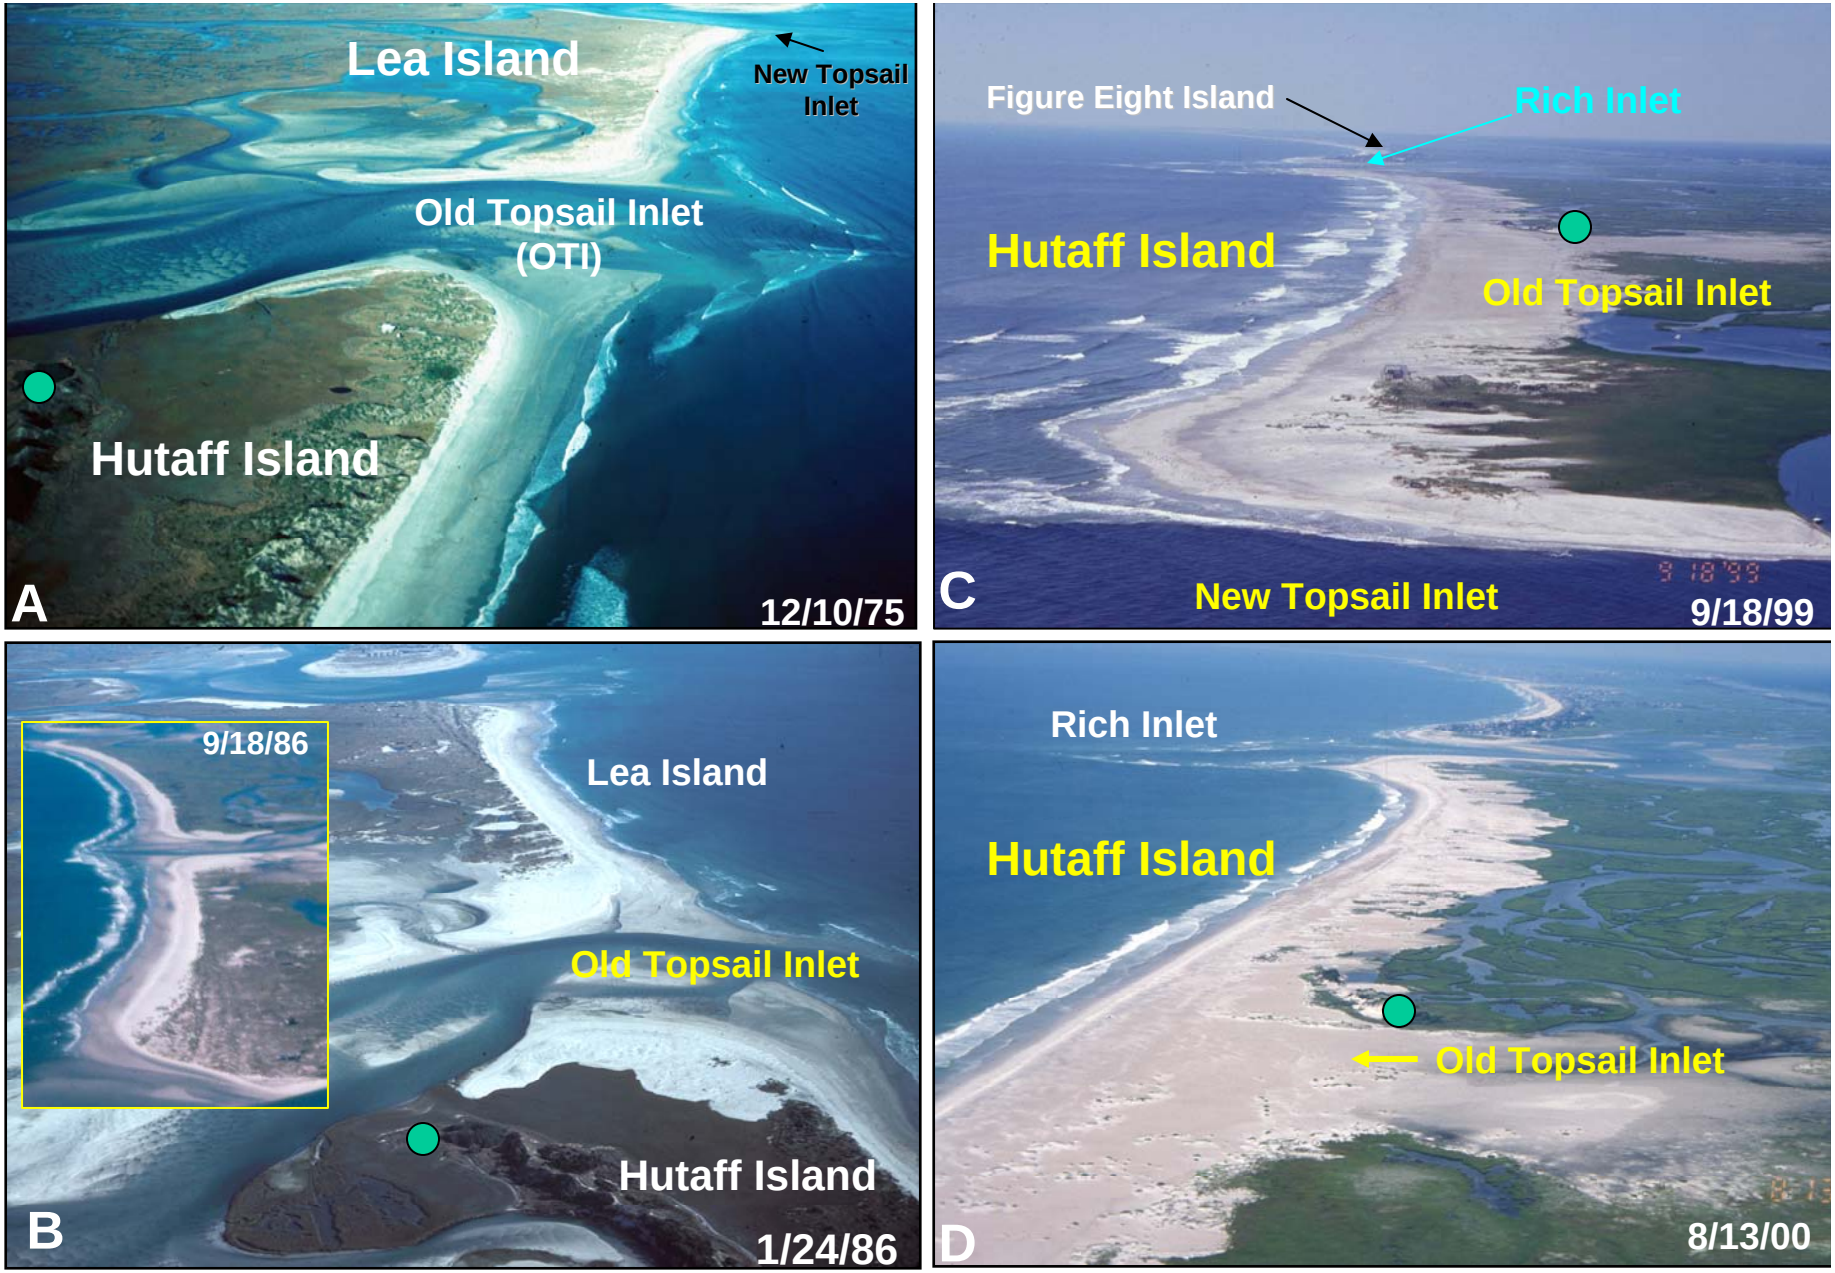
Figure 25 Appendix. Aerial photographs of Hutaff Island and closure zone of Old Topsail Inlet (4/98). **A.** North view (12/10/75) of Lea, Old Topsail Inlet and Hutaff Island . Note extent of ebb delta and slight shoreline curvature. **B.** North view (1/24/86) of OTI and welding swash bars. Insert depicts south view of islands and shoreline curvature near inlets. **C.** South view (8/13/00) of former inlet area and washover terrace and remnant dunes in OTI closure zone. **D.** South view (8/13/00) of the extensive washover terraces and embryo dunes. Green circle is reference feature.

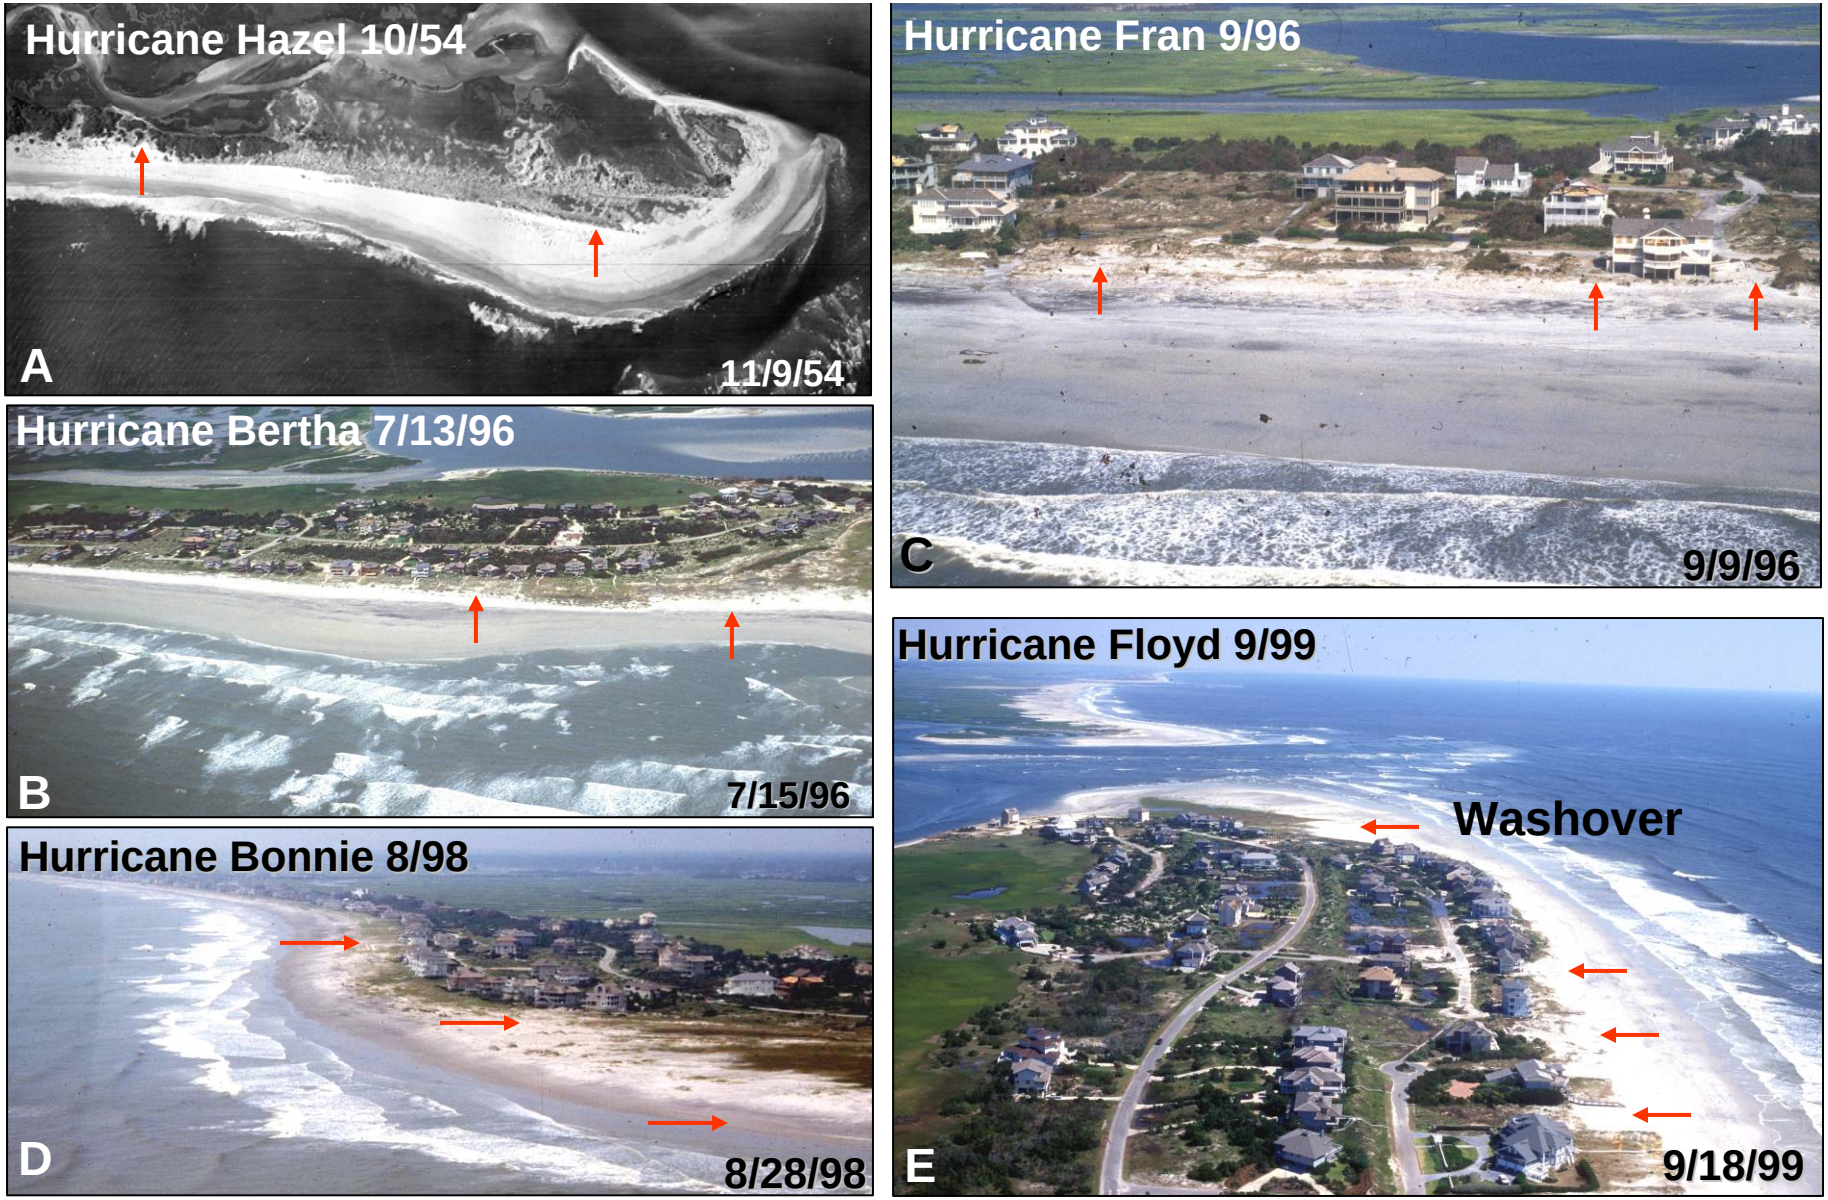
Figure 29 Appendix. Aerial photographs depicting post-hurricane F8I IHA impacts. **A.** Hurricane Hazel (10/54) shoreline recession and minor dune erosion **B.** Hurricane Bertha (7/13/96). Scarped intact foredunes with minor overwash. **C**. Hurricane Fran (9/96) erosion of dunes and washovers. **D.** Hurricane Bonnie (8/98). Increased overwash and dune erosion. Bulk of protecting dunes remain in place. **E.** Hurricane Floyd (9/99) dunes eroded nearest inlet and overwash common to south. Portions of dune line remains intact along homes along north end of F8I.

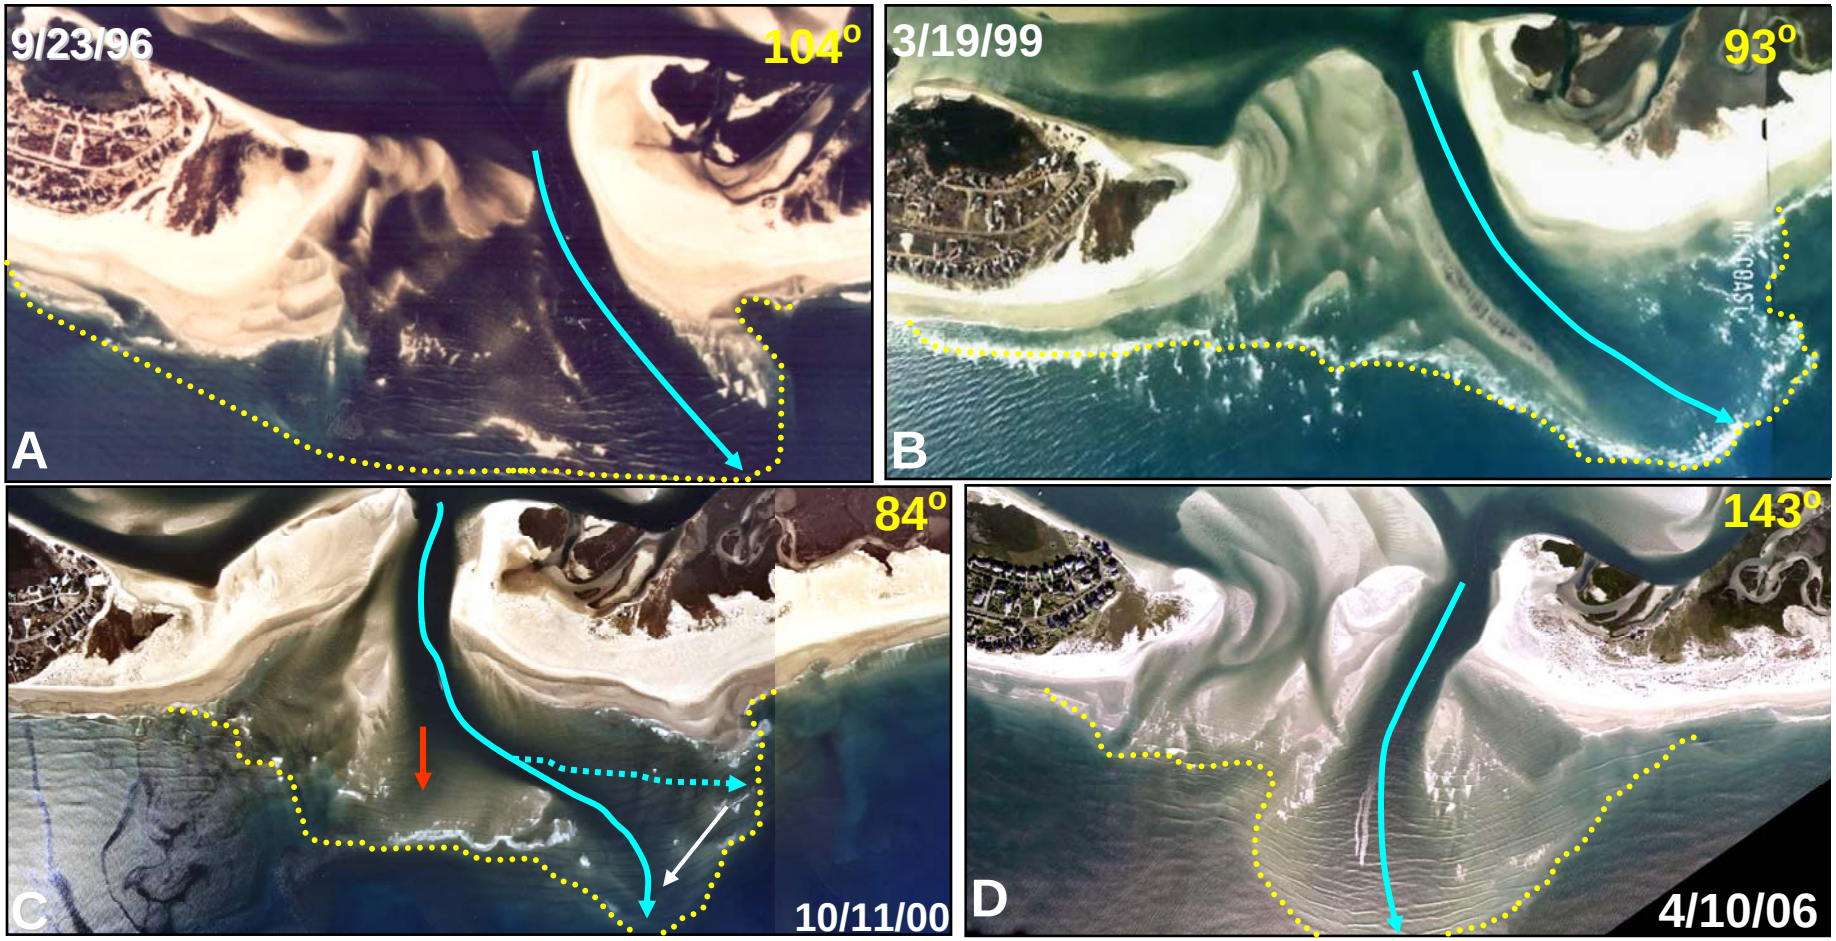
Figure 44 Appendix. Aerial Photographs depicting differing alignments and positions of the ebb channel and shapes of the ebb-tidal delta. **A.** Image (9/23/96) depicting ESE aligned ebb channel and corresponding asymmetric shape of ebb delta that now affords protection and nourishment of HI oceanfront. Ebb delta apex has shifted far eastward during its ongoing reconfiguration. **B**. Image (3/19/99) depicting ESE aligned ebb channel and continuing shift of ebb delta apex toward HI. Note that the majority of the ebb delta fronts the wide marginal flood channel adjacent to F8I that facilitated the elongation of the F8I spit.. Note slight change in barrier offset pattern. **C.** View (10/11/00) of ebb channel that has been deflected/reoriented from a ENE alignment to a ESE alignment. Note bar buildup along HI oceanfront that stems form pervious configuration. The elongation of the F8I spit has resulted in dramatic constriction of the inlet. Note erosion along F8I and the significant change in the barrier offset pattern in comparison to "**A**". Red colored arrow denotes the spillover channel and location of a future breach site. **D.** Aerial photograph (4/10/06) depicting realigned ebb channel following the aforementioned ebb delta breaching event and an expanded inlet due to erosion of the F8I spit. Note erosion along the HI margin due to the SW shift of the ebb channel and the expansion of the marginal channel along the HI margin. The position of the ebb channel dictates that large volumes of material are transported thru the wide southern flood channel.
