Appendix B:
Summary of Winslow Levee and Ruby Wash
Diversion Levee, Winslow, AZ (Navajo County):
History, Composition, Foundation
(USACE 2010)

Summary of Winslow Levee and Ruby Wash Diversion Levee, Winslow, AZ (Navajo County): history, composition, foundation

What is known from literature on materials and construction, geotechnical conditions in the levee embankments and their foundations: data to support the Little Colorado River at Winslow feasibility study

12 March 2010

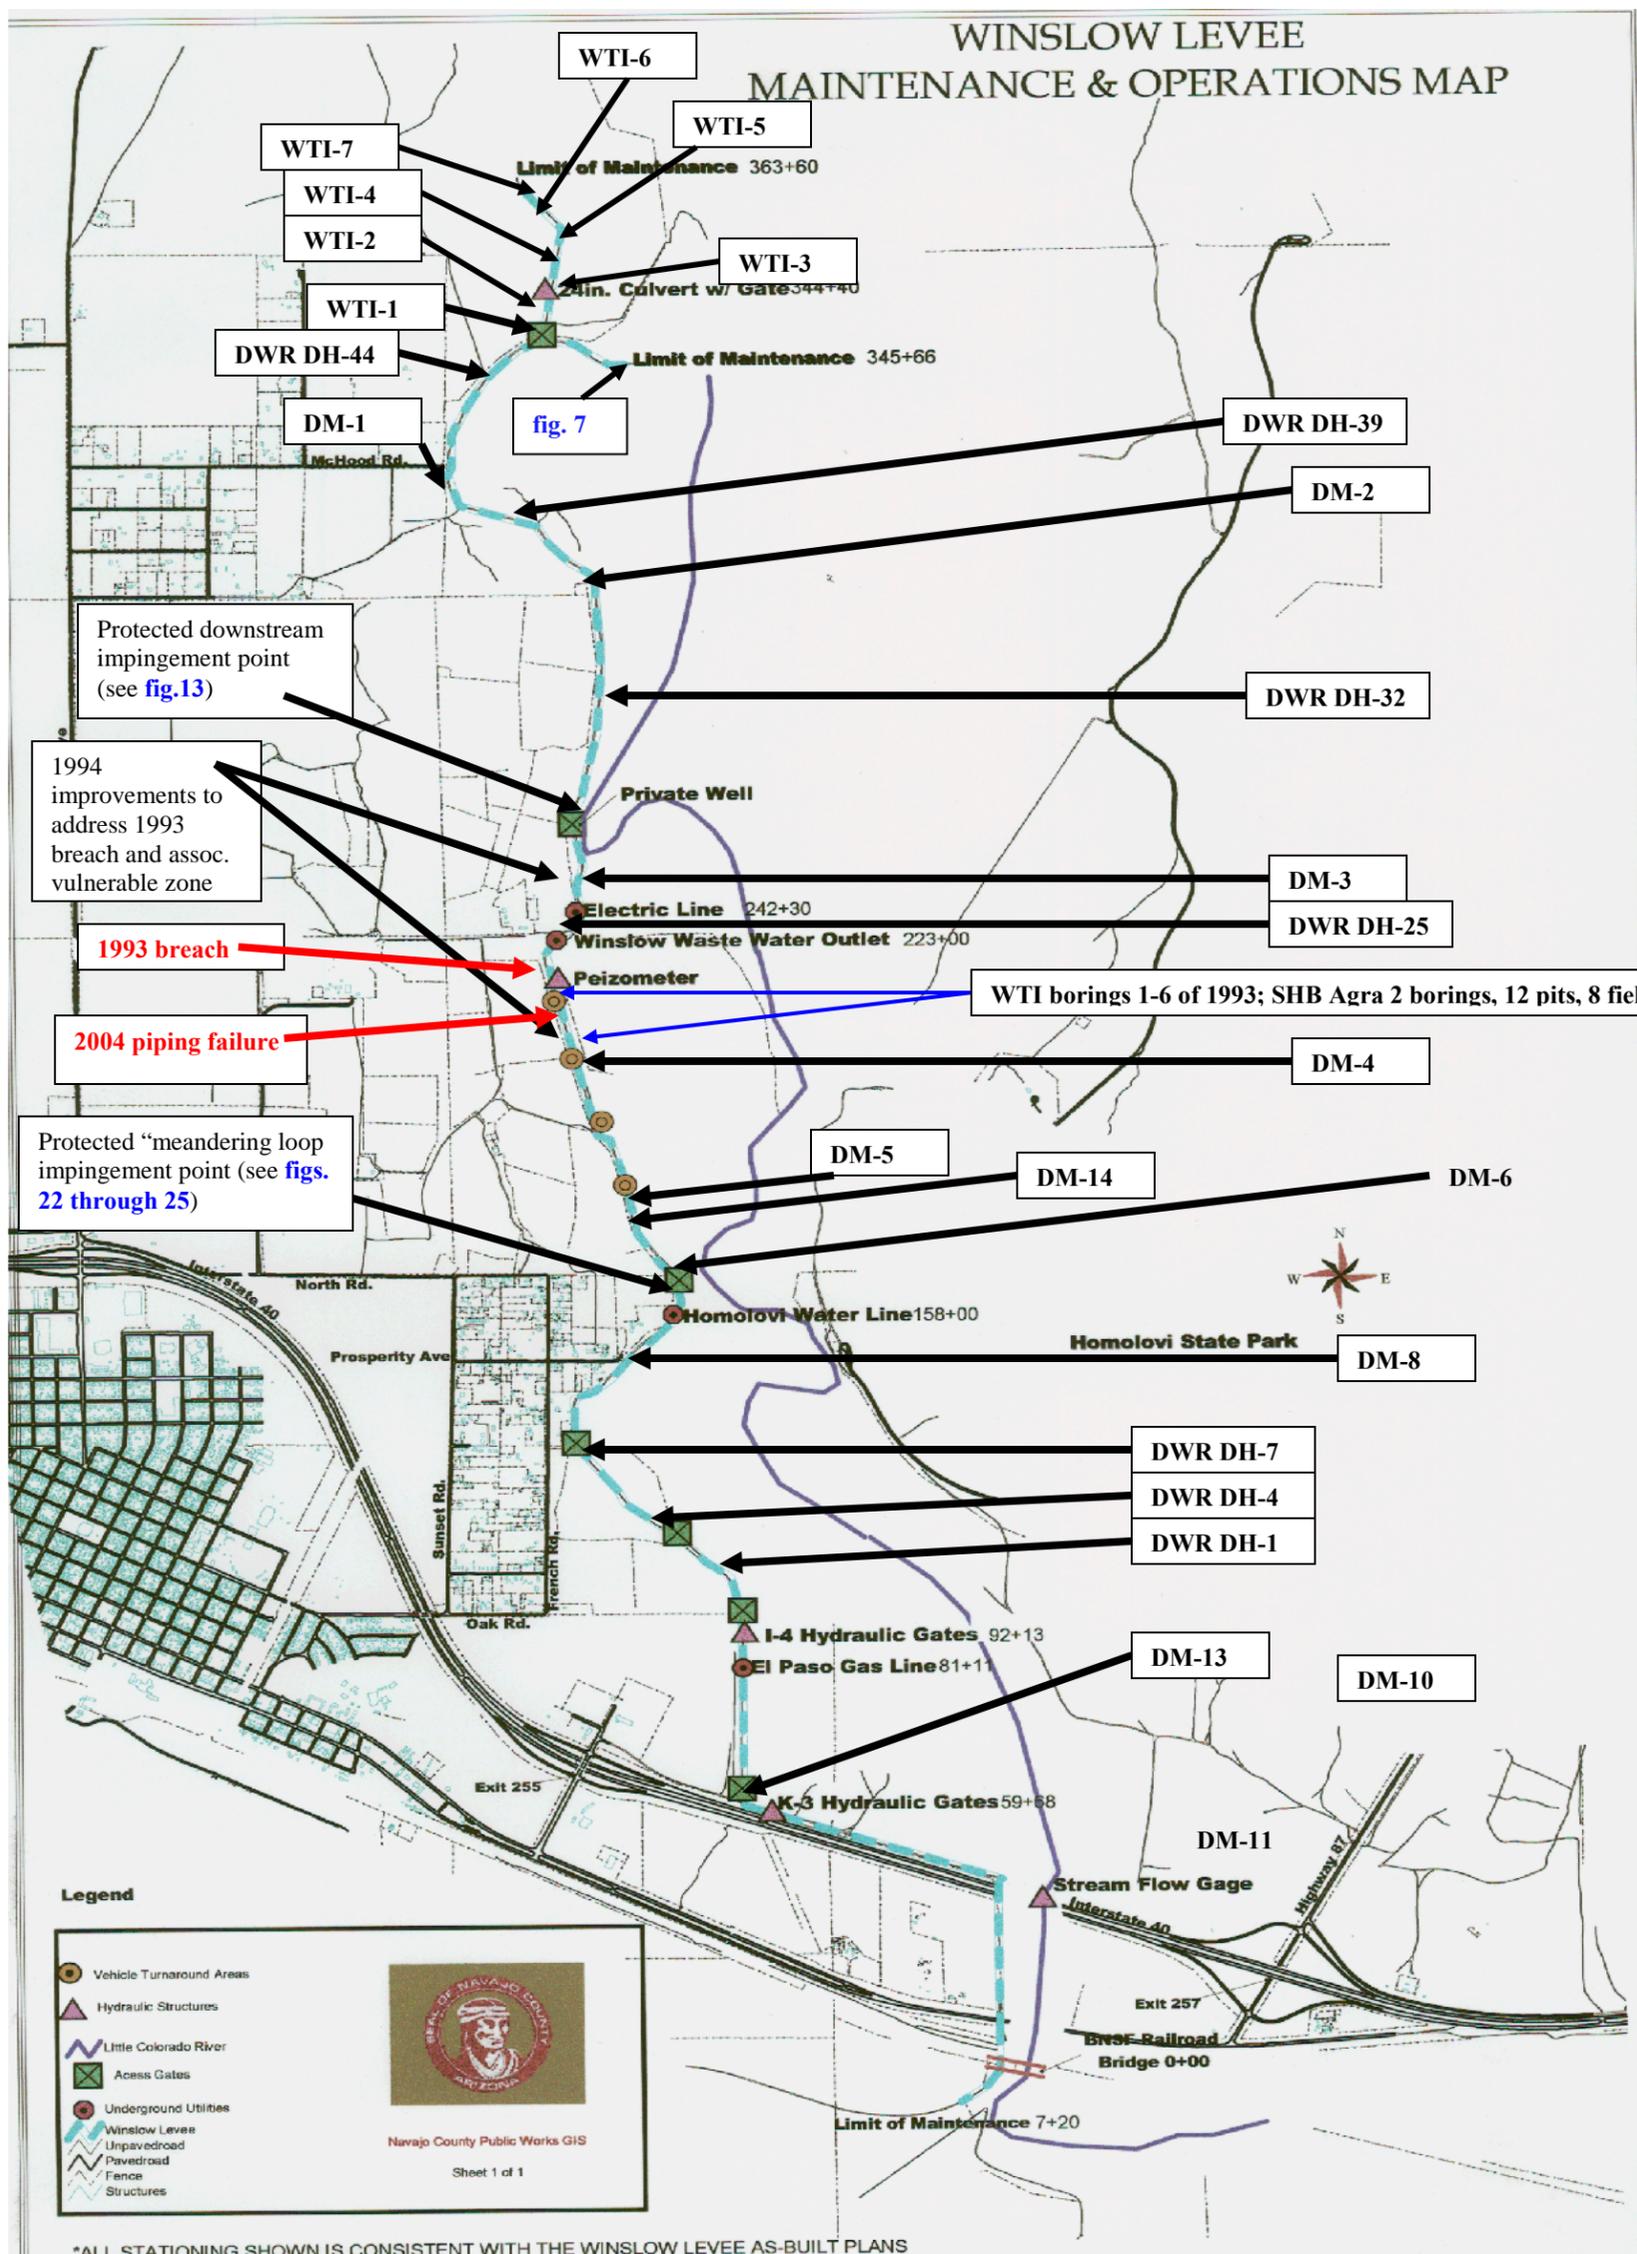
Fig. 6.—Existing Winslow Levee (see pale blue / aqua colored line), showing locations of 1993 and 2004 failures, and all known geotechnical explorations (borings, trenches). Original map source: Navajo County. Map modified by the Corps by adding the annotations showing exploration and failure points. Use your document browser's zoom feature to expand the size of this drawing and see more detail. DM = Dames and Moore boring location (shown are Dames and Moore borings from 1980, numbered DM-13, -11, -10, -8, -6, -5, -4, -3, -2, -1. DWR DH= Arizona Dept. Water resources boring from 1980 (shown are DWR borings from 1980 numbered DWR DH-44, -39, -32, -25, -7, -4, -1). WTI = Western Technologies, Inc. boring location (shown are WTI borings from 1982, numbered WTI-7, -6, -5, -4, -3, -2, -1). Also shown are a set of borings 1-6 by WTI from 1993 at the 1993 breach area. SHB Agra work of 1994 was spread along 3,500 ft of the levee; approximated work area shown. **Where sta. 242+30 is shown on this map, probably is approx. sta. 229 or 230, based on a study of the as-builts (sheet 8).**

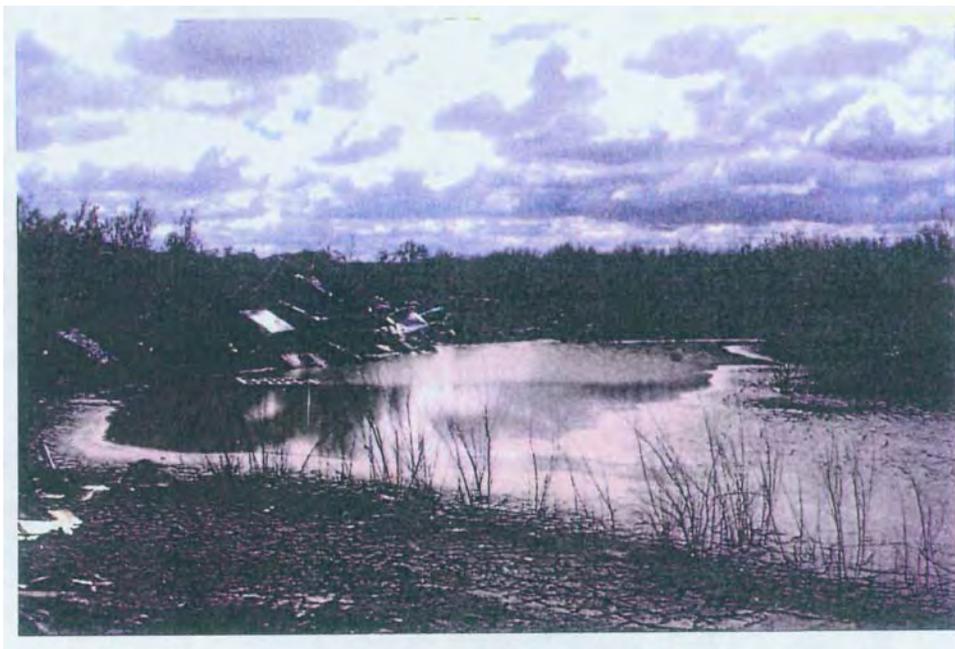
Fig. 7.—(2 frames, one above, one below) Two views that include at least one car body in the Levee on 25 April 1990, which is after the 1989 rebuild was completed. The top frame is Gregory (1990, enclosure no. 8), and is reported to be at station 345+66. The bottom frame, also with Gregory (1990) files, was un-annotated, but appears to be a view of the same location, with better resolution.

All available evidence and field observations support that the above listed objectives were attained by the late 1980s rebuild of the Levee.

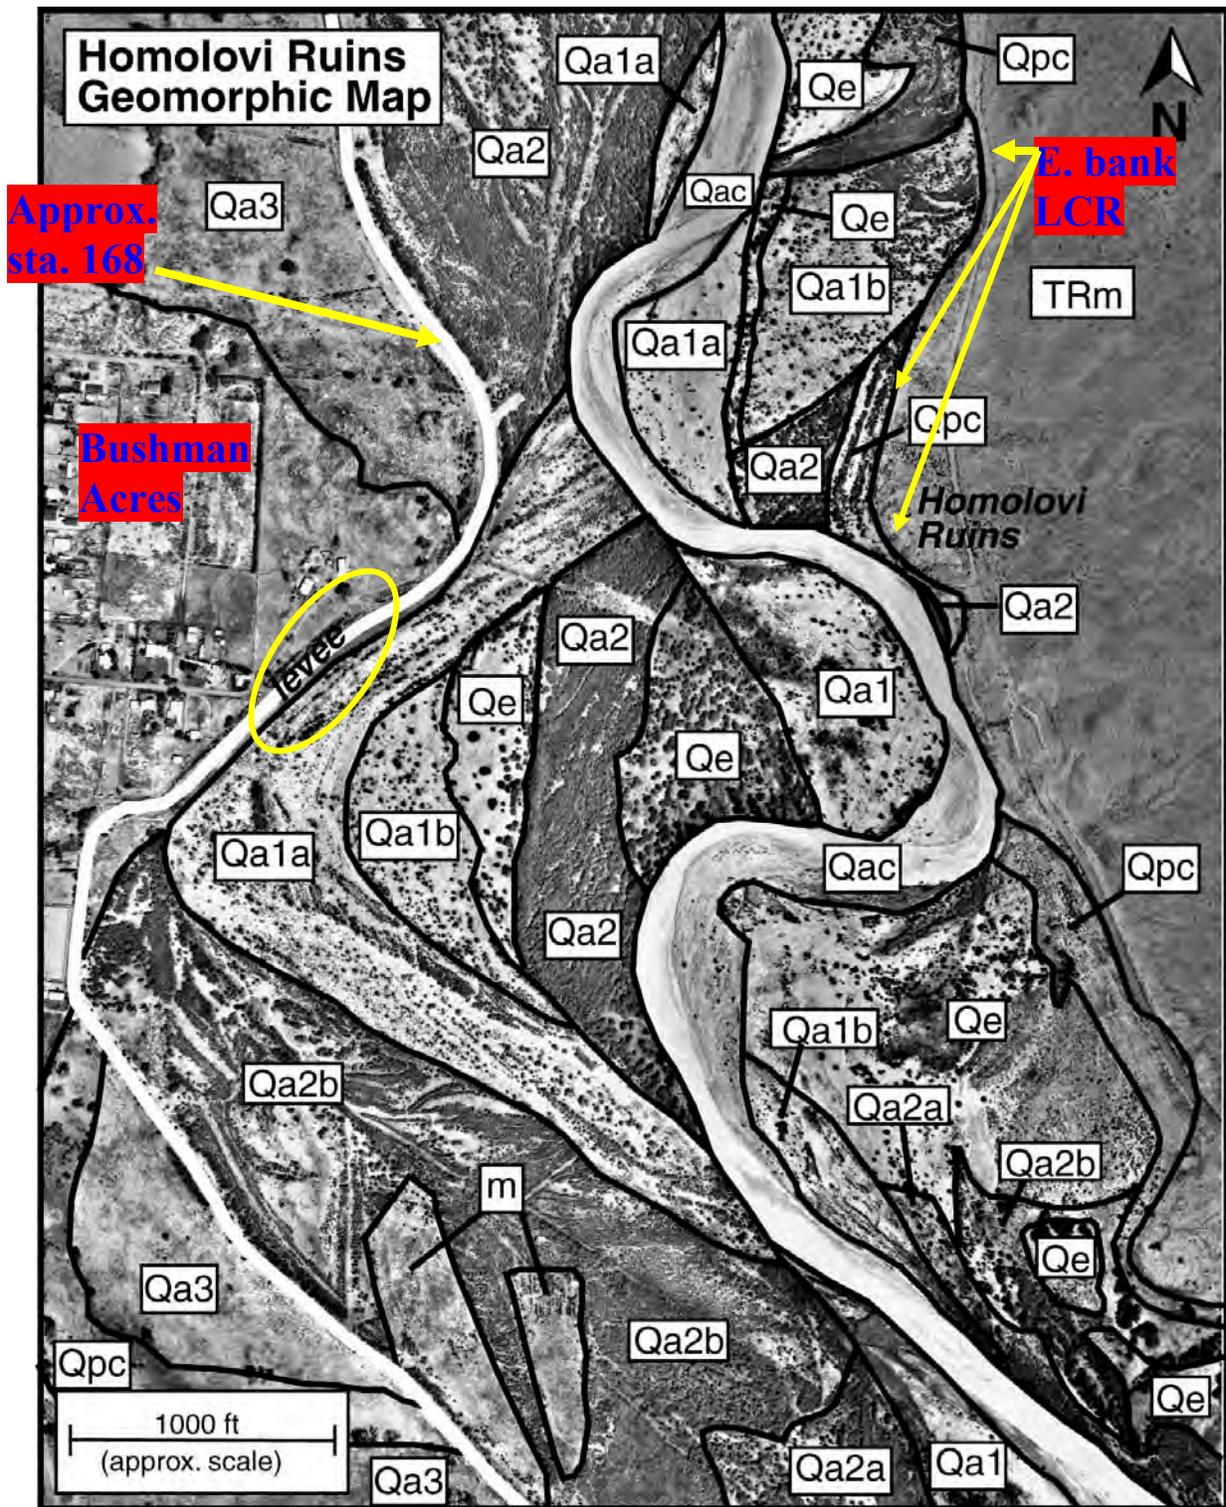
Fig. 10.—Mapped Little Colorado River meanders at the Bushman Acres – Winslow Levee – meandering loop junction, from Bureau of Reclamation (2003, p. 34), as annotated in red and yellow for this report. Note the Winslow Levee (marked “levee” on the map). “LCR” = “Little Colorado River”.

River meanders mapped in **figs. 10 and 11**, including the “meandering loop” in **fig. 10**, mapped as units Qpc, Qa2, or Qa3, all underlie the Levee foundation and all, according to Bureau of Reclamation (2003, p. 34-35) are less than 100 years old, meaning the river has flowed there in very recent times and reasonably could be expected to return. That the opposite bank of the River is in places entrenched against a wall of bedrock enhances the possibilities of meander return to the west (Levee-side) bank by future meanders, as currents would be expected to bounce off the bedrock and move elsewhere, probably to the west. The land immediately under Bushman Acres and adjacent Levee is the only land under or near the Levee in this vicinity that is *not* mapped as a past river meander. Granular, sandy zones are anticipated to be present within these meanders below the foundation of the Levee, and, as such, hold the potential to support piping (the known piping failure zone was not mapped by Bureau of Reclamation (2003)). Alluvial unit Qa1a was the main channel up against the Levee, prior to “dredging and channelization” from 1984 to 1993 that “shifted the channel to the east” (Bureau of Reclamation, 2003, p. 34).

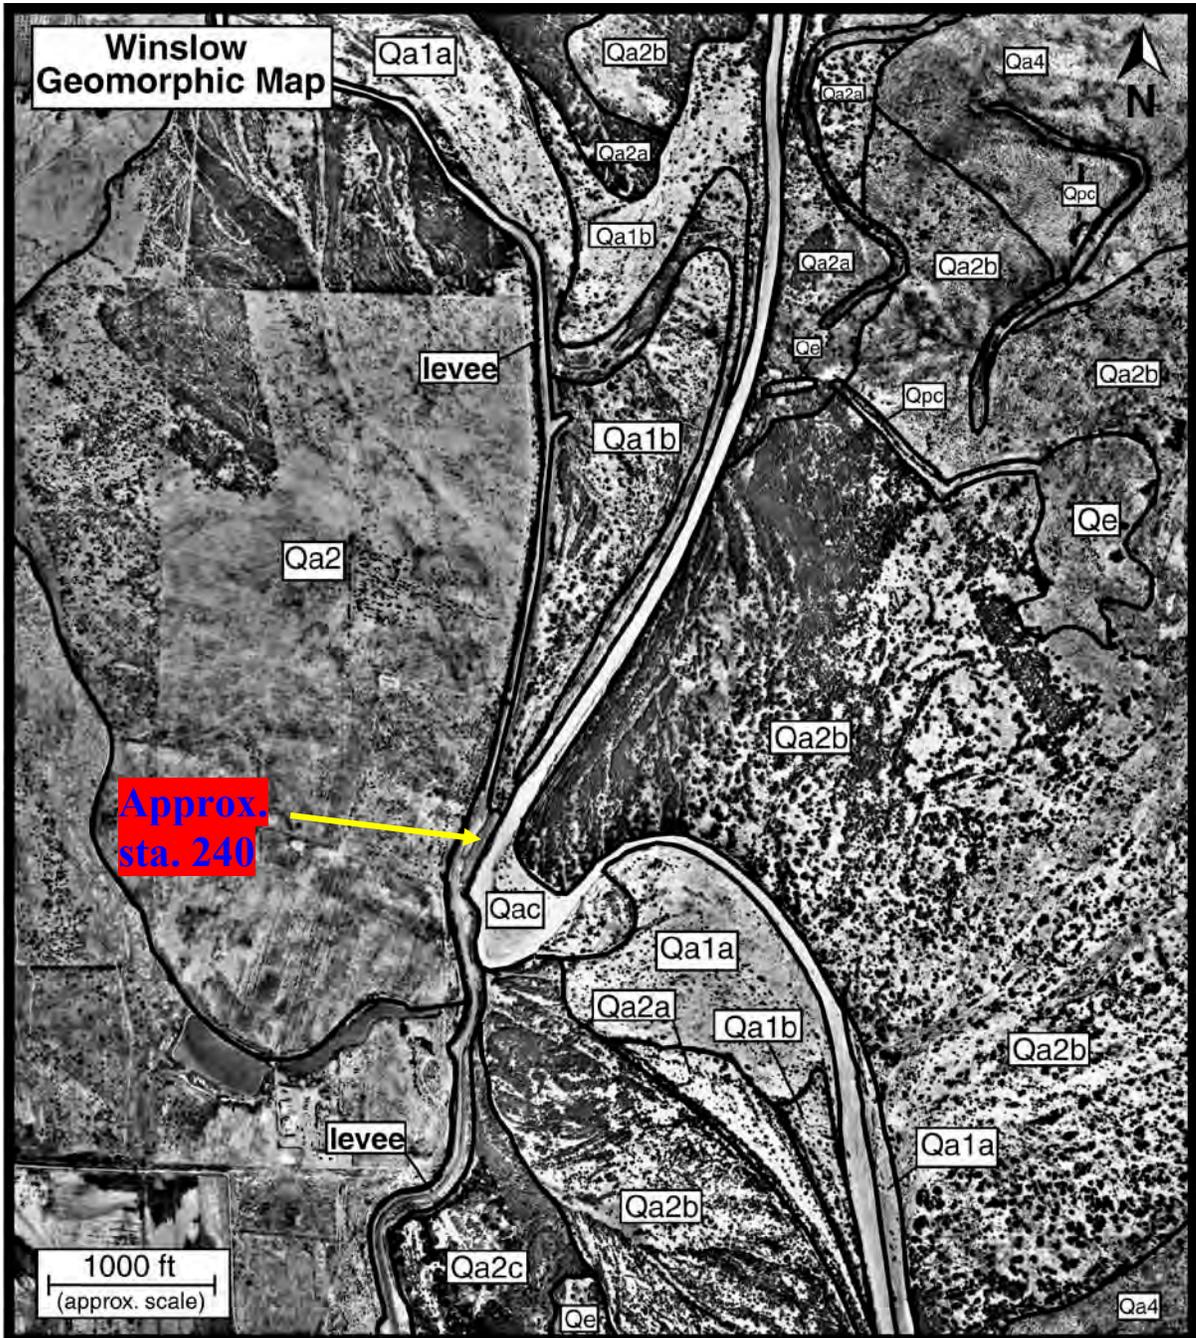
Fig. 11.--Mapped Little Colorado River meanders at the downstream impingement point, from Bureau of Reclamation (2003, p. 35), as annotated in red and yellow for this report. Note the Winslow Levee (marked "levee" on the map).

There isn't any documentation on the characteristics and testing of this riprap protection stone. Observations by the Corps in 2008 suggest that several different riprap sources were used. The fact that the riprap-protected area shown in [fig. 11](#) is composed of dense and apparently very durable basalt, and comparison of that stone to other, more recently added basalt, suggests that all the basalt on the Levee may have come from the Bidahochi quarry on the Navajo Indian Reservation, which supplied a riprap protection that is used on this Levee in other locations and which is discussed in more detail later in this report.

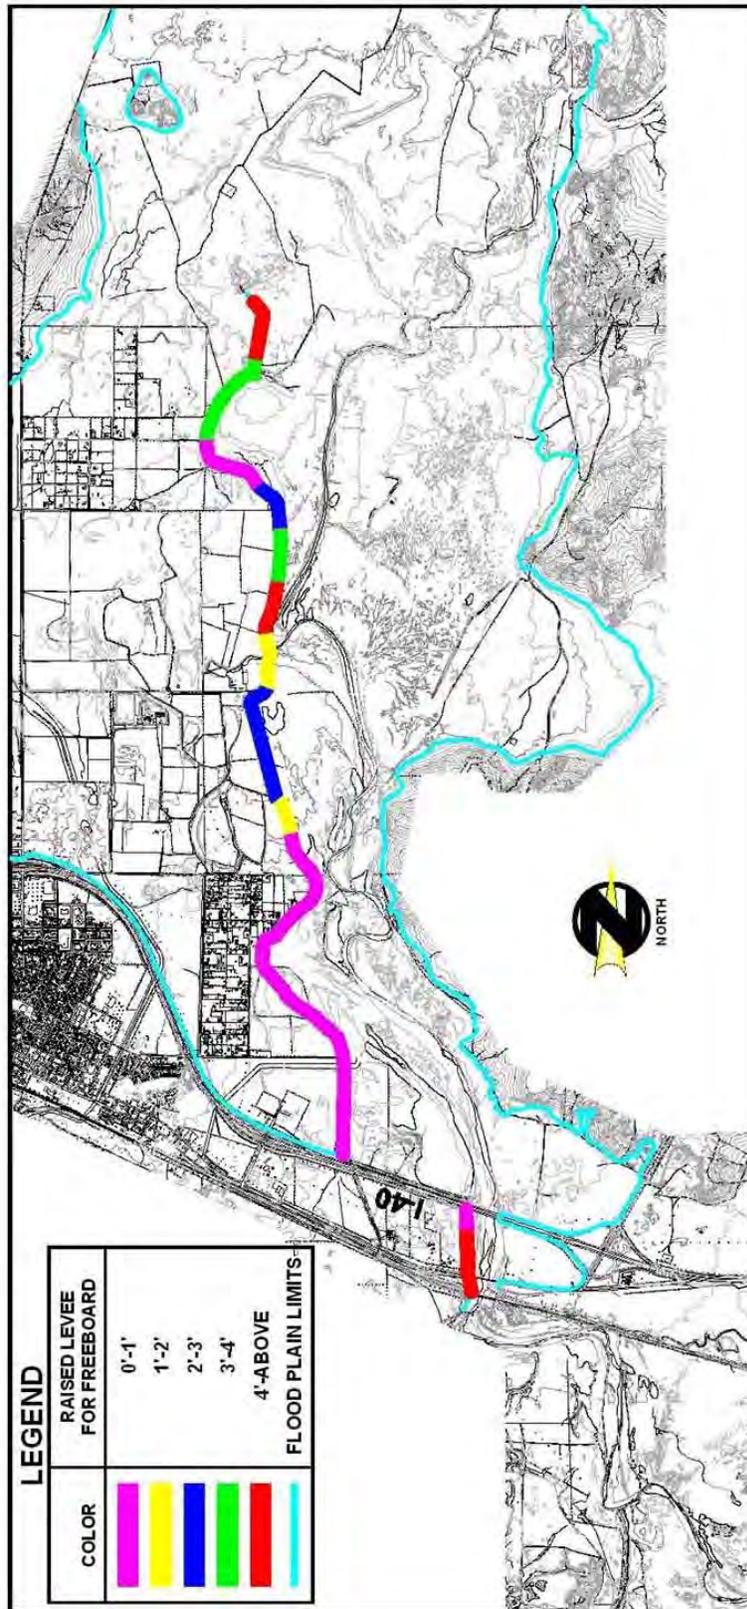
1.3.2 *Freeboard issues.* A past study to assess suitability of the original Levee noted that Levee overtopping was a concern upstream of sta. 235+74, which is in the northern one-third of the Levee, but that levee overtopping was not anticipated to be a concern downstream of sta. 235+74 (ADWR, 1980, p. 9). A study done with the thought of overtopping risks of the current Winslow Levee resulted in calculation of the different amounts of freeboard available in different segments of the Levee in response to the 100-year flood event. All this information may be out-of-date, compared to Corps hydraulic studies underway at the time of this writing. Any freeboard and overtopping information that might result from that on-going work should be used preferentially, instead of the above listed stationing and **fig. 12** which is presented here primarily as background information on past work done. As of the time of this writing, the Levee is thought to be capable of containing the 50-year flood event, but not the 100-year flood event.

Fig. 12.—Older freeboard estimates for the current Winslow Levee. Floodplain boundary is out-of-date (more area would be inundated), and freeboard likely is less than shown on this drawing.

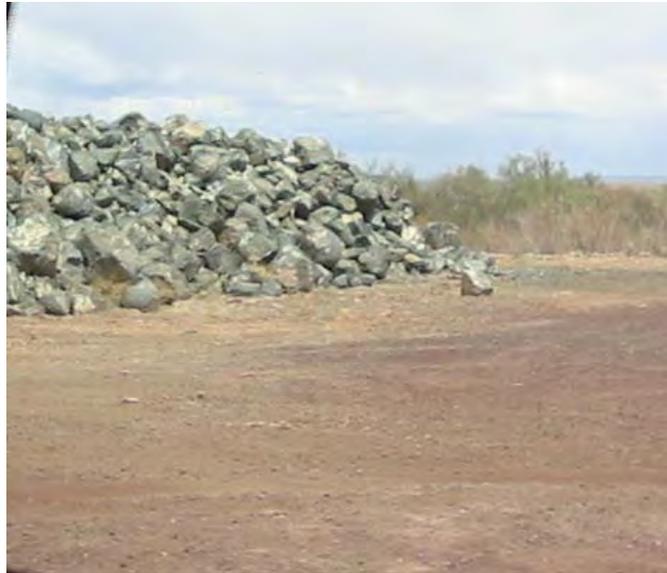
Fig. 20.— Stockpiled Bidahochi basalt, ready for the next flood fight, on the Winslow Levee, 18 May 2008.

1.3.4.5 Amount of stone on the Levee. Surely, much of total amount of riprap that was placed on the Levee as part of the 1994 repair work (292,705 tons) is in place as the riprap stone protection blanket. Some unspecified quantity of that total remains on the Levee in emergency stockpiles (as in [fig. 20](#)).

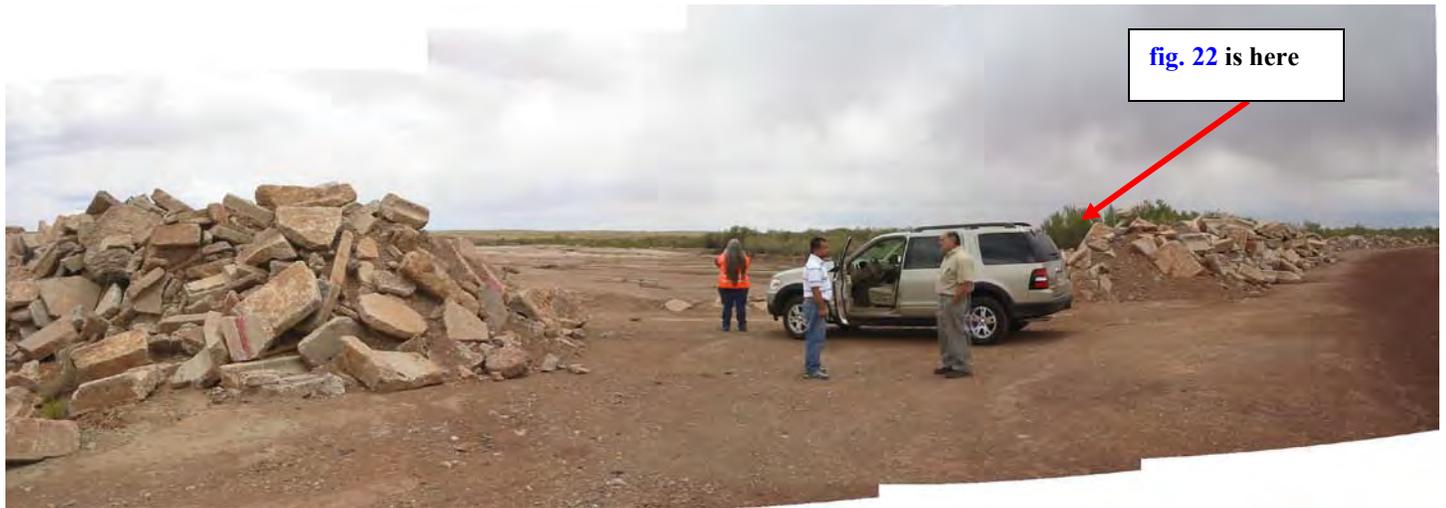
Fig. 23.— Waste concrete riprap stockpiled at the riverside edge of the Levee and ready to use under flood fight conditions to arrest Levee toe undercutting by the meandering loop of the Little Colorado River. Location is approximately sta. 163+80 and looking upstream. See also [figs. 22, 24, and 25](#). Photo of 15 May 2008.

drawings showing stone protection on Levee cross sections indicate this stone riprap addition originally was intended to begin at sta. 163+28.45 and extend downstream to sta. 176+96.34, which is 1,338 ft of coverage. Navajo County Public Works' Trent Larson reported to the Corps via an 8 June 2010 memo that the 2009 riprap addition began farther downstream than indicated on the design drawings, at approximately sta. 163+80, and essentially abuts the downstream end of the waste concrete emergency riprap. That suggests this 2009 riprap armoring segment is about 1,313 ft long. Views of the downstream end of the waste concrete and the upstream area that was covered with riprap in 2009 can be seen in [figs. 23, 24, and 25](#).

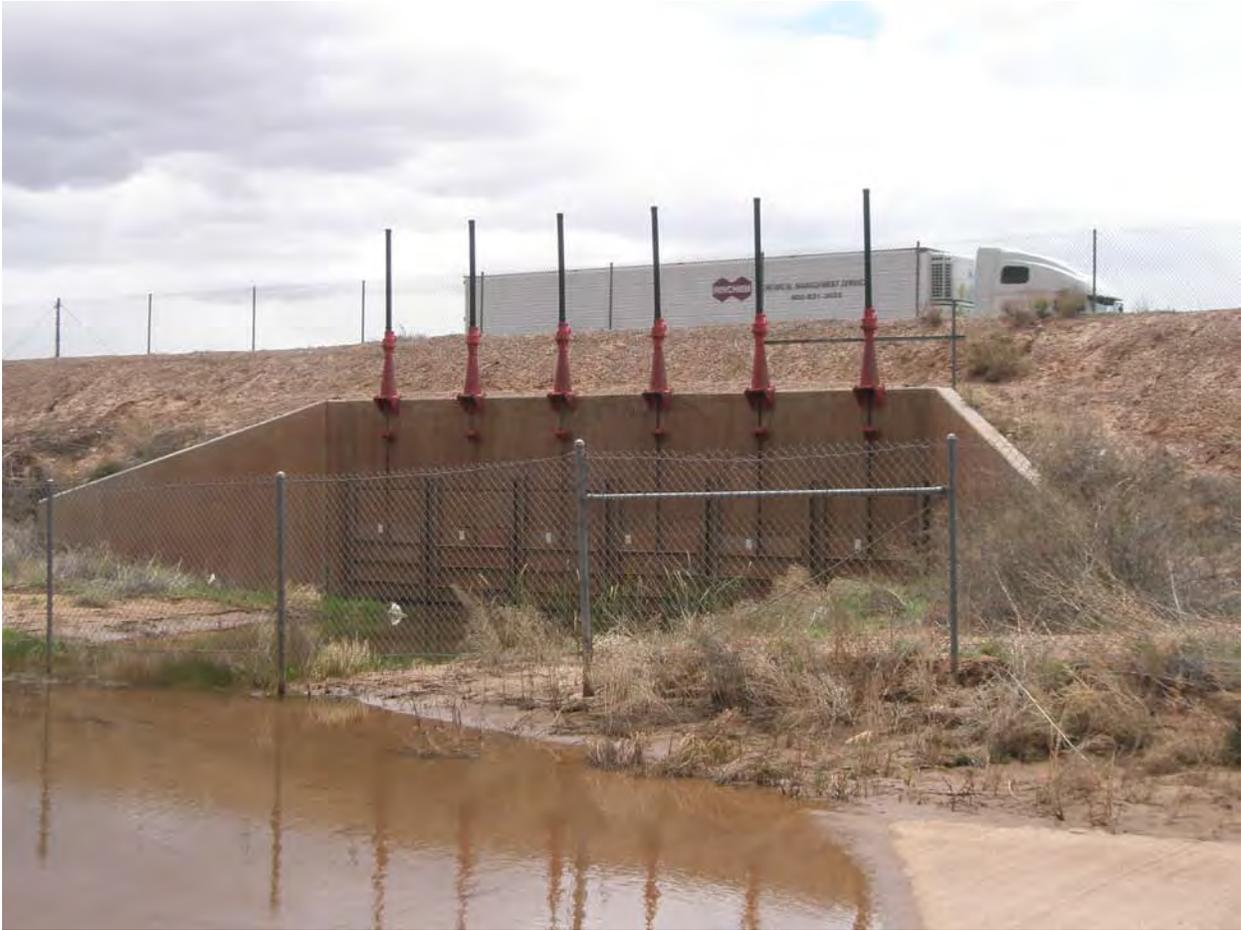
Current criteria in place for levees disallows the incorporation of a highway embankment as a part of a Levee. Structural changes will have to be made so that the two embankments, Levee and highway, are separate. Such work is beyond the scope of the current report. What is known of the gates has been cataloged here for future reference.

Fig. 26.—ADOT K-3 channel conduit set through the Interstate 40 embankment, looking south-southeast (upstream) from the downstream side of I-40. Photograph of 15 May 2008.

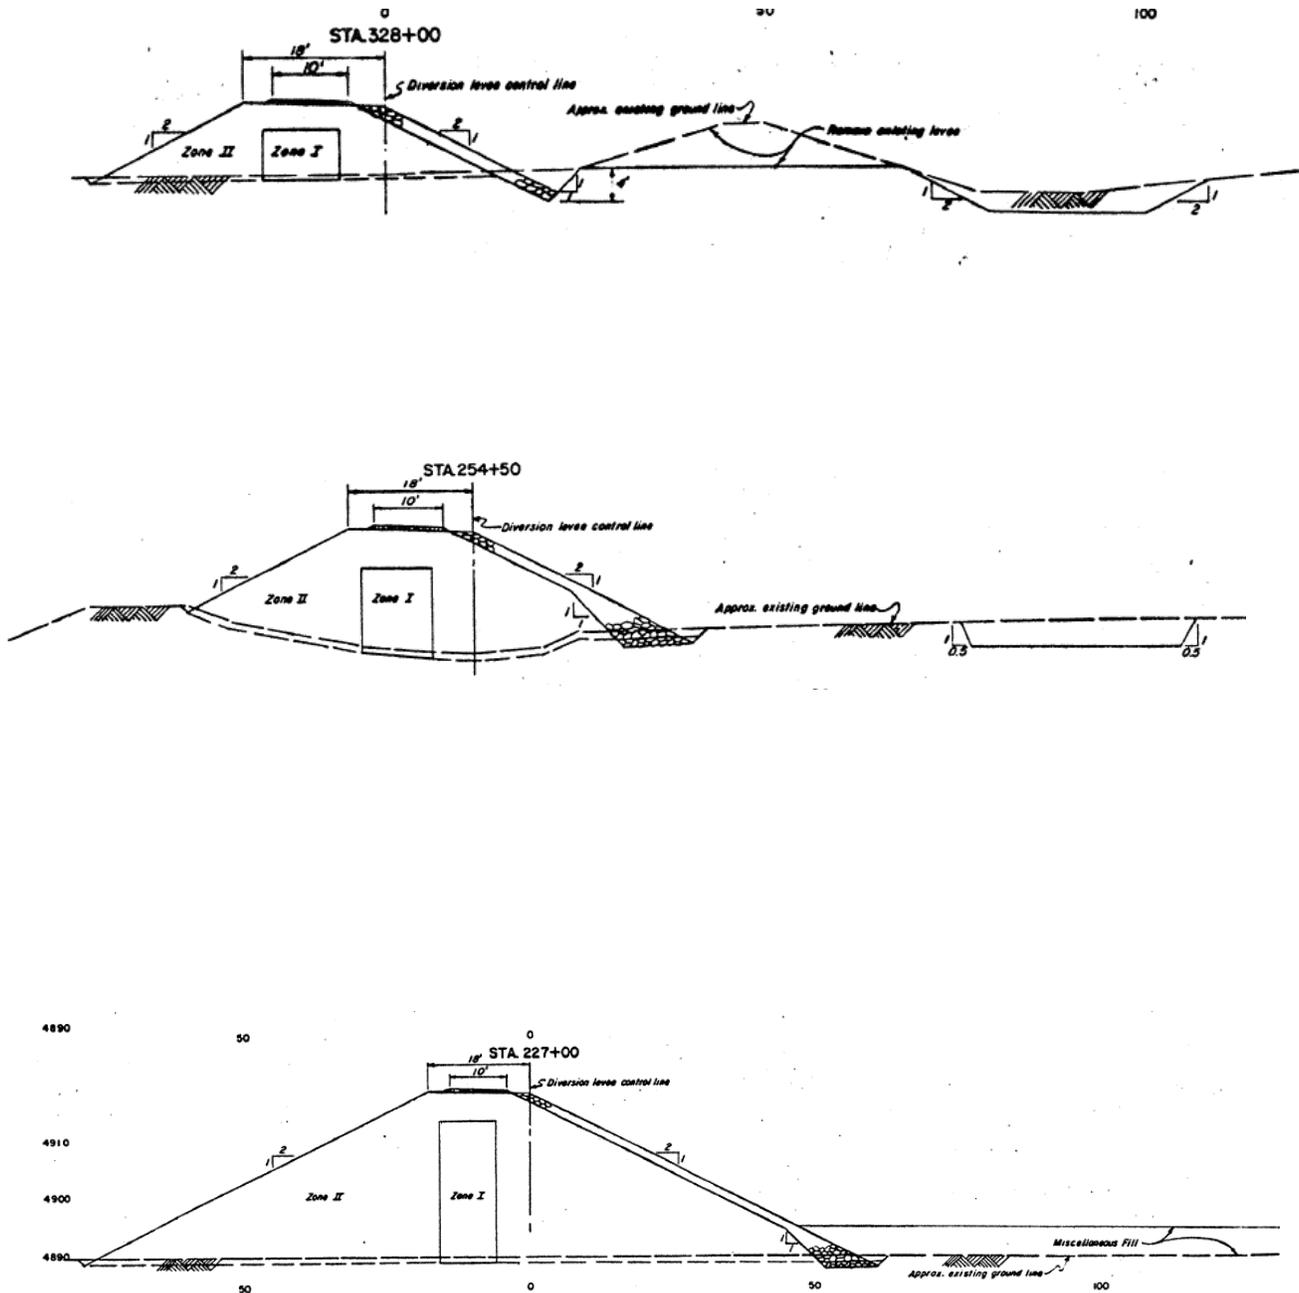
Fig. 37. Typical Ruby Wash Diversion Levee cross sections, at sta. 227+00, where the levee is tall and the diversion channel is a fill zone; at sta. 254+50, where the levee is less tall, and the diversion channel is an excavation, and sta. 328+00, where the old levee has to be demolished. Note the 2:1 riverside and landside side slopes, the 1:1 side slopes leading into the toe down, the tow-down depth, the riverside facing of riprap, and the zones of the earthen fill levee (zones I and II). From project as-builts, sheet 9, available as [attachment 6](#) to this report).
