**APPENDIX C**  
*Final Restoration Plan*

**Final Restoration Plan  
for the Otay River Estuary Restoration Project**

**MAY 2014**

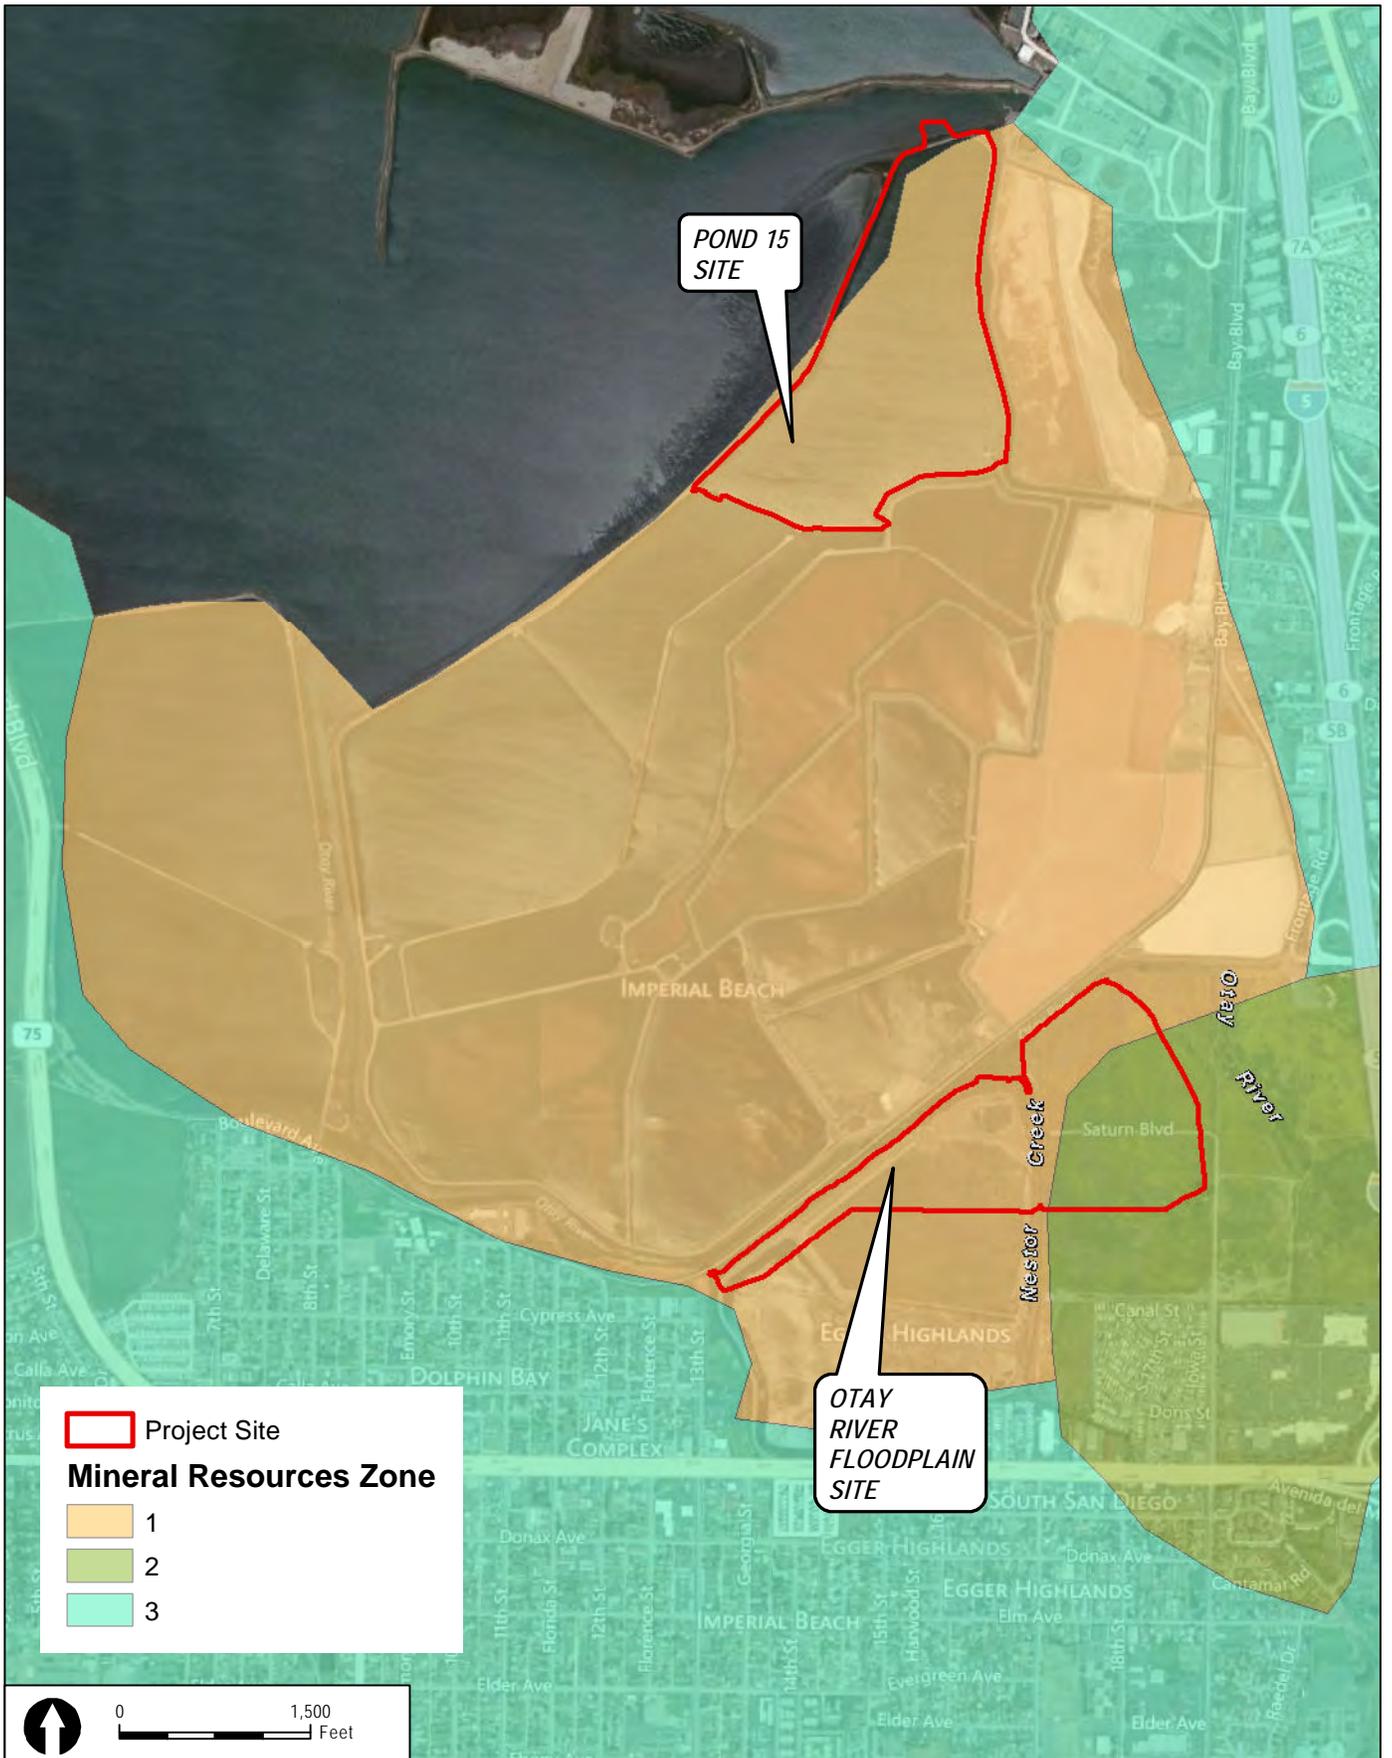
**FIGURE 4**  
**Mineral Resource Zones**

Mineral Resource Zones for the City of San Diego, which indicate the probability of an area having valuable mineral resources, are shown in Figure 4. Although Pond 15 Site is a part of the salt production at the Salt Works, the area is not classified as Mineral Resource Zone. The Otay River Floodplain Site is classified by the City of San Diego as a Mineral Resource Zone 1, which is considered an area where no significant mineral deposits are present, or where it is judged that there is little likelihood for their presence (City of San Diego 2008). No mineral resources of value are expected to occur on the Otay River Floodplain Site.

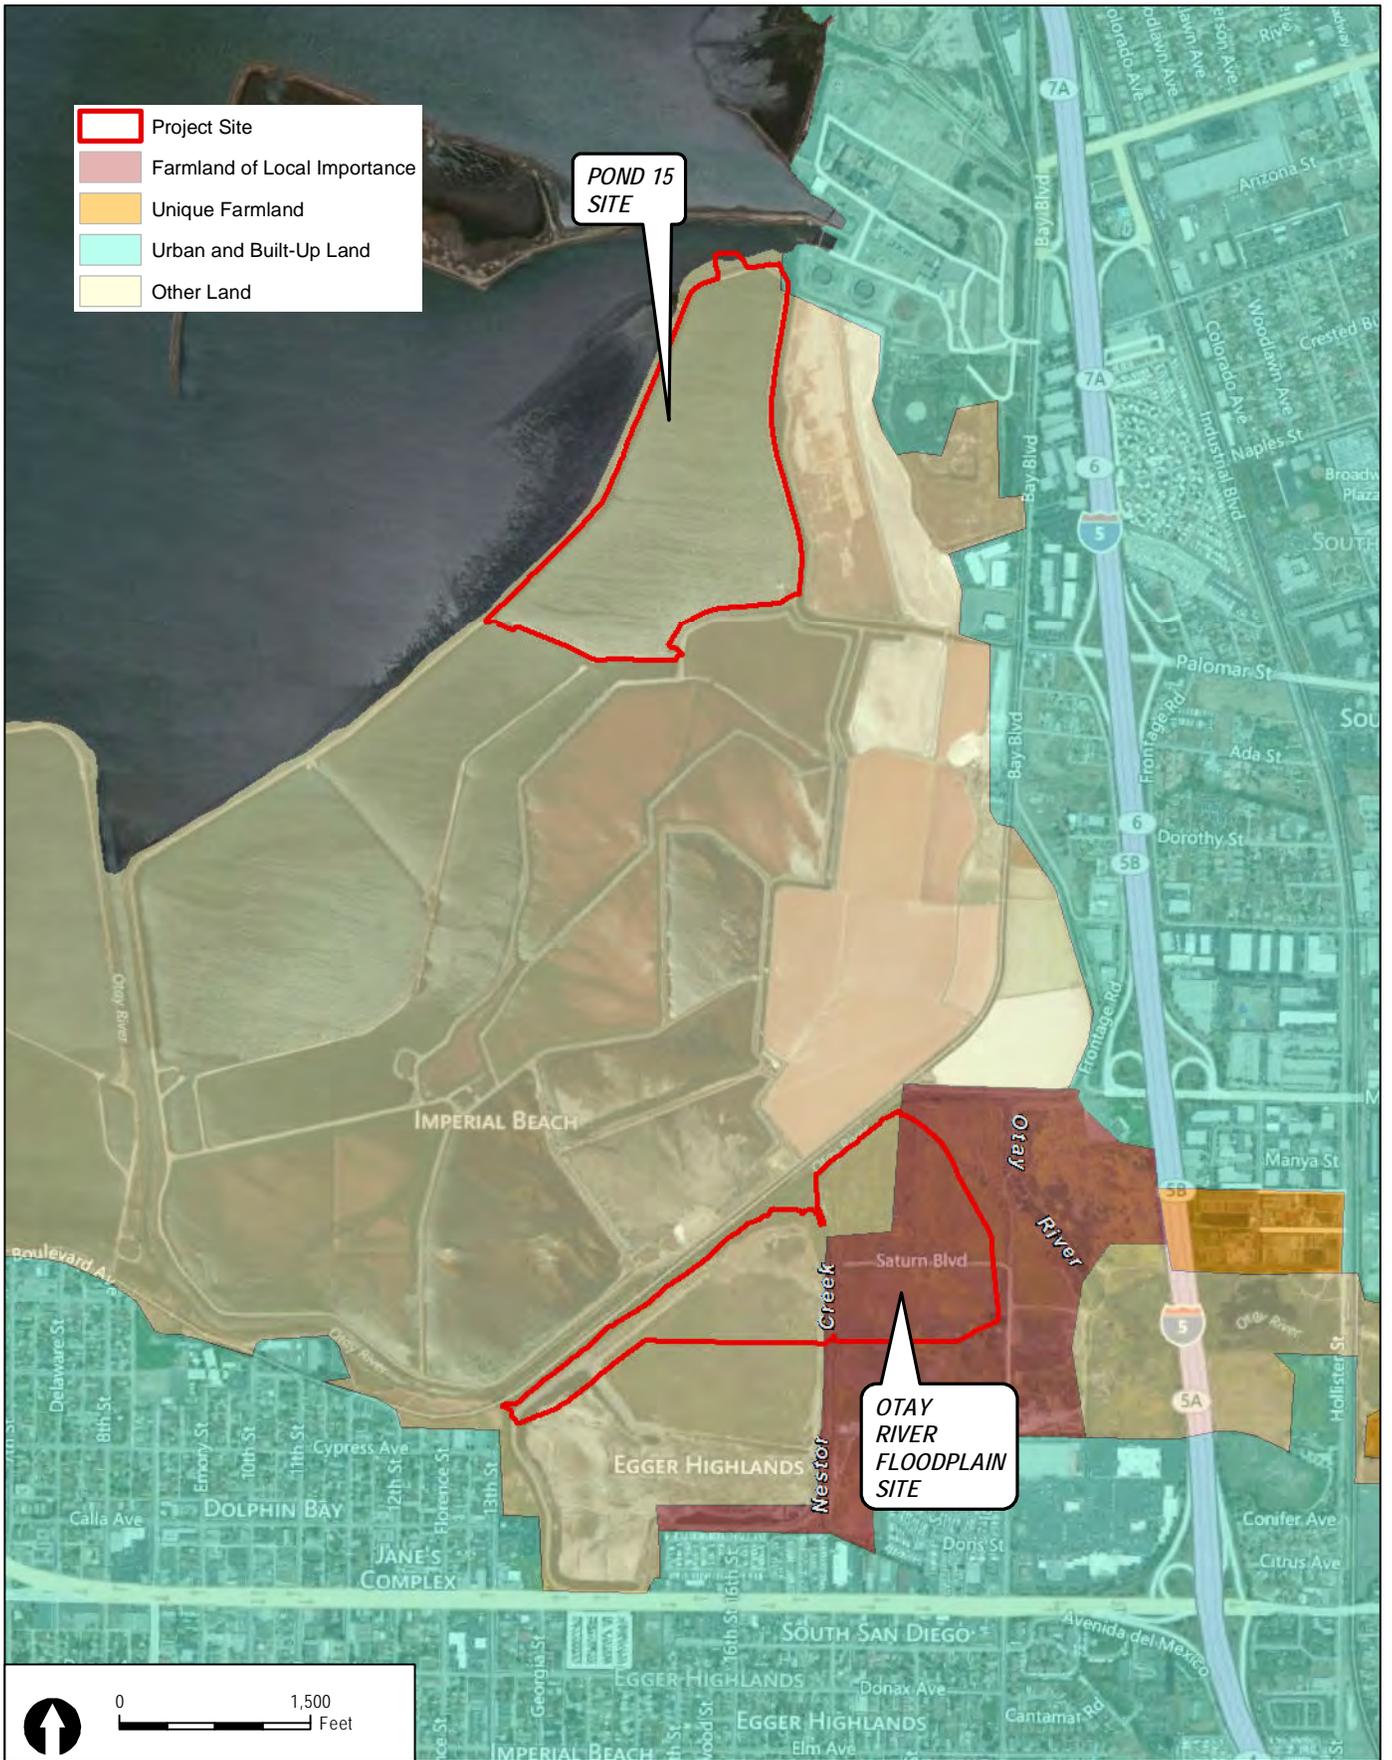
**FIGURE 5**  
**Farmland Mapping and Monitoring Program Designations**

Both the County of San Diego and the City of San Diego have experienced a loss in available agriculture land from the expansion of urban development. The areas designated as important agricultural resources by the Department of Conservation Farmland Mapping and Monitoring Program are identified in Figure 5. The best soils for agricultural production in San Diego County are primarily located in the western inland areas and in northern parts of the County. In the City of San Diego, agriculture is primarily located in the San Pasqual Valley where it represents over 30% of the land use (City of San Diego 2008). Portions of the Otay River floodplain were identified as Prime Farmland in 1998 according to the California Department of Conservation. Prime Farmland is defined as land with the best combination of physical and chemical characteristics able to sustain long-term production of agricultural crops (USFWS 2006a). However, in 2008 these portions of the Otay River floodplain were designated as Farmland of Local Importance, which is described as land that meets all the characteristics of Prime Farmland and Farmland of Statewide Importance, with the exception of irrigation. The soils of these lands are suited for truck crops and orchard crops and have a history of good production for locally adapted crops of significant economic importance to the County (California Department of Conservation 2011).

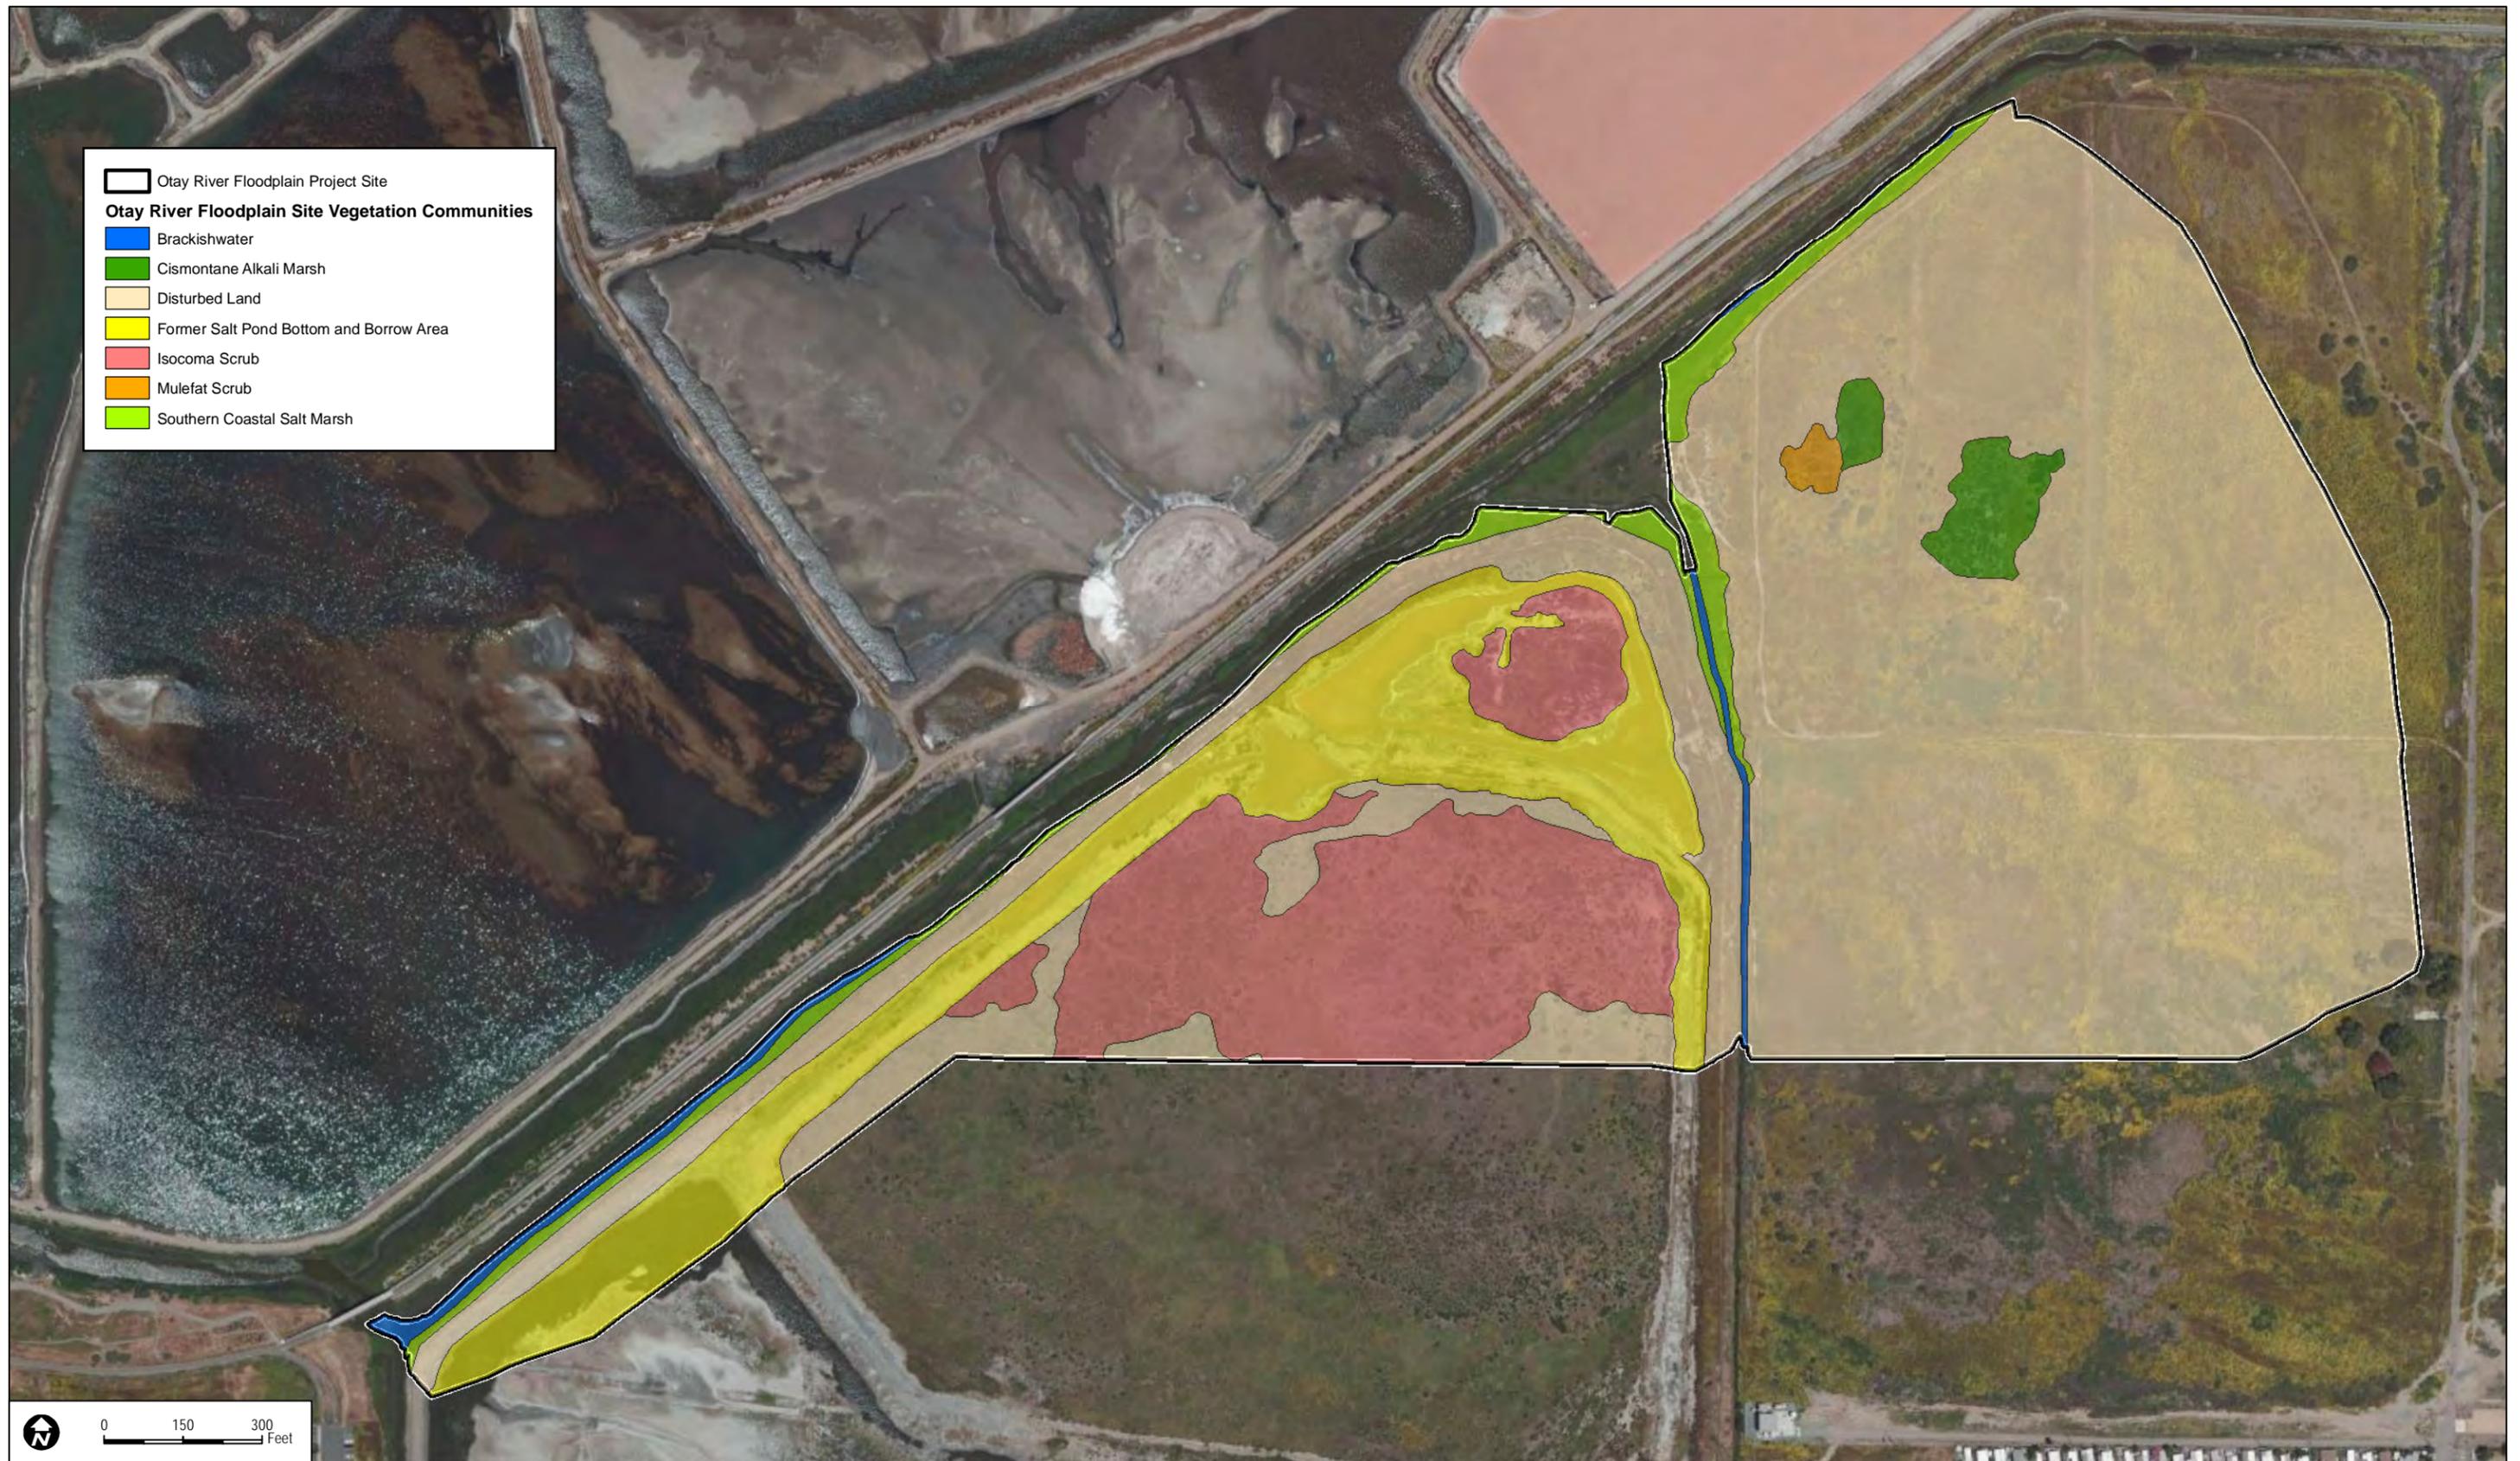
**Figure 6**  
**Otay River Floodplain Site Vegetation Communities**

*Isocoma* scrub is dominated by coast goldenbush (*Isocoma menziesii*). The stands of *Isocoma* scrub vegetation on the site, which occur to the west of Nestor Creek, form a sparse to open shrub layer. The overall height of these shrubs varies from 0–3 feet and overall vegetation shrub cover is approximately 50%. There are a few patches of coast cholla (*Opuntia prolifera*) within the community, but the community lacks diversity, and is predominantly composed of a nearly monotypic stand of coast goldenbush in the shrub layer. The understory is predominantly composed of non-native annual weeds such as filaree (*Erodium* spp.), mustard (*Brassica nigra*; *Hirschfeldia incana*), tocalote (*Centaurea melitensis*), and annual grasses (*Bromus* spp., *Avena* spp.).

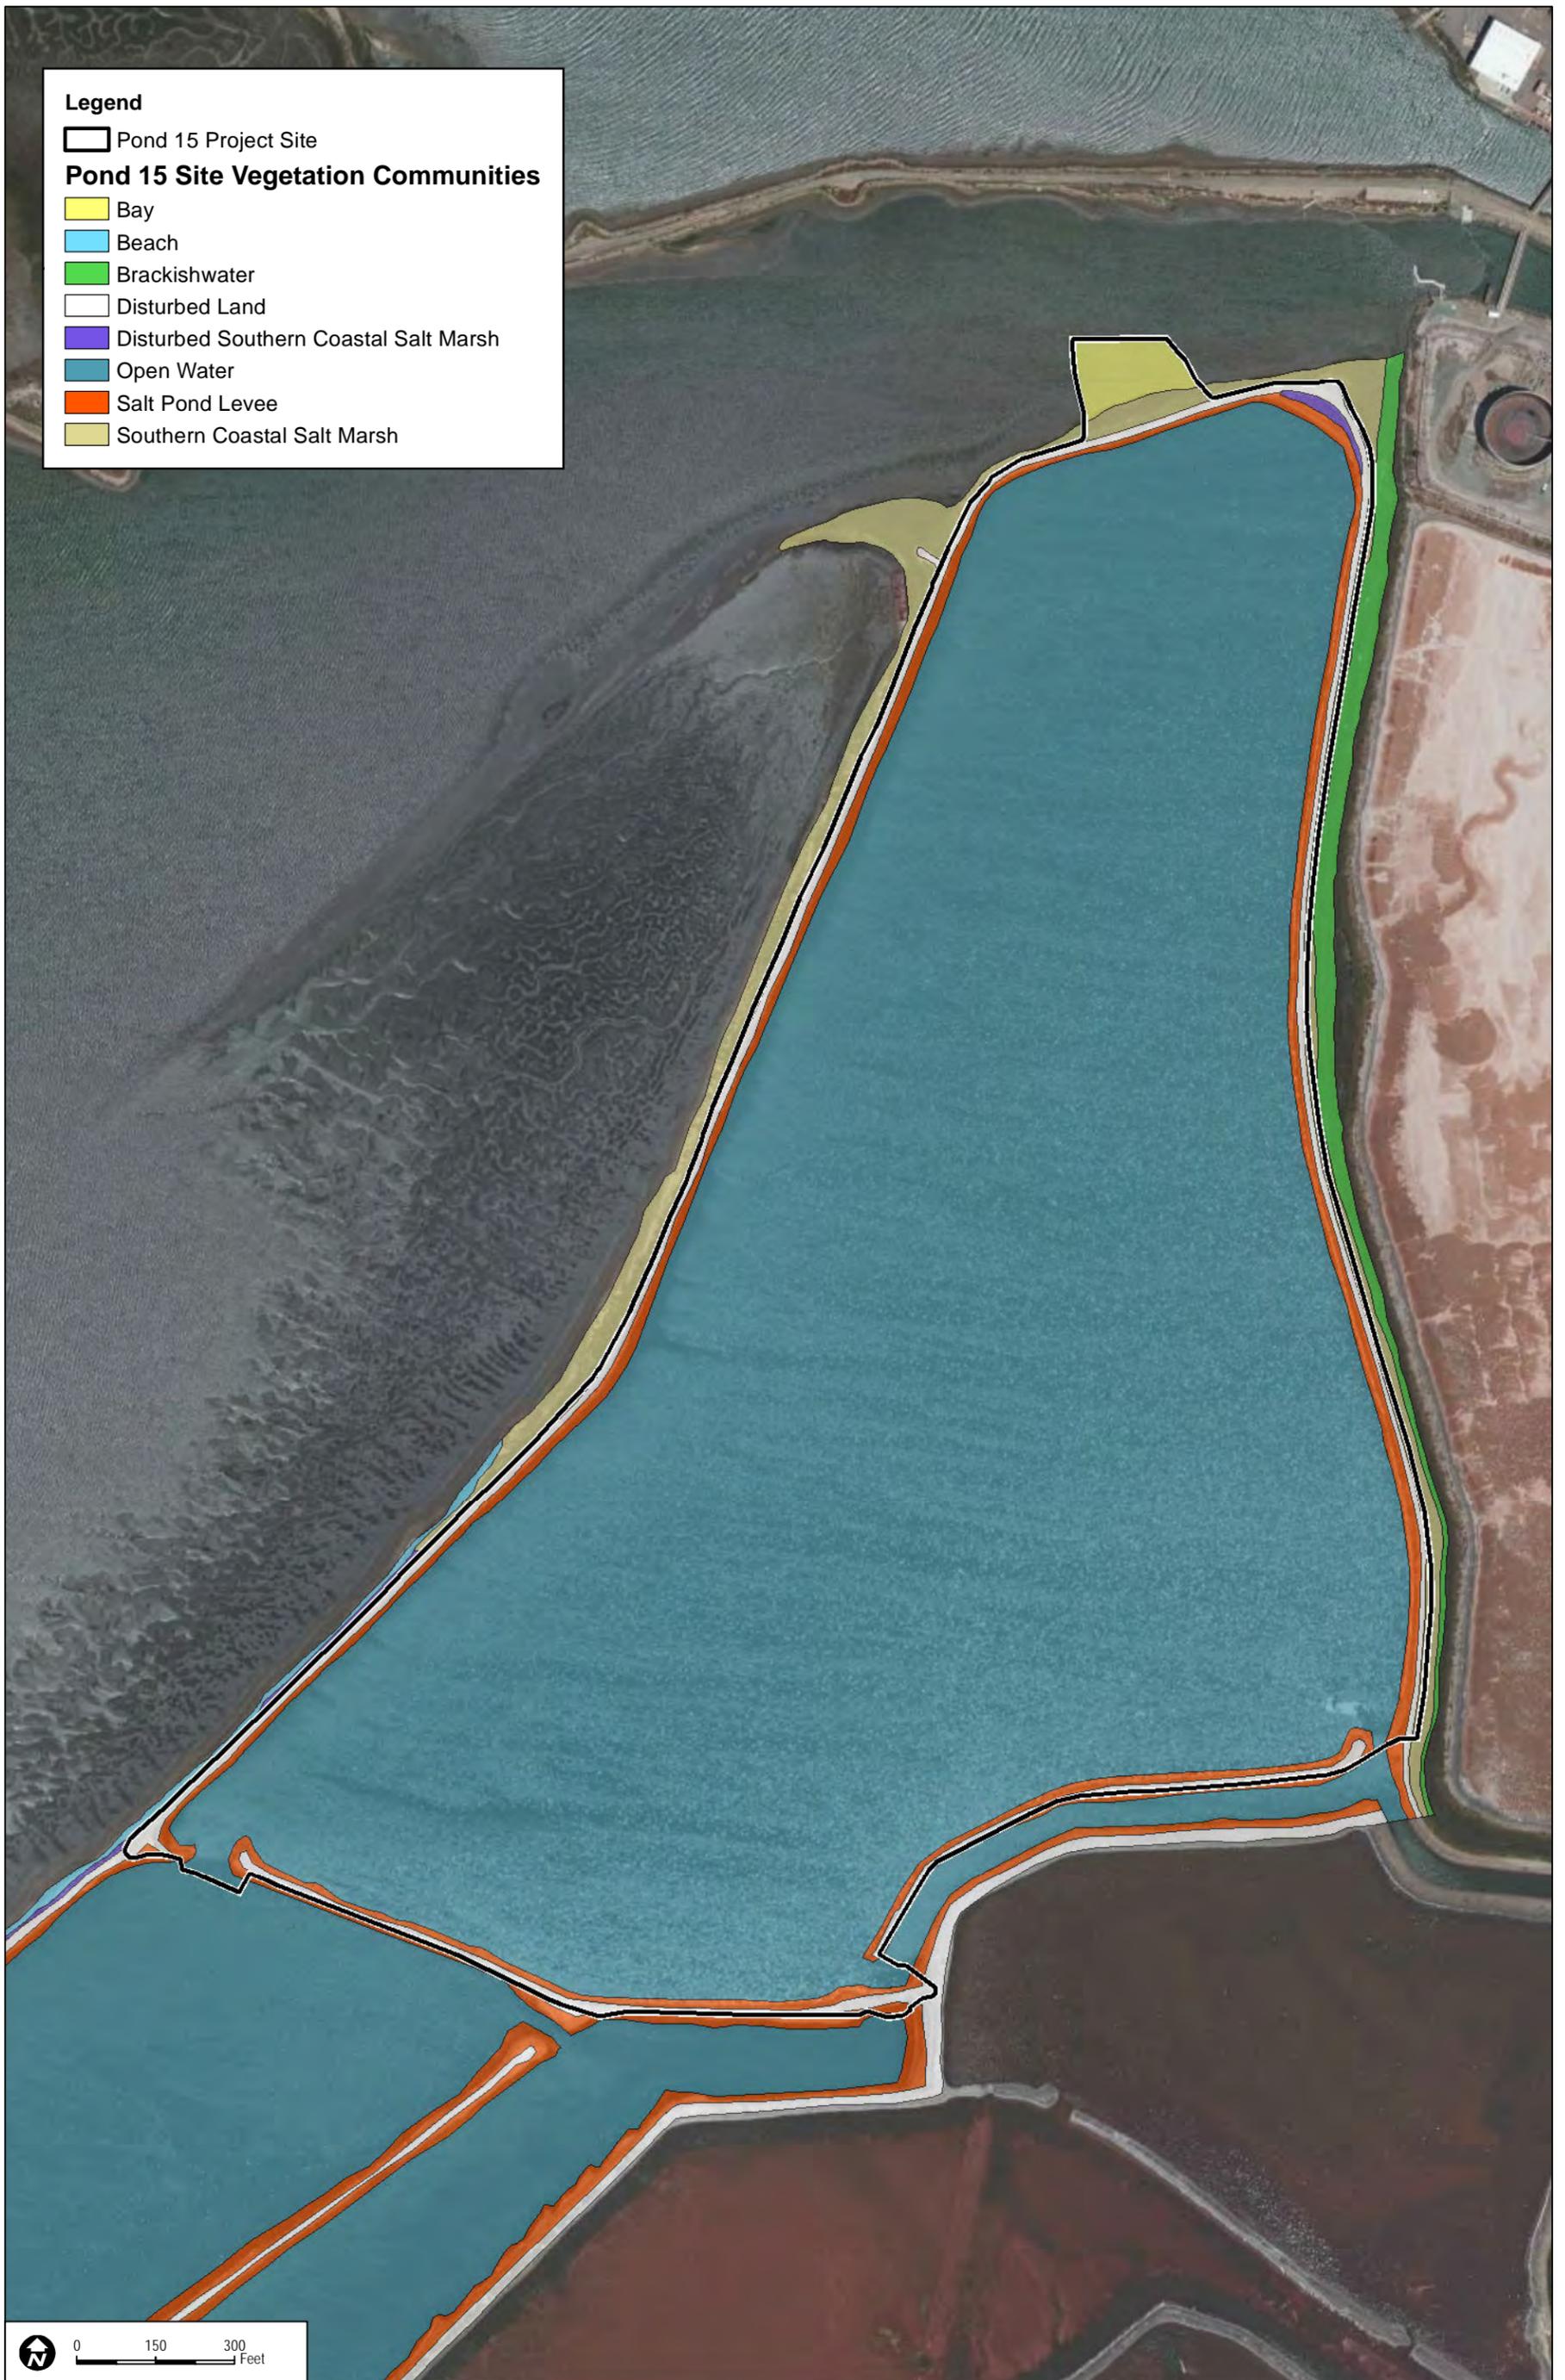
**FIGURE 7**  
**Pond 15 Site Vegetation Communities**

The salt pond levees separate the salt ponds for controlling the salinity as part of the salts works operation. The levees vary in the degree to which they are compacted with the lower and outer edges being less compacted, and the surfaces intended for vehicle access being more compacted. Areas with less compaction occasionally support disjunct patches of vegetation, while the compacted areas are devoid of vegetation. Areas intended for driving access that are devoid of vegetation were classified as disturbed habitat (see below) to distinguish them in the context of regulated versus non-regulated jurisdictional areas. Patchy vegetation occurring on the salt pond levees consists of a combination of native and non-native species. Native species that occur on the levees are typical of middle and upper salt marsh habitat, such as salt grass, seaheath, glasswort, and seepweed. Non-native species occurring on the levees consists of ice plant (*Mesembryanthemum* spp.), annual grasses (e.g., *Bromus*), as well as patches of Australian saltbrush (*Atriplex semibaccata*).

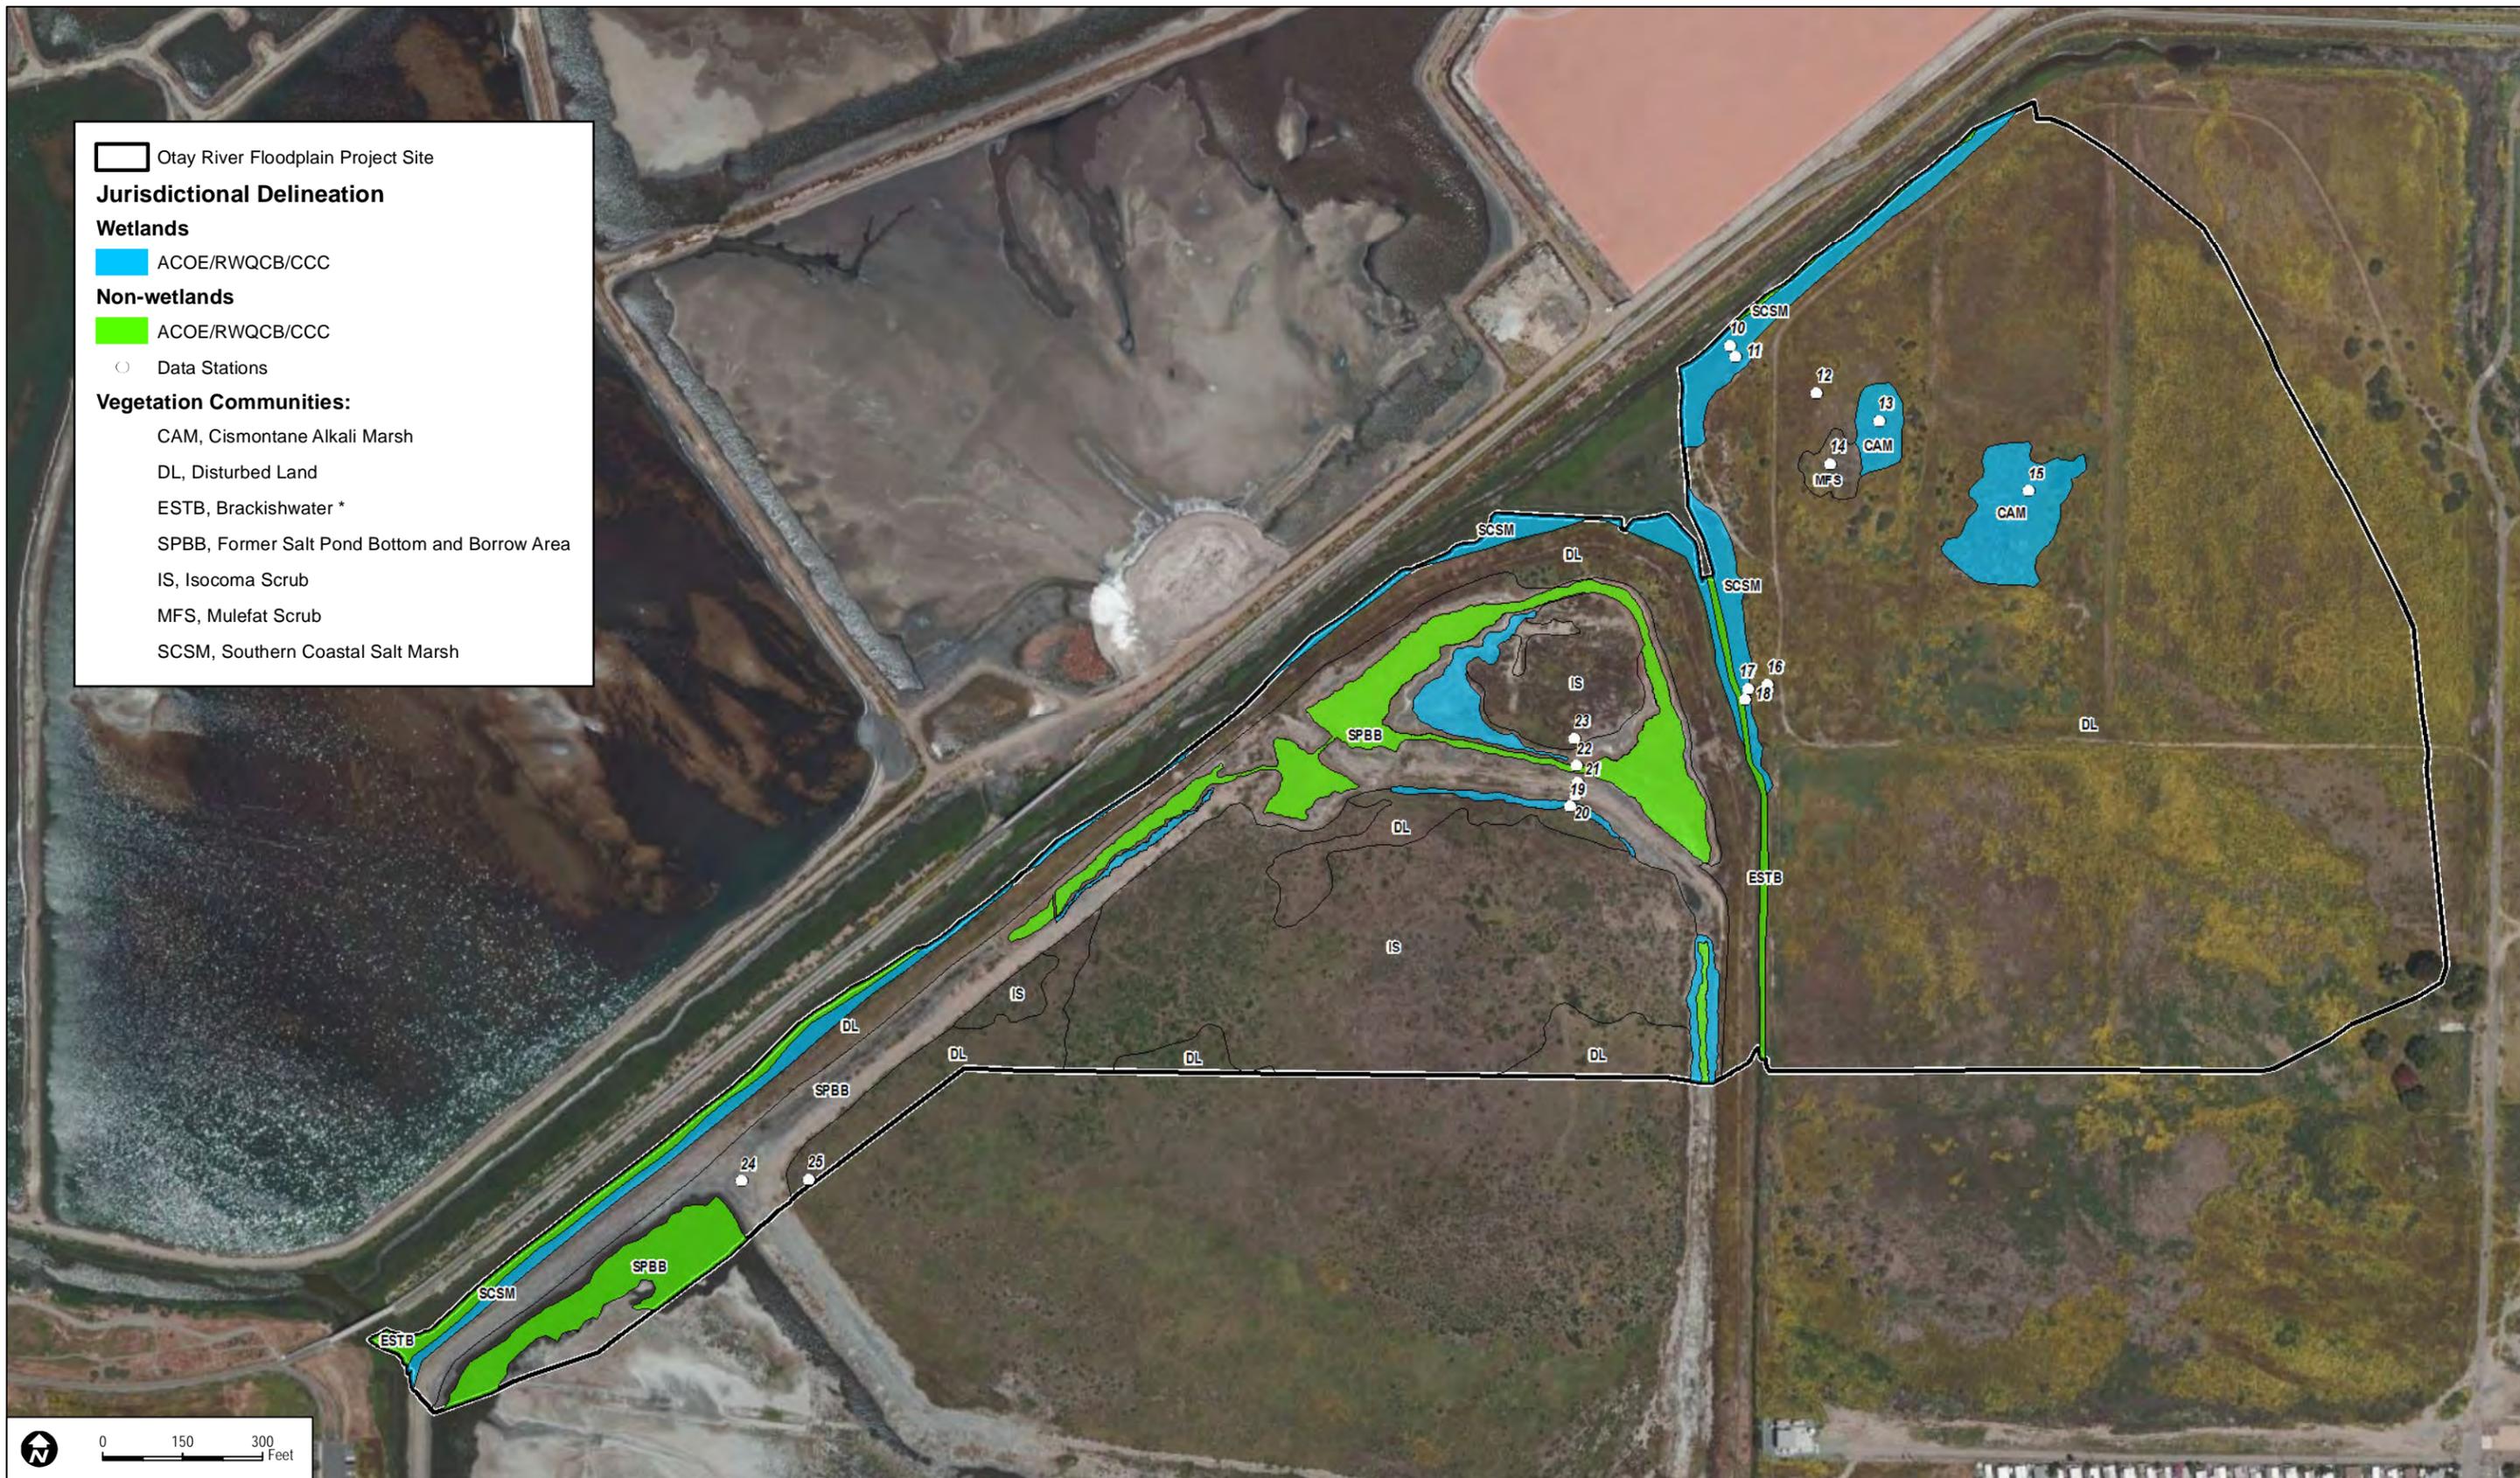
The Otay River Floodplain Site supports two geographically distinct cismontane alkali marsh areas (1.28 acres) that, based on intensive field review, support greater than 50% hydrophytic vegetation and, in some instances, hydric soils but lack hydrology indicators (Table 3). A sewer treatment facility and settling ponds were formerly located in this area. For the purposes of the Preliminary Jurisdictional Delineation (PJD), the ACOE determined that although the areas are more than 700 feet from the hydrophytic vegetation associated with the tidal channel, that these areas were close enough to be considered adjacent wetlands under the ACOE's jurisdiction. These areas also meet the definition of wetland pursuant to Coastal Commission guidelines. However, because these areas are on federal land and because they are more than 700 feet from the tidal channels, CDFW jurisdiction is not presumed.

The western portion of the Otay River Floodplain Site contains a series of low-lying areas that are remnants from the construction and operation of the former industrial salt evaporation pond, as described in section 3.3-1 of this document. The functions and values of these areas are considered degraded and low due to the extensive site disturbance, lack of vegetation, lack of surface water hydrologic connectivity, and excessive salinity.

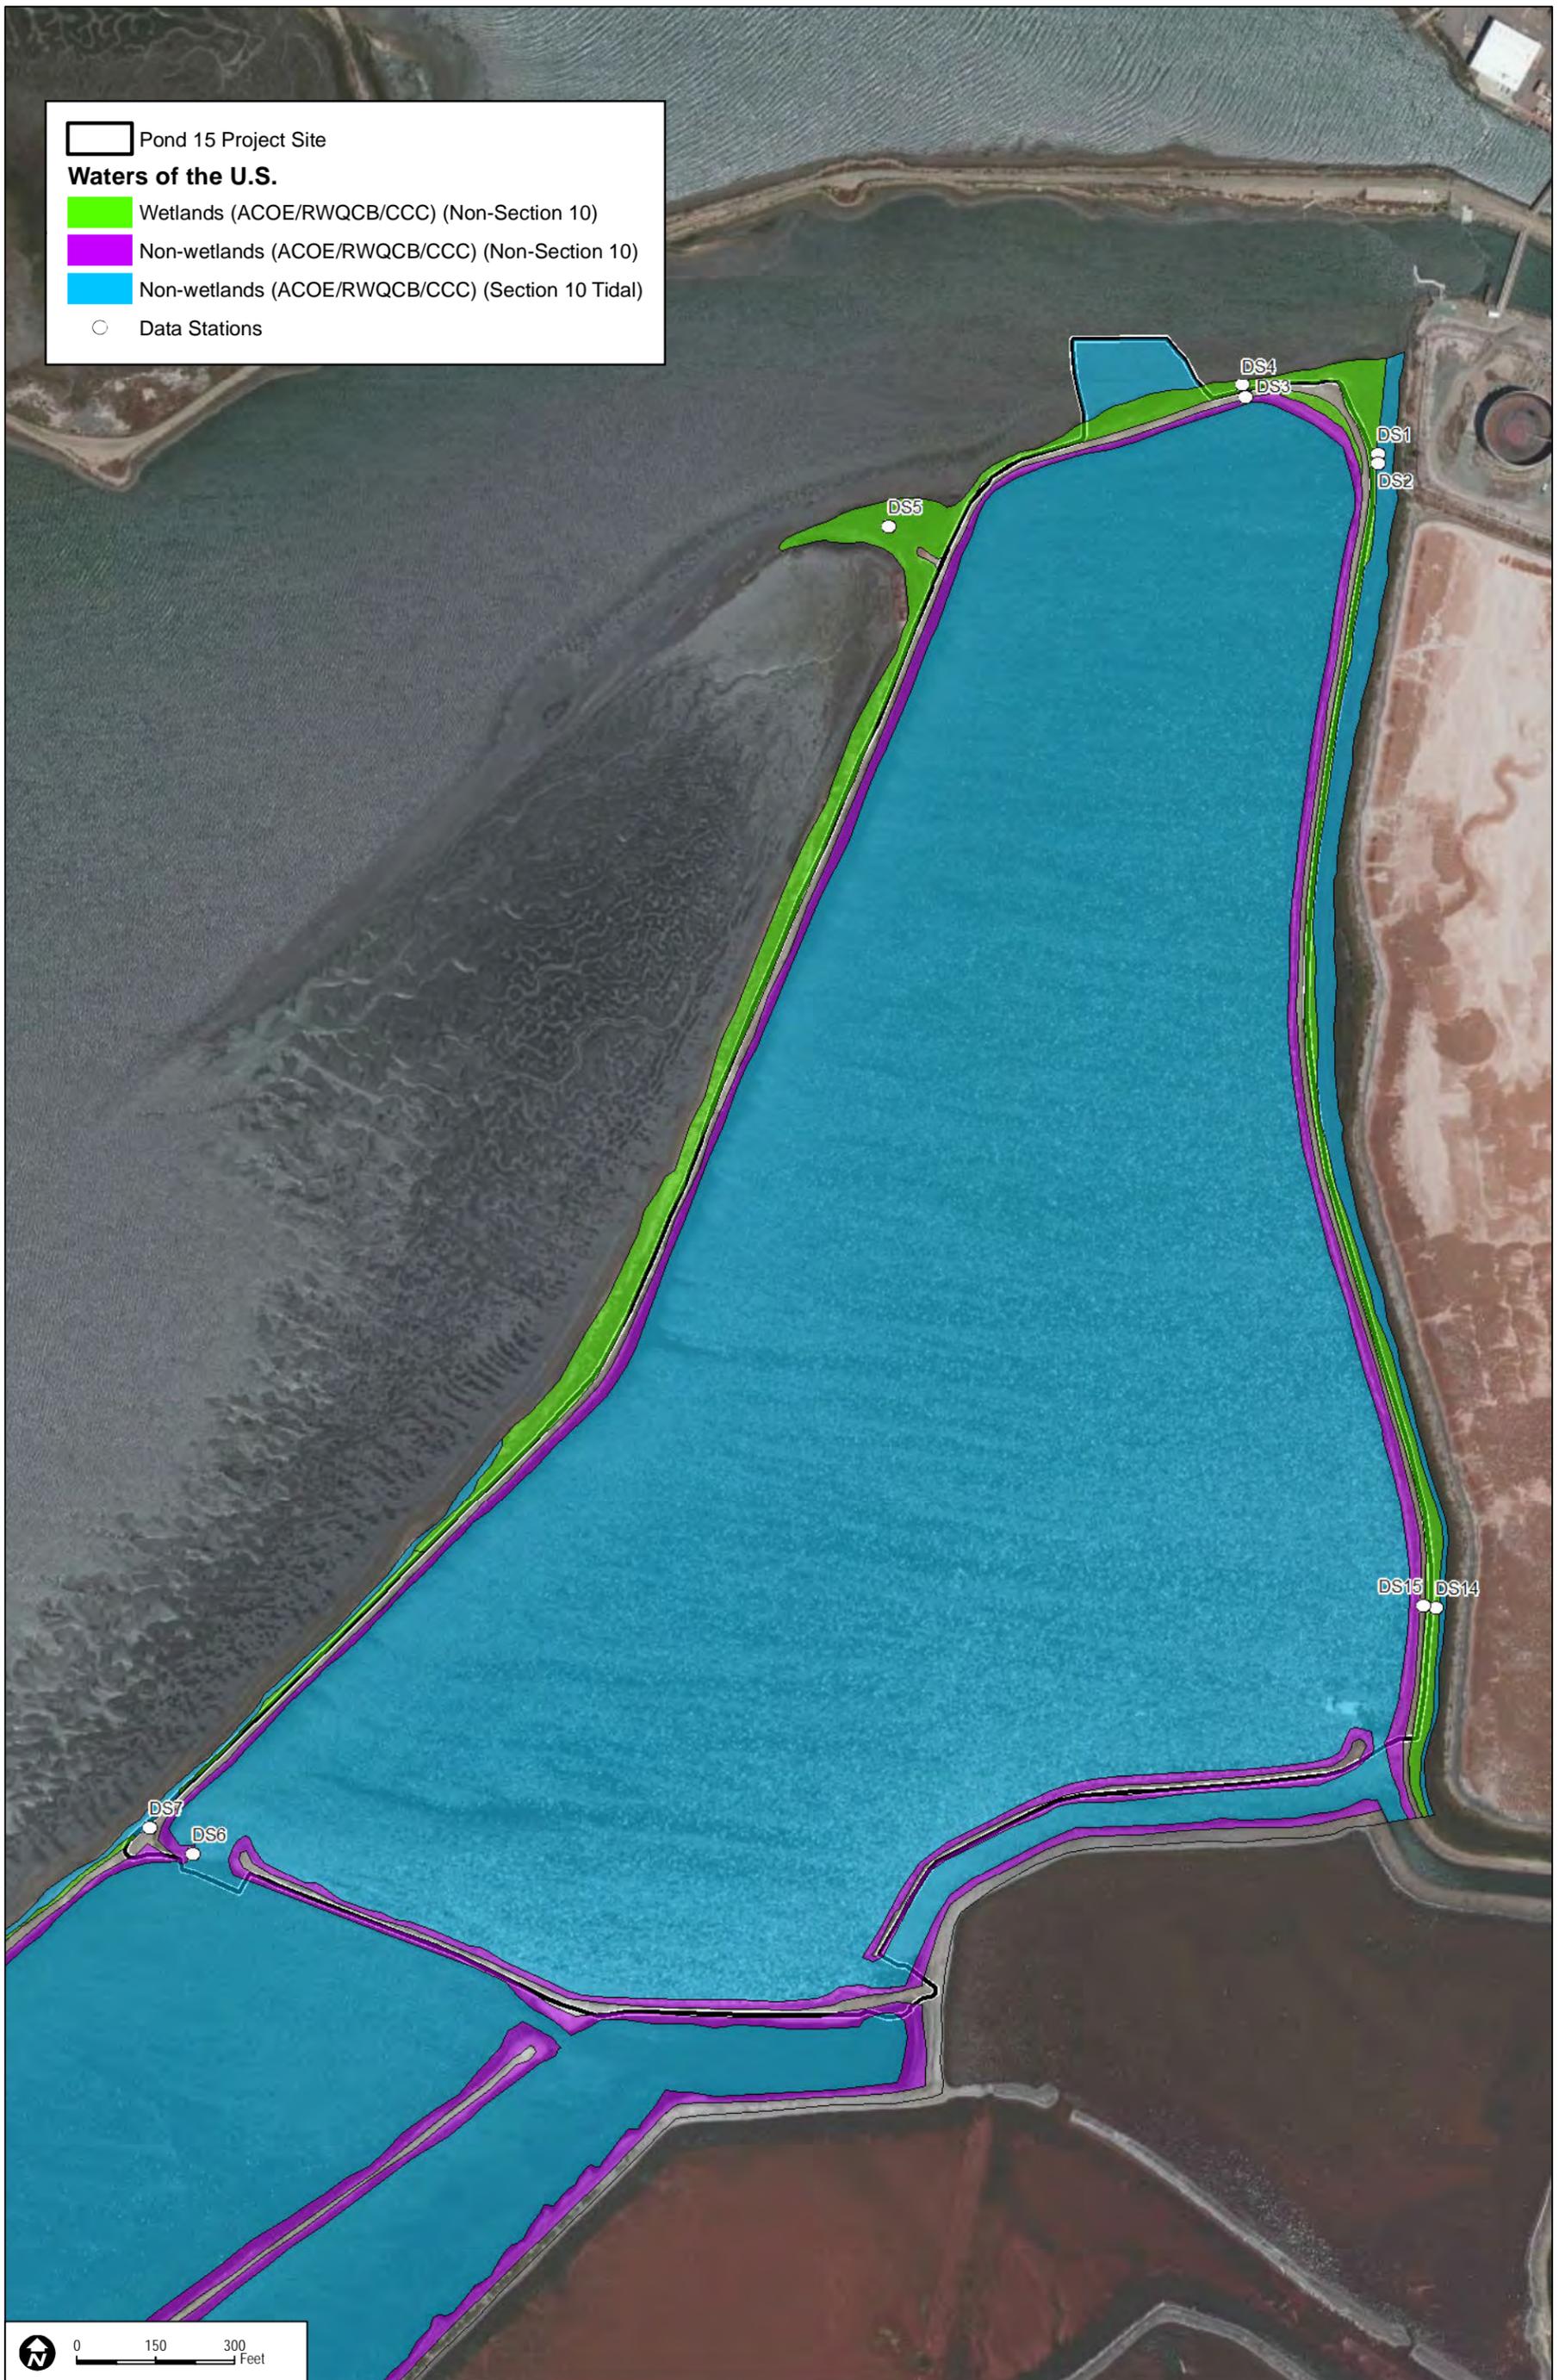
**FIGURE 9**  
**Pond 15 Site Jurisdictional Delineation**

Vegetation Community	Jurisdiction
	<i>ACOE, RWQCB, Coastal Commission</i>
Open Water (Brines)	82.24
Salt Pond Levee	3.57
Southern Coastal Salt Marsh	0.84
Disturbed Southern Coastal Salt Marsh	0.10
Bay	0.59
Beach	0.01
<b>Total</b>	<b>87.35</b>
