**APPENDIX C**  
*Final Restoration Plan*

**Final Restoration Plan  
for the Otay River Estuary Restoration Project**

**MAY 2014**

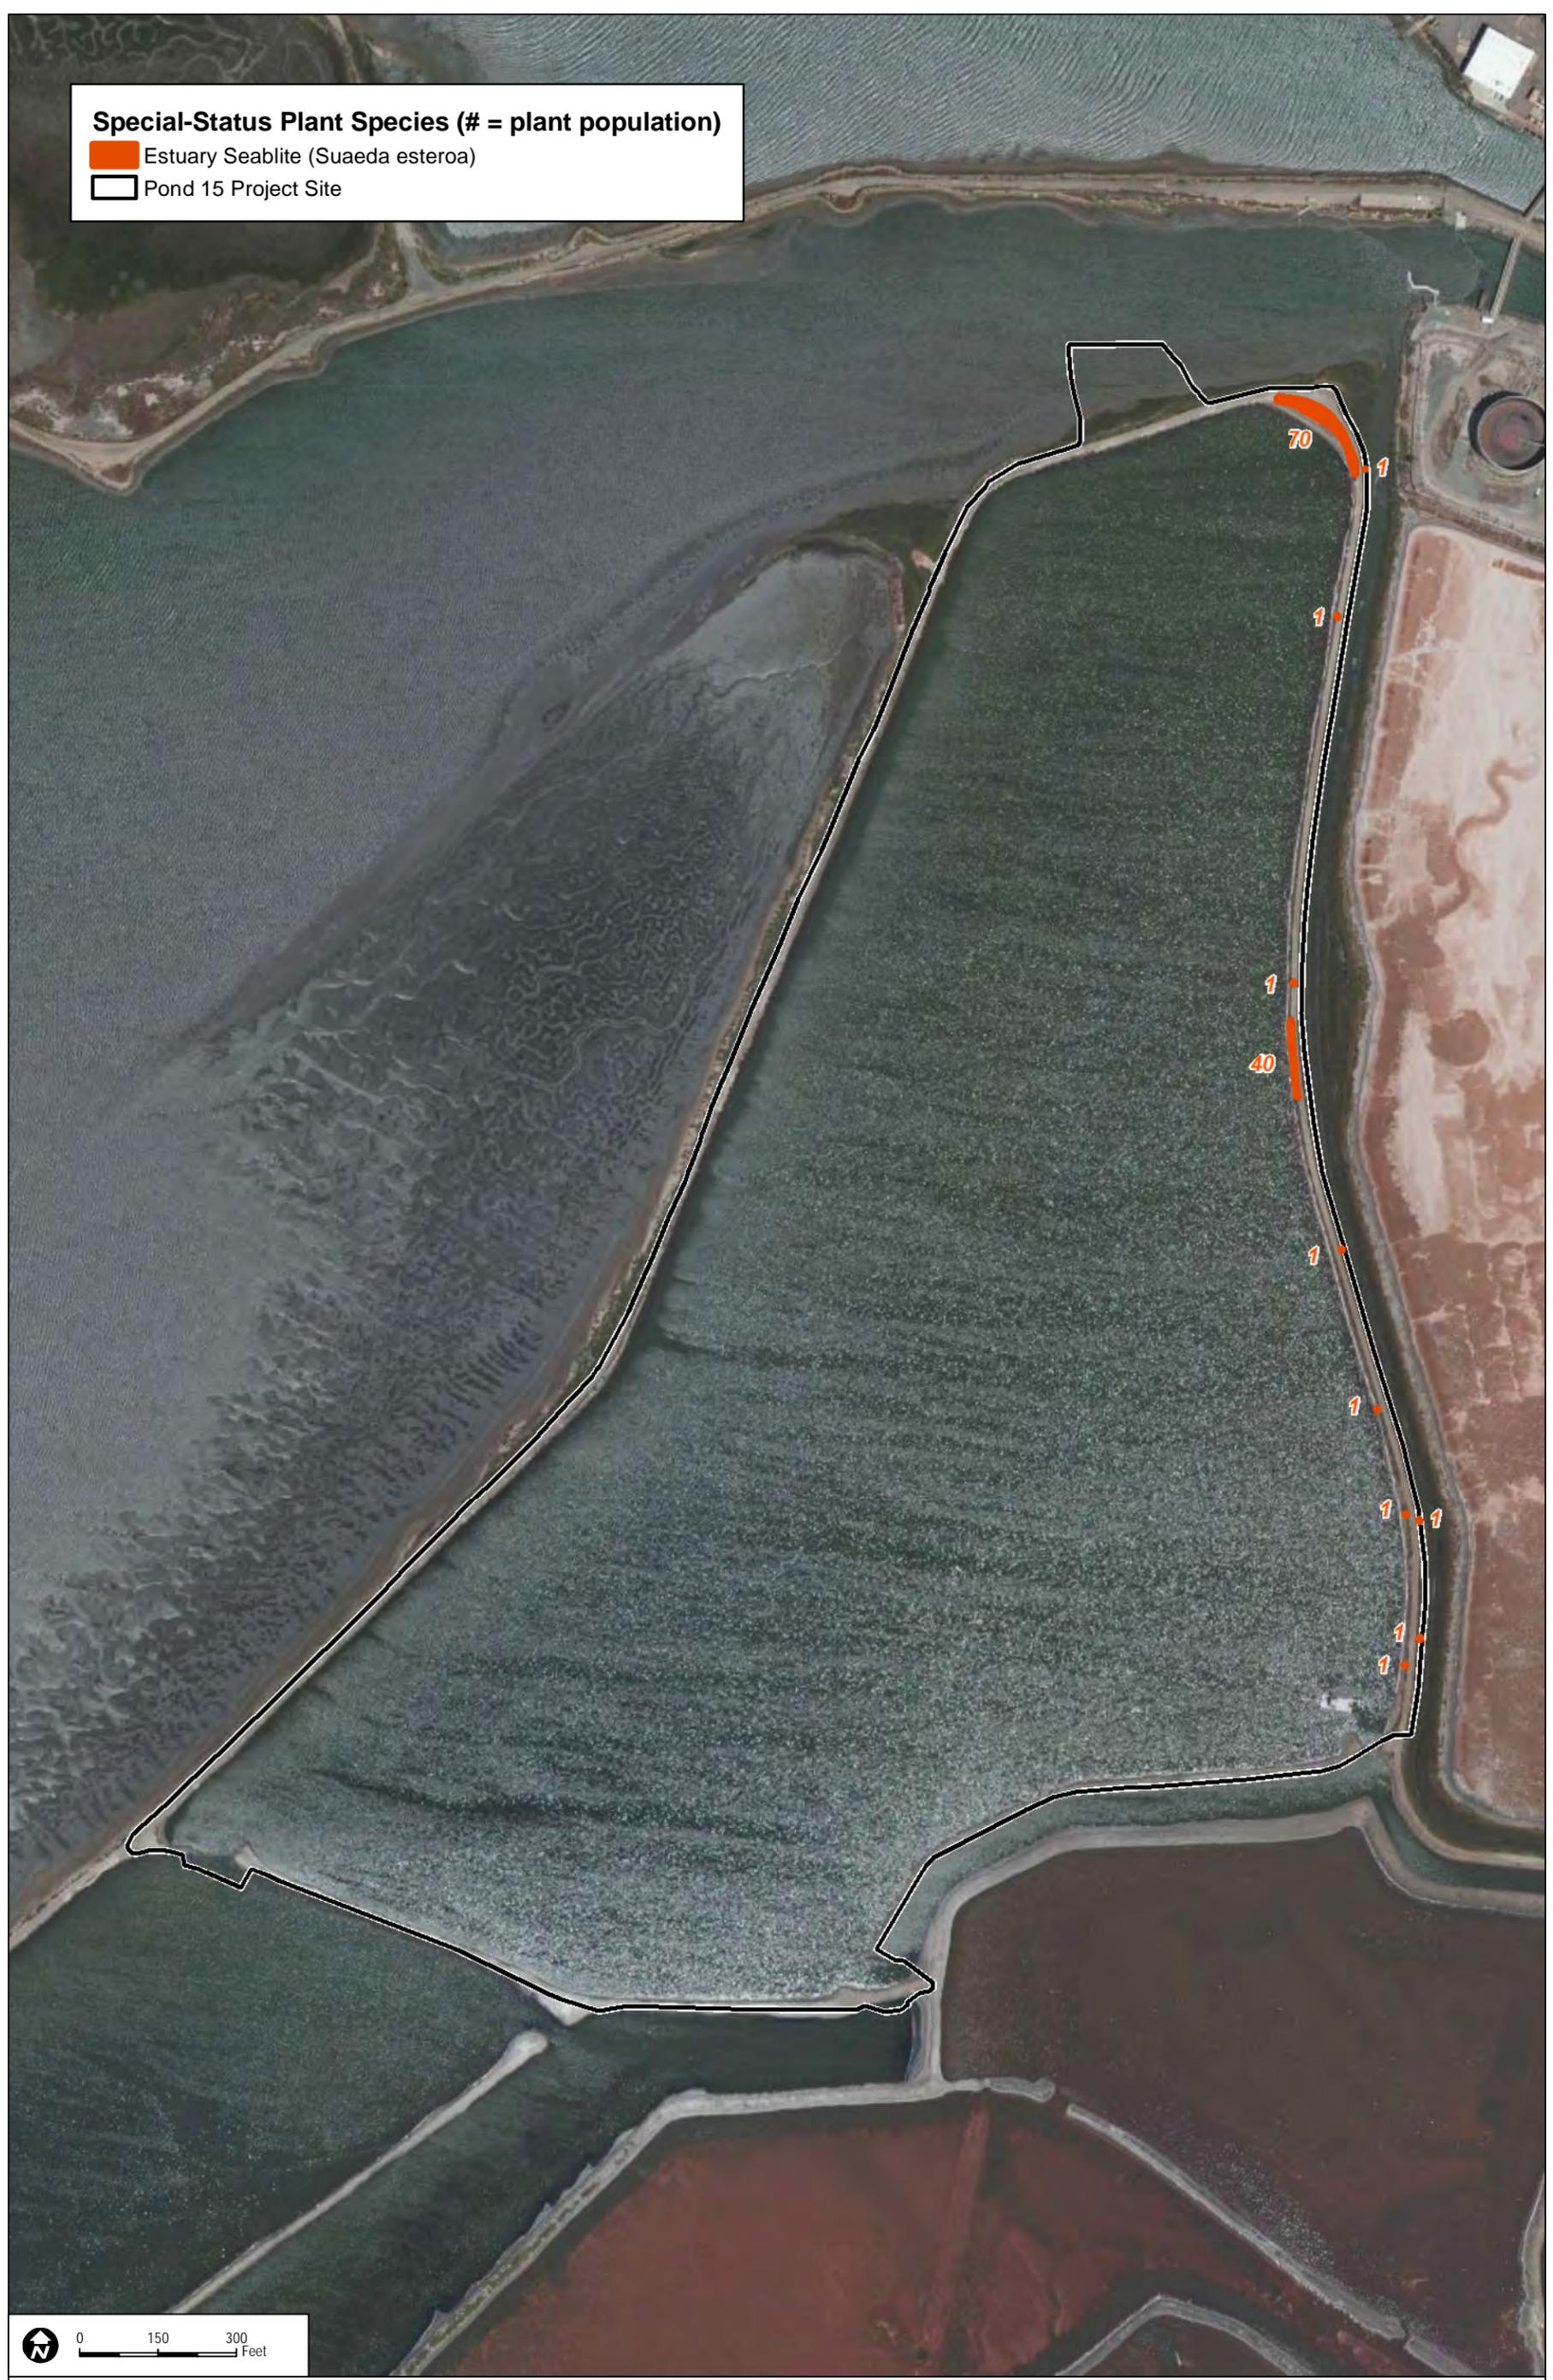
**FIGURE 11**  
**Pond 15 Site Special-Status Plant Species**

- Estuary Seablite (*Suaeda esteroa*)
- Pond 15 Project Site

Scientific Name	Common Name	Status Federal/State/MSCP	Rare Plant Rank	Primary Habitat Associations/ Life Form/Blooming Period/Elevation Range	Status on Site or Potential to Occur
<i>Juncus acutus</i> <i>spp. leopoldii</i>	Southwestern spiny rush	None/None/None	4.2	Coastal dunes (mesic), meadows and alkaline seeps, coastal saltwater marshes and swamps/rhizomatous herb/May–June/<3000 feet	Observed during focused plant survey (Figure 10).
<i>Lycium californicum</i>	California box-thorn	None/None/None	4.2	Costal bluff scrub, coastal scrub/perennial shrub/December–August/15–590 feet	Observed during focused plant survey (Figure 10).
<i>Suaeda esteroa</i>	Estuary seablite	None/None/None	1B.2	Coastal salt marshes and swamps/perennial herb/May–October (Jan)/< 20 feet	Observed during focused plant survey (Figure 10).
<i>Suaeda taxifolia</i>	woolly seablite	None/None/None	4.2	Coastal bluff scrub, coastal dunes, Marshes and swamps (margins of coastal salt)/perennial evergreen shrub/January–December/0–165 feet	Observed during focused plant survey (Figure 11).

Scientific Name	Common Name	Status Federal/State/MSCP	Rare Plant Rank	Primary Habitat Associations/ Life Form/Blooming Period/Elevation Range	Status on Site or Potential to Occur
<i>Suaeda esteroa</i>	Estuary seablite	None/None/None	1B.2	Coastal salt marshes and swamps/perennial herb/May–October (Jan)/< 20 feet	Observed during focused plant survey (Figure 11).

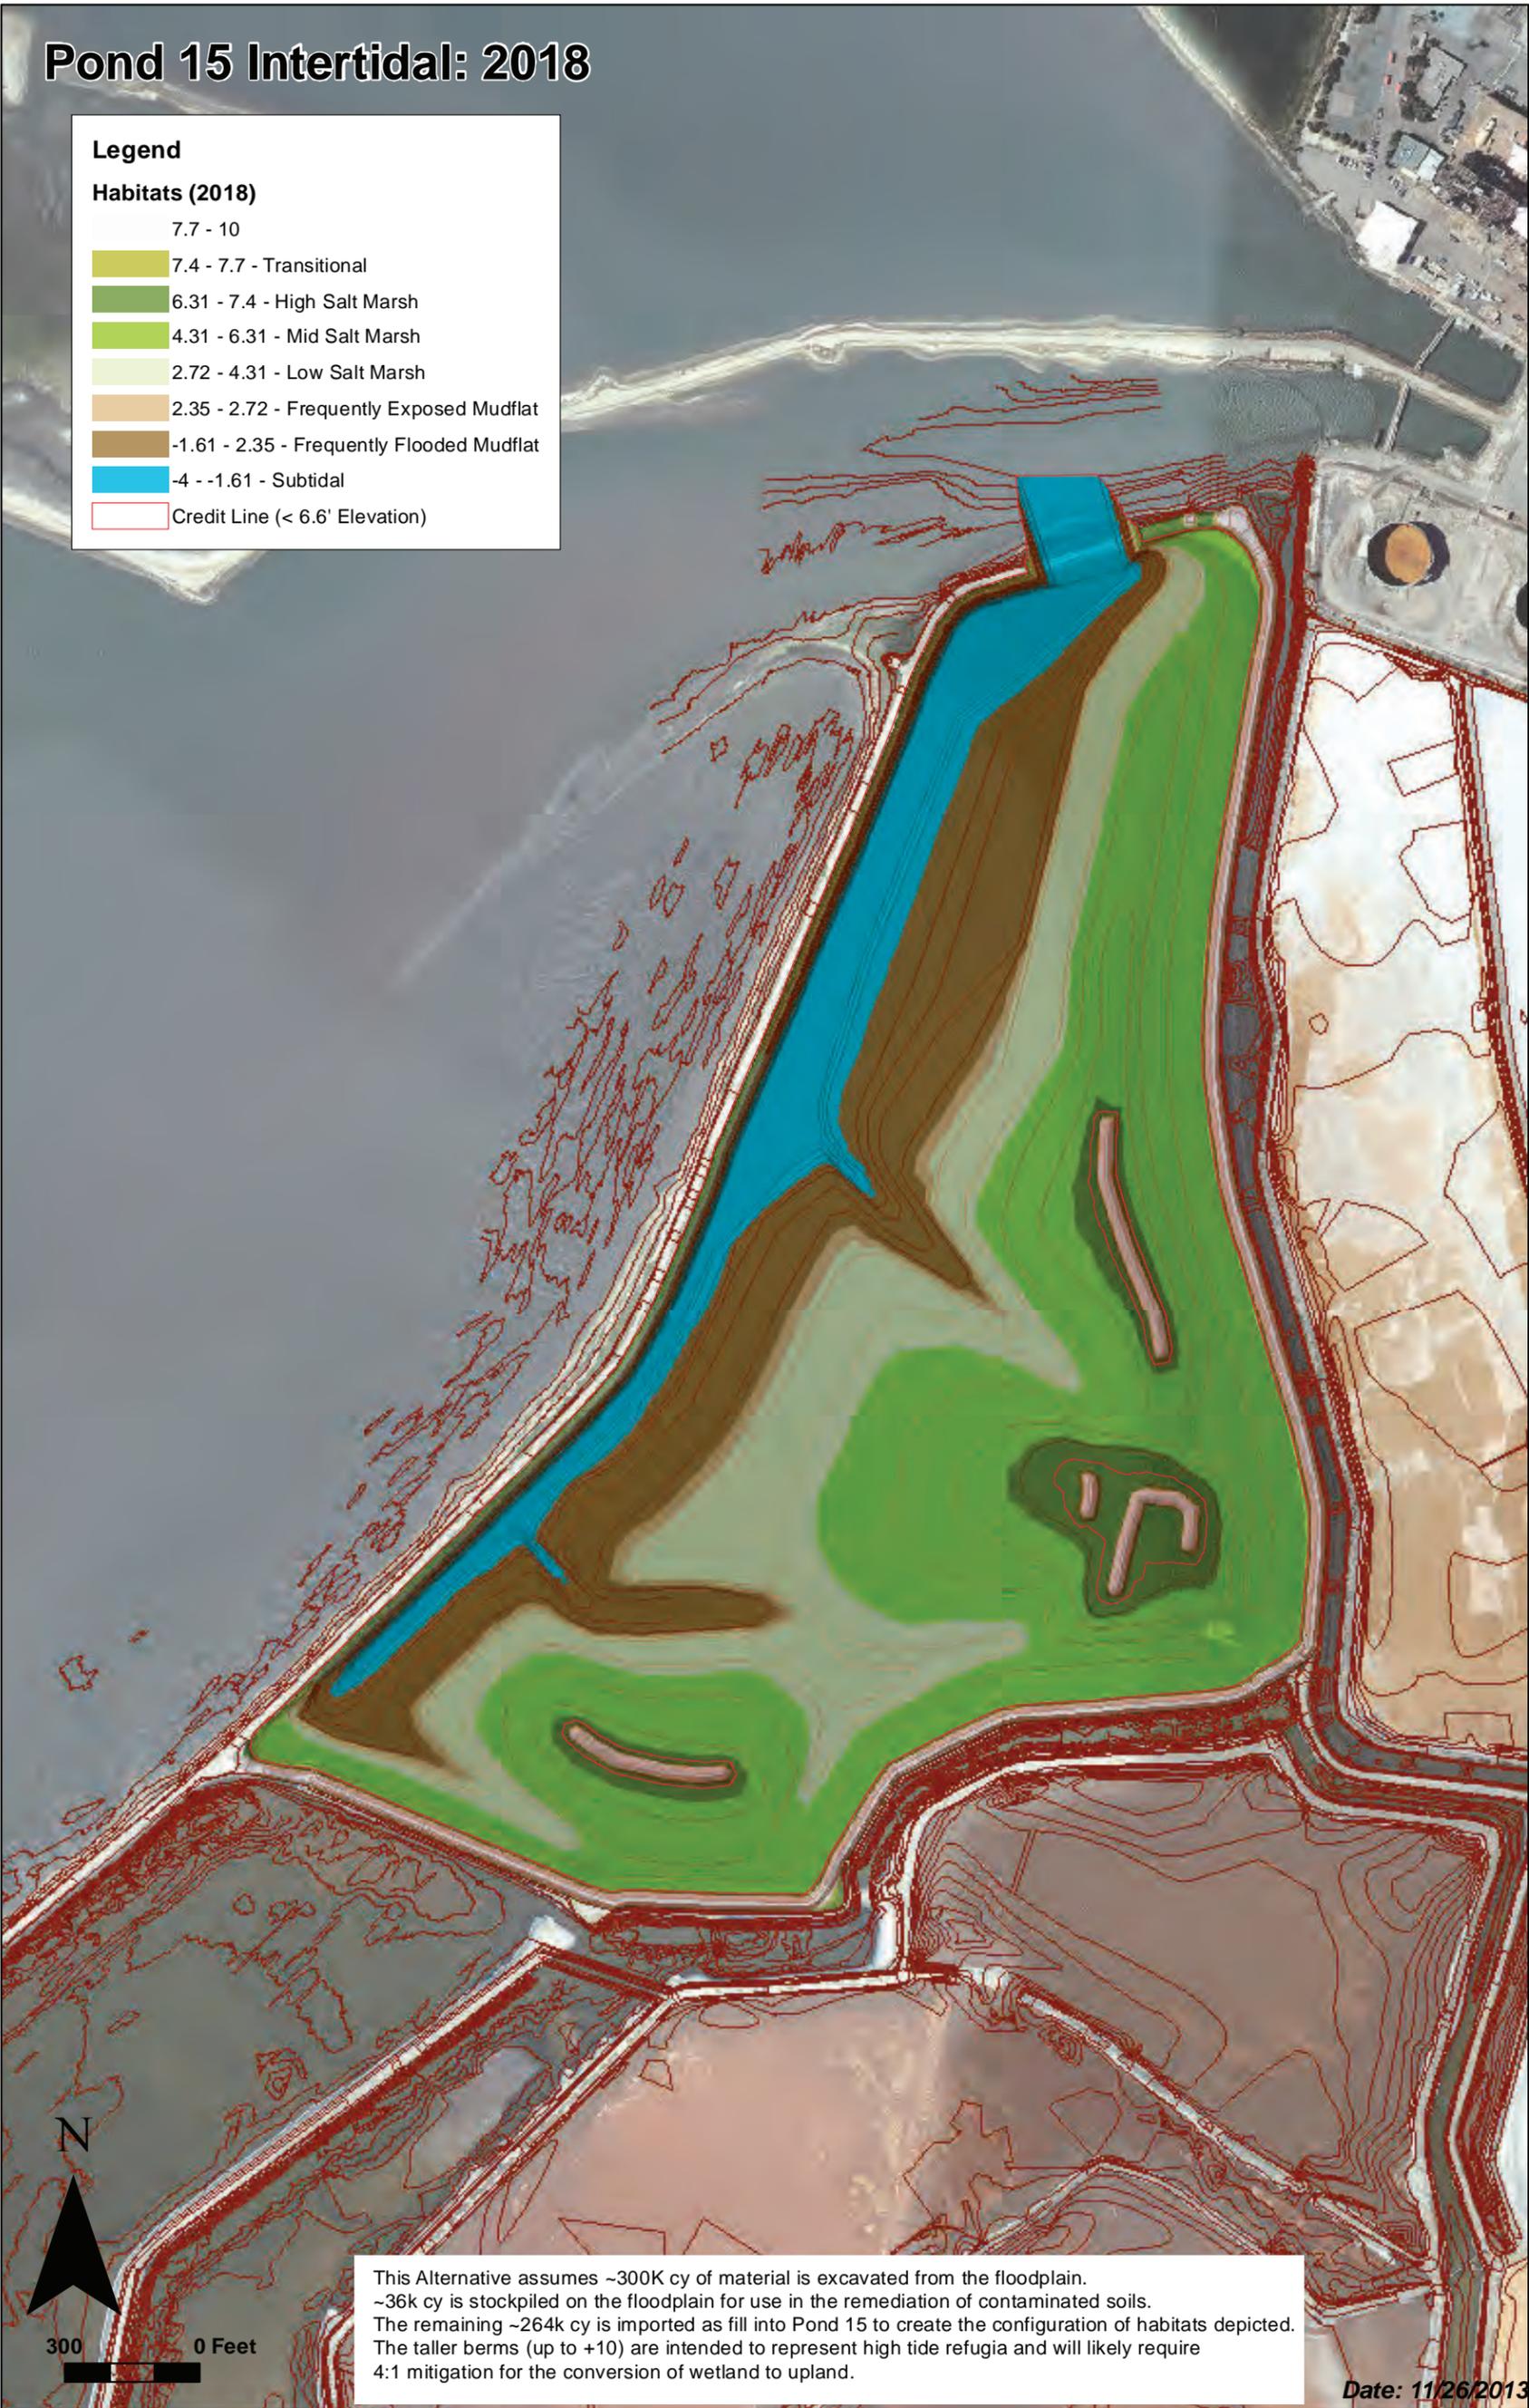
This Alternative assumes ~300K cy of material is excavated from the floodplain. ~36k cy is stockpiled on the floodplain for use in the remediation of contaminated soils. The remaining ~264k cy is imported as fill into Pond 15 to create the configuration of habitats depicted. The taller berms (up to +10) are intended to represent high tide refugia and will likely require 4:1 mitigation for the conversion of wetland to upland.

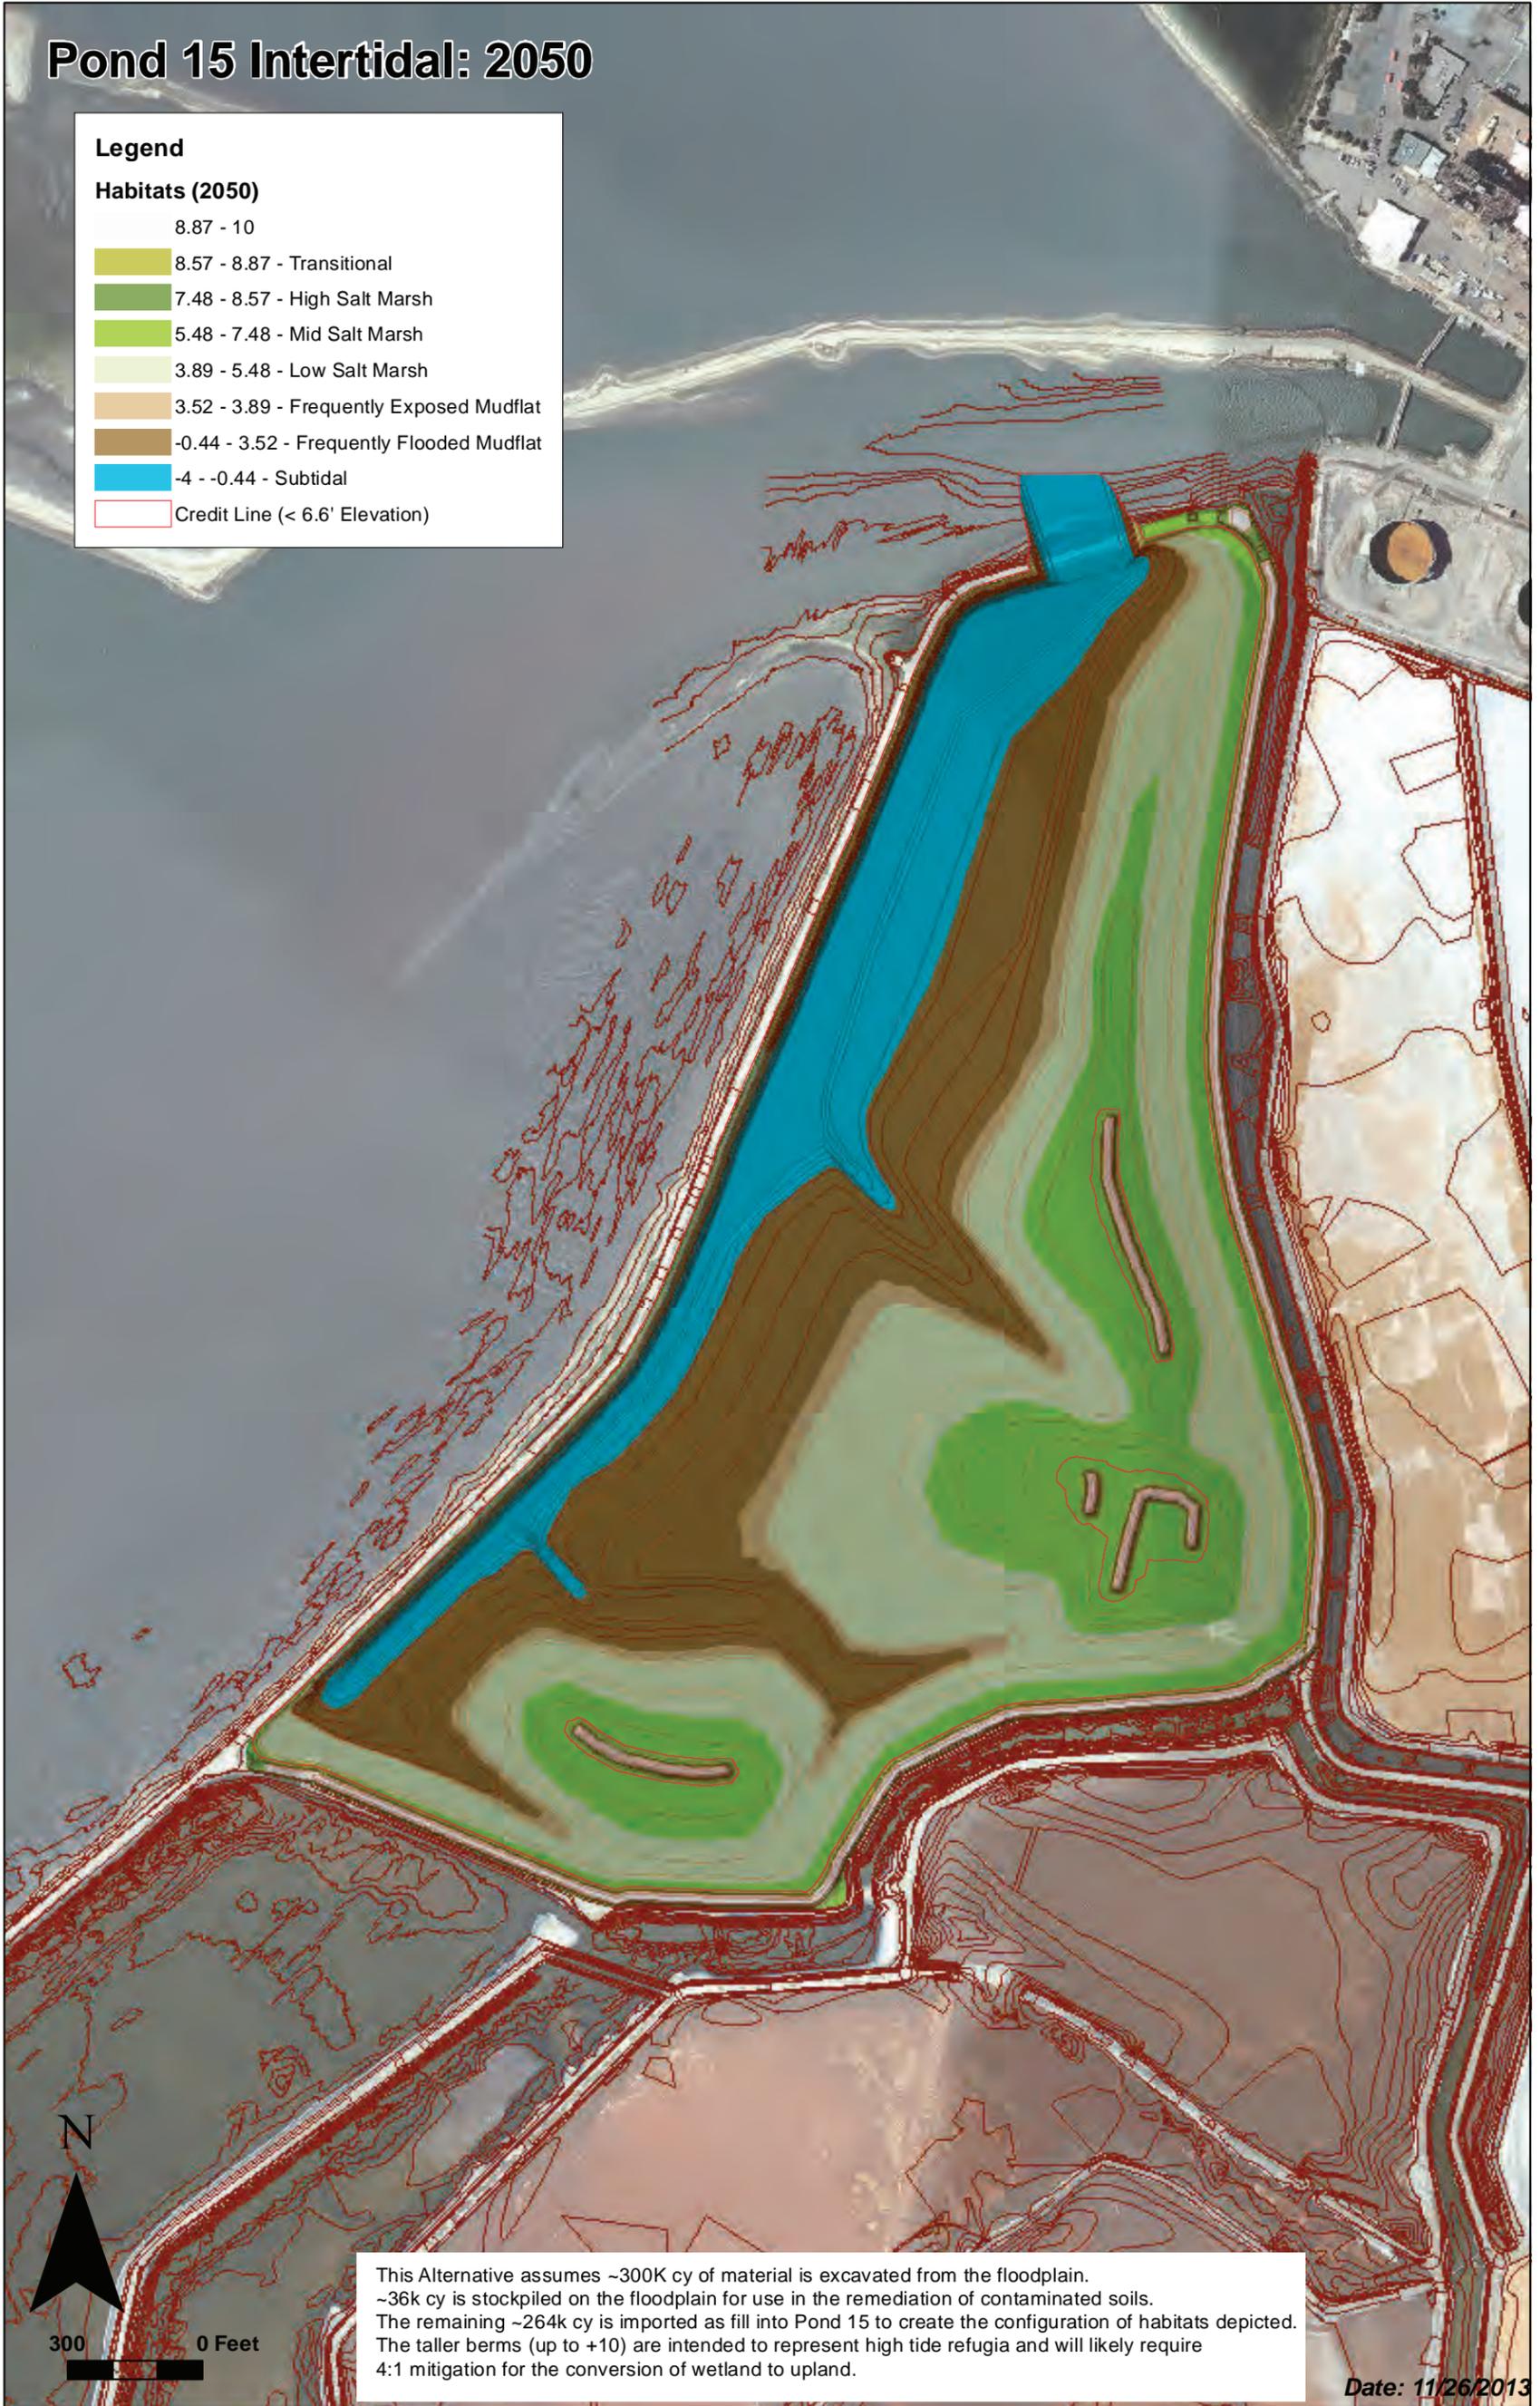
This Alternative assumes ~300K cy of material is excavated from the floodplain. ~36k cy is stockpiled on the floodplain for use in the remediation of contaminated soils. The remaining ~264k cy is imported as fill into Pond 15 to create the configuration of habitats depicted. The taller berms (up to +10) are intended to represent high tide refugia and will likely require 4:1 mitigation for the conversion of wetland to upland.

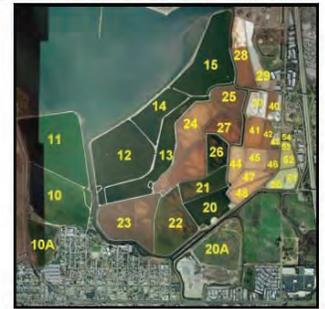
**FIGURE 29**  
**100 Year Flood Impacts –Change in Maximum Water Elevations when compared with existing conditions**

The differences in area flooding between the existing condition and proposed restoration are shown in Figure 29. Reductions in flood elevations primarily occur in the Otay River floodplain, Pond 20A, Pond 15 and Pond 20 through restoration of the Otay River Floodplain Site and Pond 15 Site. In addition, proposed restoration would reduce flood elevations at the north end of the bike path adjacent to Pond 48. In general, the proposed restoration would not change flood elevations in tidally influence areas, including the Western Salt Pond Restoration area (formerly Ponds 10A, 10, and 11). Stockpile areas, the Pond 15 Site, and the residential area near Palm Avenue are susceptible to flooding in the existing condition, but would no longer be flooded after restoration. Increases in 100-year flood elevations were found for the south end of the bike path along Pond 22, Pond 12, 13, 14, 28, and 29. The proposed restoration would not alleviate existing potential flooding of the bike path for extreme flood events (e.g., 100-year flood), but would prevent flooding of the bike path for smaller flood events (e.g., 15-year flood).

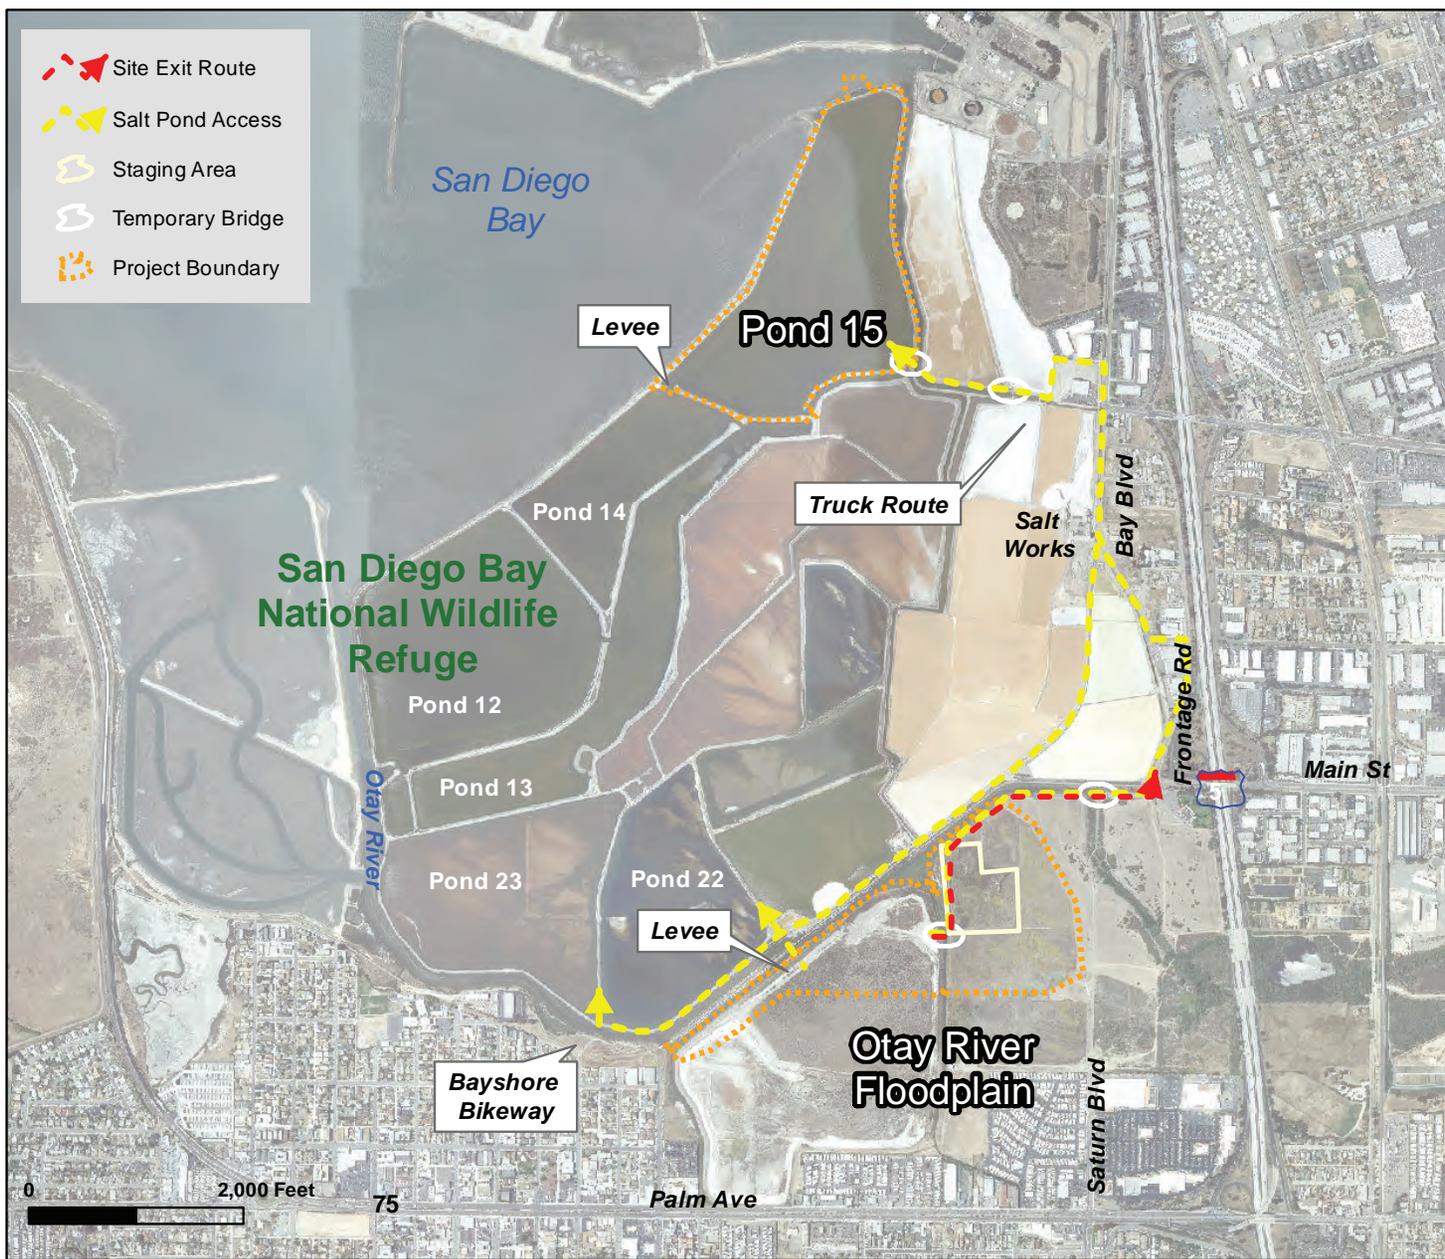
**FIGURE 30**  
**Project Construction Areas**

Roads that can be used for construction access routes in the vicinity of the restoration sites are shown in Figure 30. Saturn Boulevard is the north-south running road located along the eastern edge of the restoration plan area. The other major roads in the vicinity are Palm Avenue (State Route 75) to the south, Main Street to the north of the Otay River Floodplain Site, and Interstate 5 to the east. There are interchanges to Interstate 5 at Main Street and Palm Avenue. Using one of these interchanges, construction equipment would access the Otay River Floodplain Site via the north-eastern corner of the restoration sites where West Frontage Road, Main Street, and the Bayshore Bikeway intersect. Construction equipment would access the Pond 15 Site via a Service easement located off Bay Boulevard just north of the entrance to the Salt Works operational facility. To complete the construction work on the dike between Ponds 22 and 23, construction equipment would access the site via the main entrance to the Salt Pond Complex located off Bay Boulevard and then wind around the southern boundary of the Salt Pond Complex.

These methods, equipment, and schedules have been developed based on restoration plan requirements and constraints, in combination with experience from past projects of a similar nature. The construction methodology ultimately used would be determined by the contractor selected for construction with due consideration to the requirements specified in permits, agreements, and approval documents. If the selected contractor chooses a construction methodology that is substantially different than those considered herein then additional environmental review may be needed to verify that the restoration plan would not result in substantial environmental impacts beyond those already considered. Figure 30 provides locational information referred to as it relates to construction methods.

Staging areas would be located upland away from construction activities. The area east of Nestor Creek in the Otay River Floodplain Site would be used for staging (Figure 30). Stockpiling of excavated material for dewatering and sorting may also be carried out at this location. This area is also near the entrance/exit to/from the excavation site (Otay River Floodplain Site). Any permits and/or approvals required to conduct the dewatering activities would need to be obtained prior to commencing with this activity.

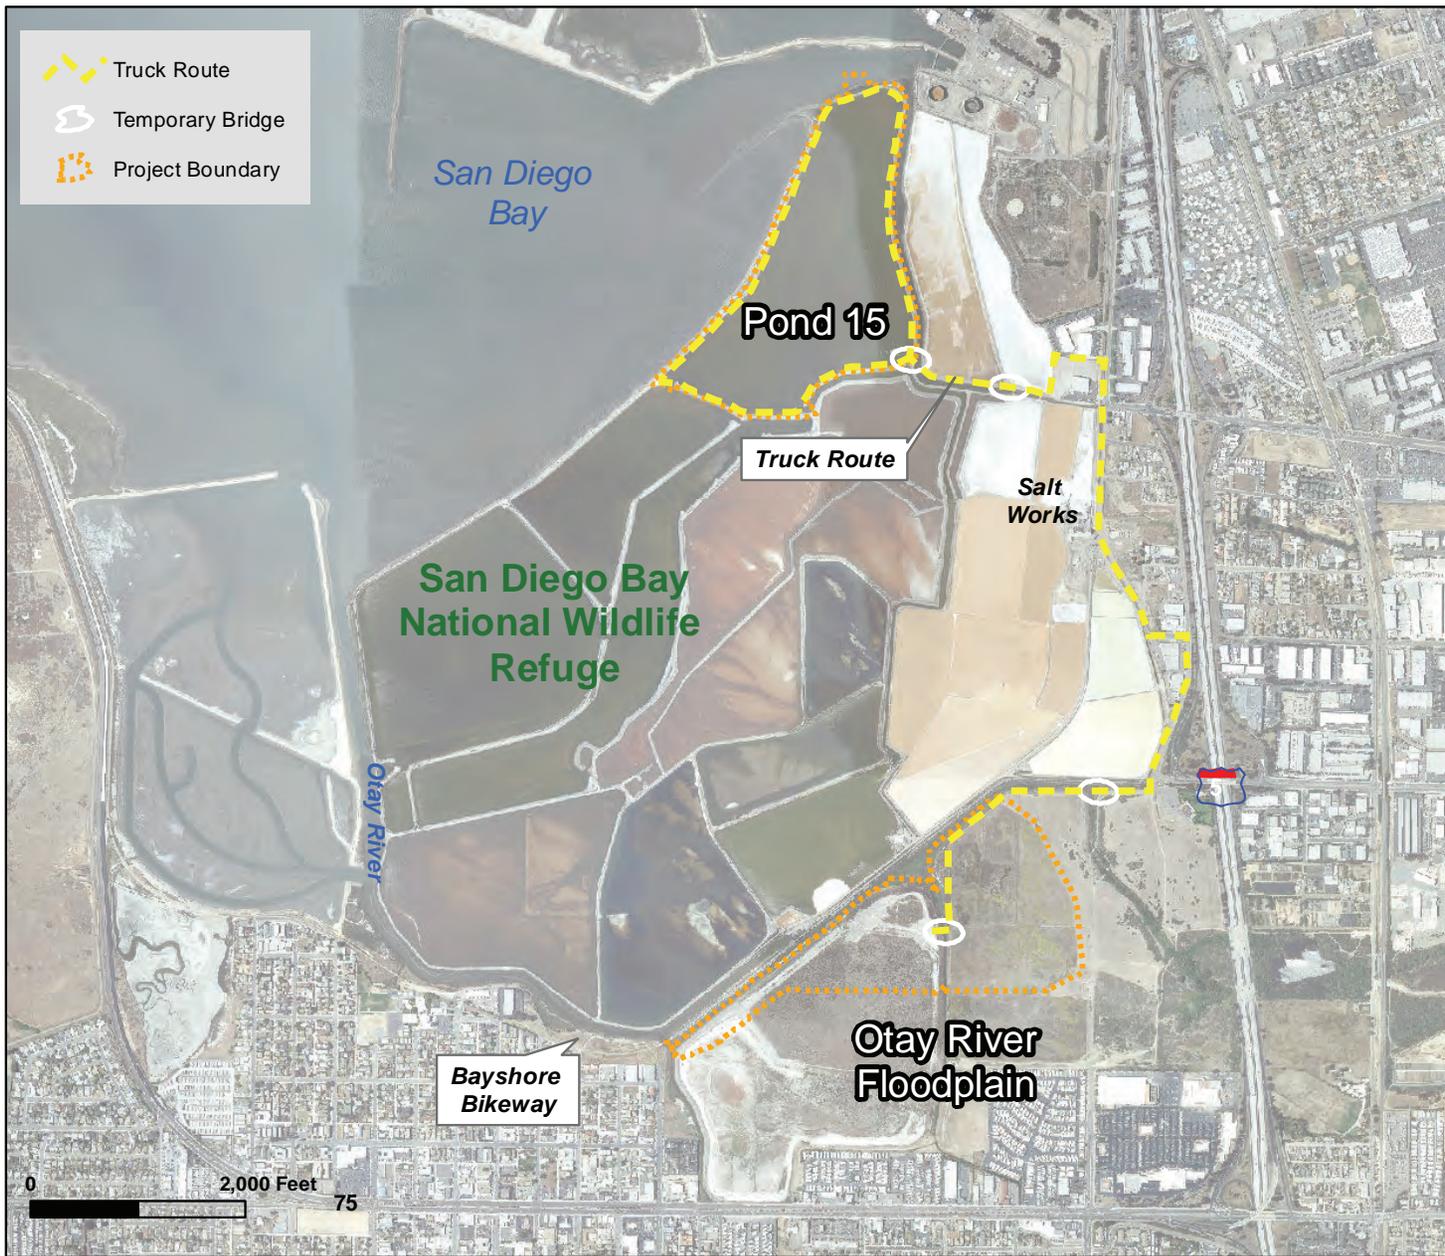
**FIGURE 31**  
**Truck Haul Routes**

Under this method, the contractor would use dump trucks to transport material from the Otay River Floodplain Site to the Pond 15 Site. The most likely truck haul route is shown in Figure 31. Temporary crossings would be necessary for the trucks to cross Nestor Creek and Otay River. Truck traffic on this route would interfere with the Bayshore Bikeway and City of San Diego bike path where the trucks exit the Otay River Floodplain Site onto West Frontage Road. Traffic flow at this intersection would be maintained by a flagman in order to ensure public safety. From West Frontage Road, the trucks would turn onto Anita Street and then to Bay Boulevard. The trucks would enter the Salt Ponds Complex via the Service easement located just north of the Salt Works operational facility off Bay Boulevard. The dikes within the salt ponds that would be used by construction traffic would be improved and widened to 30 feet to allow for two-way traffic, an exception is the dike around the Pond 15 Site where one-way traffic in a loop can be established. The dike improvements would likely require the placement of small amounts of fill into the ponds. Any such fill would be removed upon the completion of construction activities thus returning the ponded area to pre-project conditions. The round trip distance of the truck route shown in Figure 31 is about 5 miles. A round trip, including loading and dumping, would likely take about 36 minutes. A contractor using 12-cubic yard trucks would have to make about 28,000-34,000 trips.

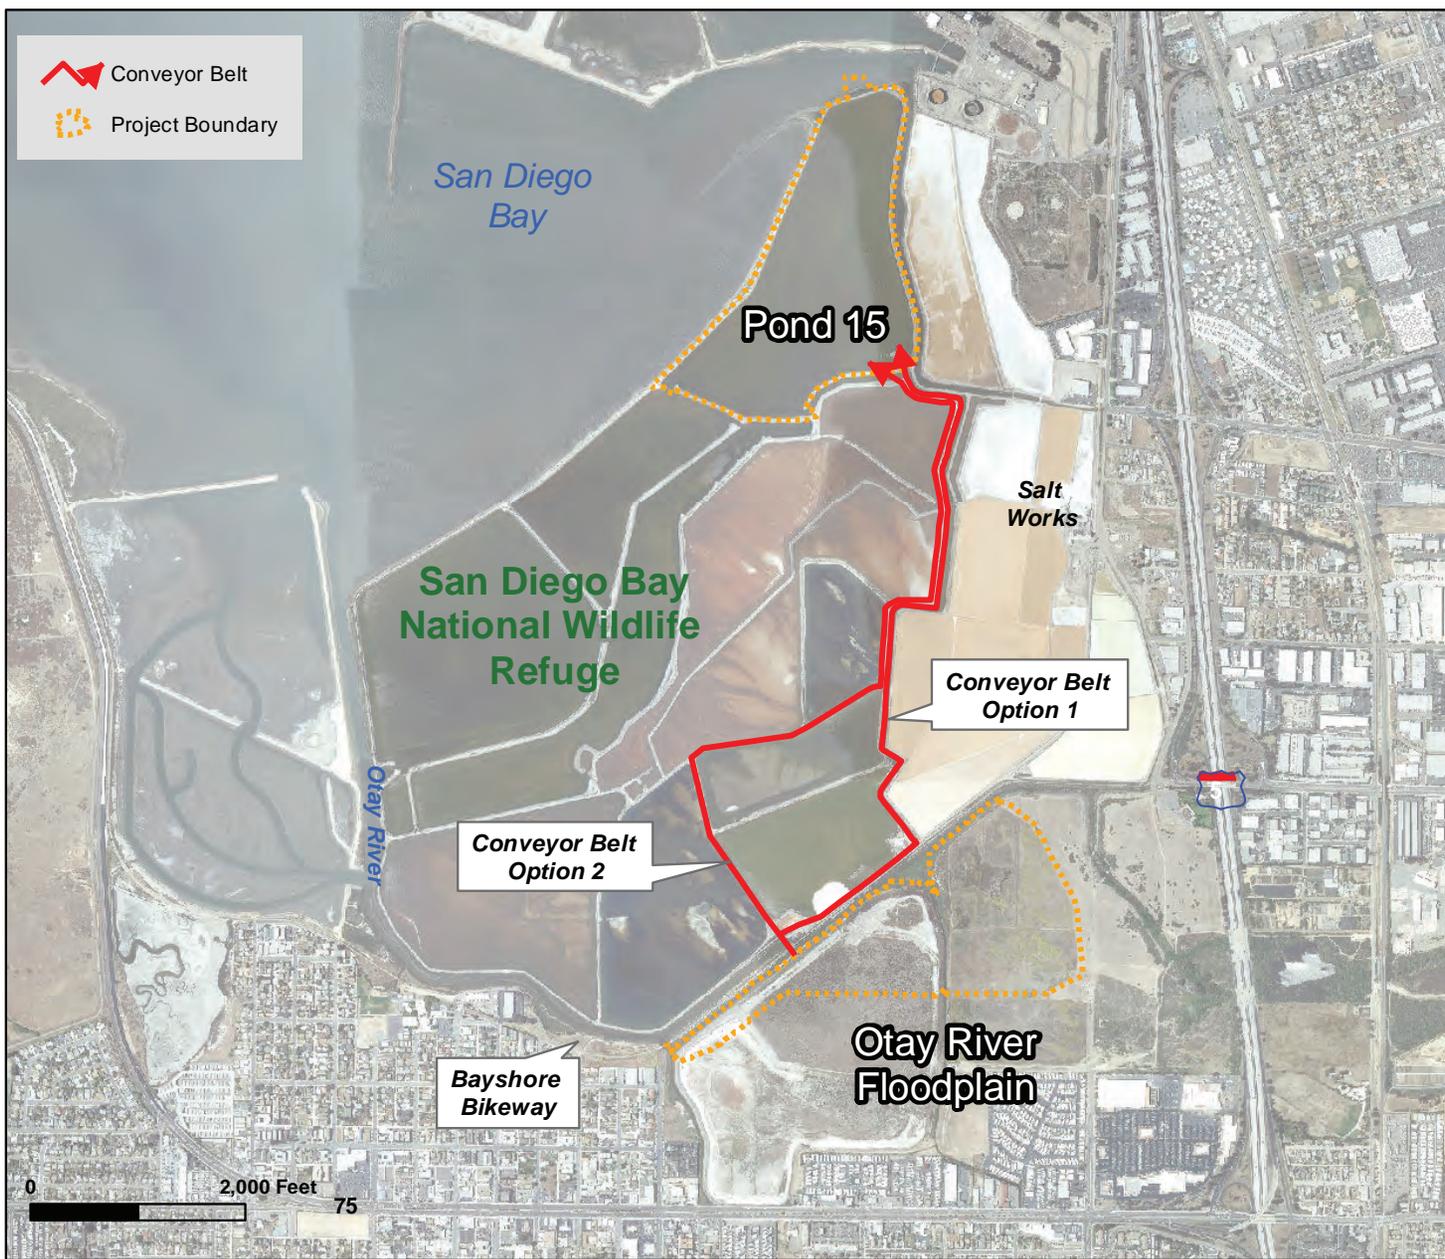
**FIGURE 32**  
**Conveyor Belt Haul Routes**

Under this method, the contractor would use a system of conveyor belts to transport material from Otay River Floodplain Site to the Pond 15 Site. Two possible routes are shown in Figure 32 and the length would be approximately 1.5 miles. The conveyor belt would be installed over the Otay River and under the existing eastern Bayshore Bikeway crossing. After crossing the Otay River and Bayshore Bikeway, the conveyor belt would continue northward using the existing dikes for support. One end of the conveyor belt would be near the Otay River Floodplain Site excavation site and the other end would end either directly into the Pond 15 Site or into awaiting trucks in the Pond 15 Site, which would move the material a short distance within the pond.

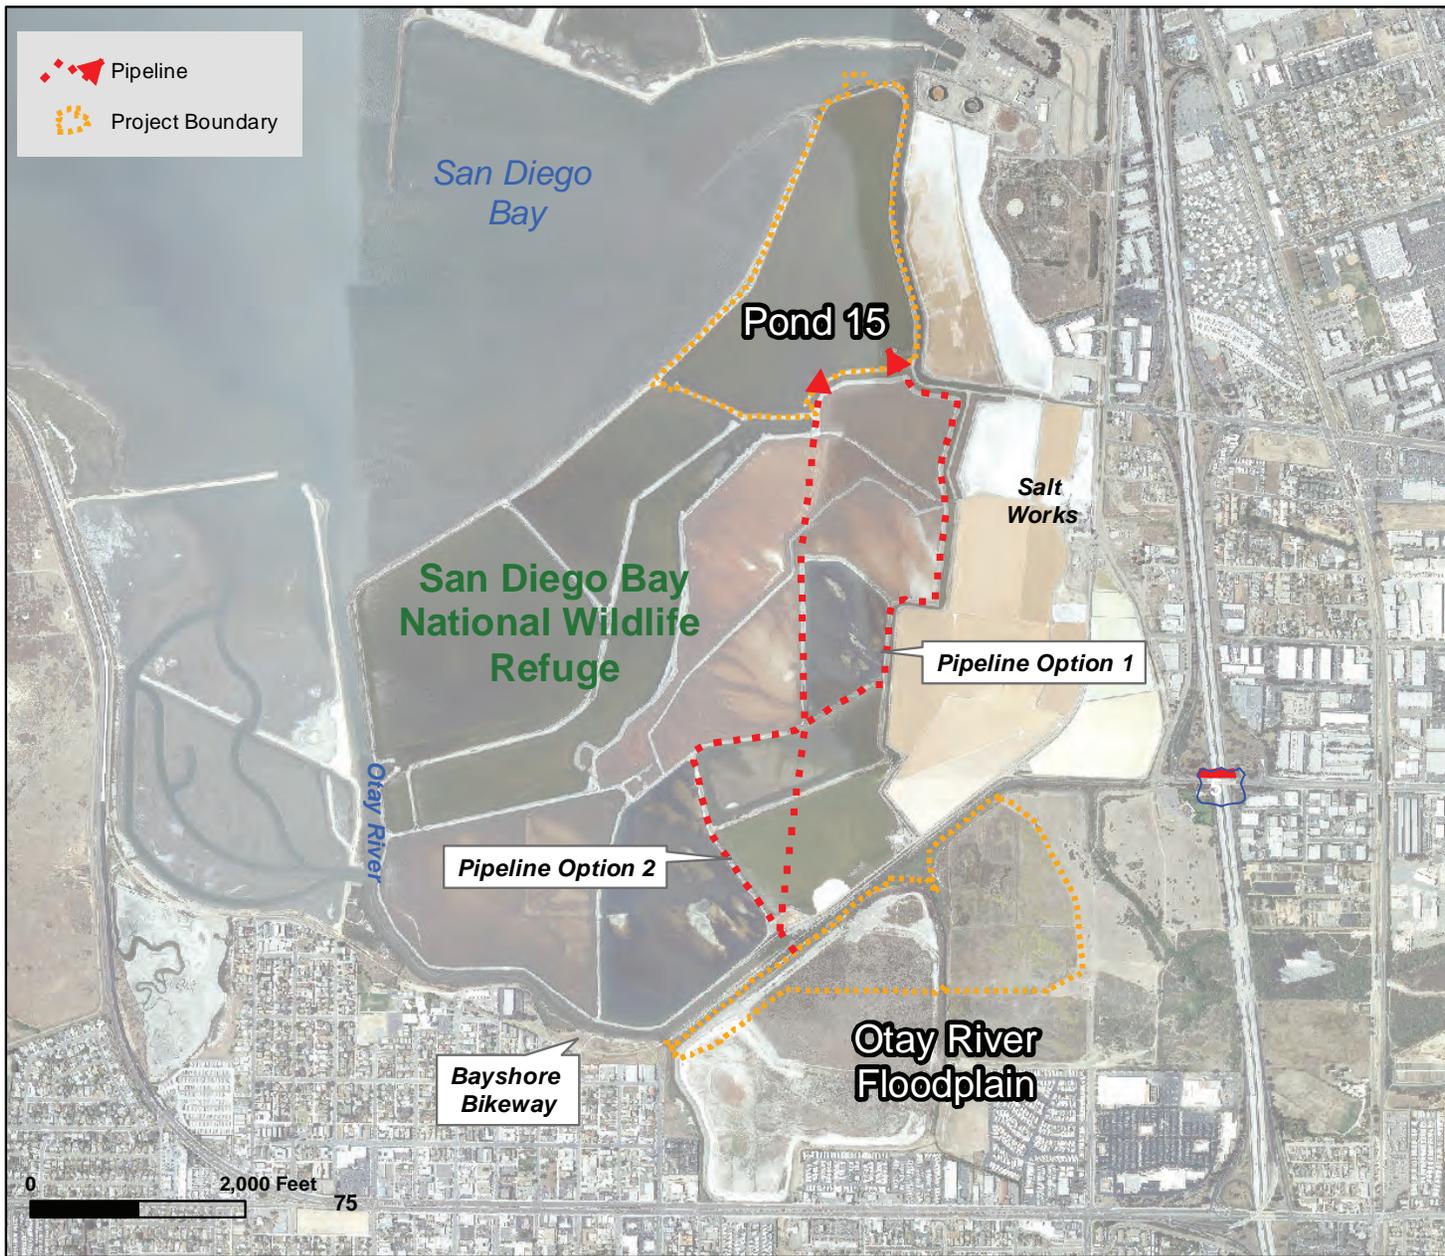
**FIGURE 33**  
**Pipeline Haul Routes**

Under this method, the contractor would use a pipeline to hydraulically transport material from Otay River Floodplain Site to the Pond 15 Site. Two possible pipeline routes are shown in Figure 33. The pipeline would be installed over the Otay River and under the existing eastern Bayshore
